Sinnemahoning Portage Creek In-Stream Habitat Assessment

December 2013

Western Pennsylvania
Conservancy

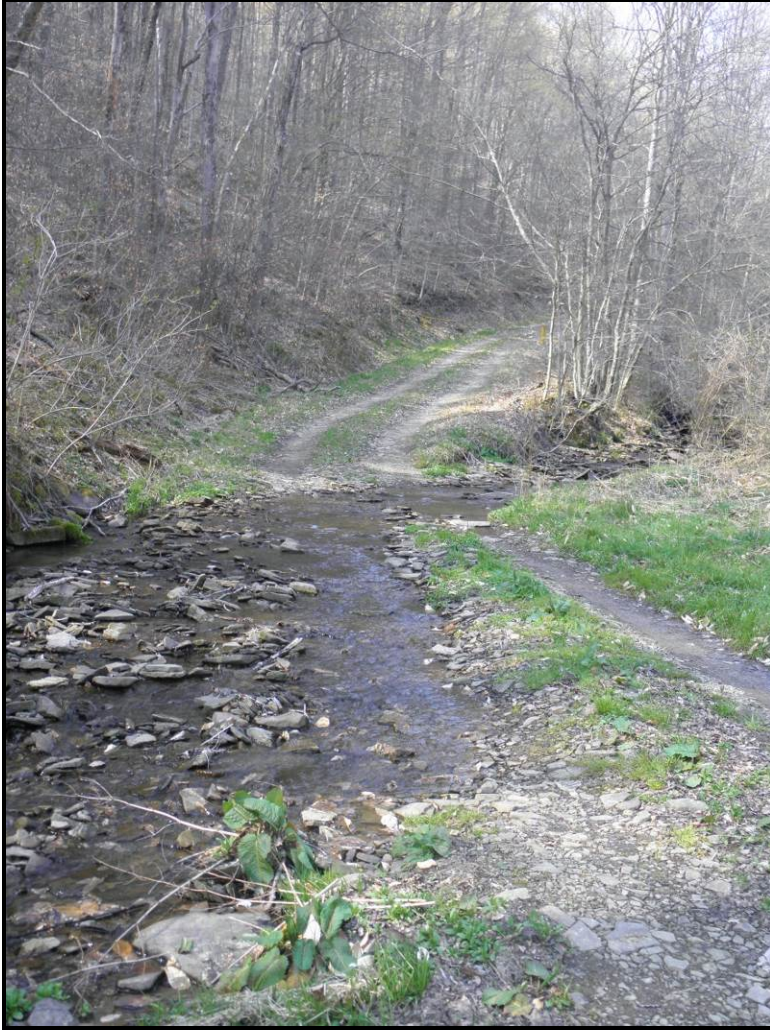
Moderate sediment contributions to the streams were noted due to a dirt and gravel road (gated and locked) that runs parallel for a majority of the mainstem of Half Mile Run before splitting and following along the two branches. Generally, the road maintains a distance from the stream channel; however, it is affecting the riparian zone for its length. The road also fords the stream at multiple locations, creating potential sources of increased sedimentation (Figure 17). Sediment deposition was evident enough on segment 1904 for the reach to be scored as Marginal for that category; however, the minimal use this road receives is likely why the issue is not more severe. Potential stormwater inputs from road ditches are also contributing sediment to the stream. Dirt and gravel road projects were mentioned as possible improvement opportunities in the places where the road is impacting the stream, therefore it is likely this will be a top priority project for improvements to Half Mile Run.

Figure 17. Ford on segment 193, Right Branch of Half Mile Run

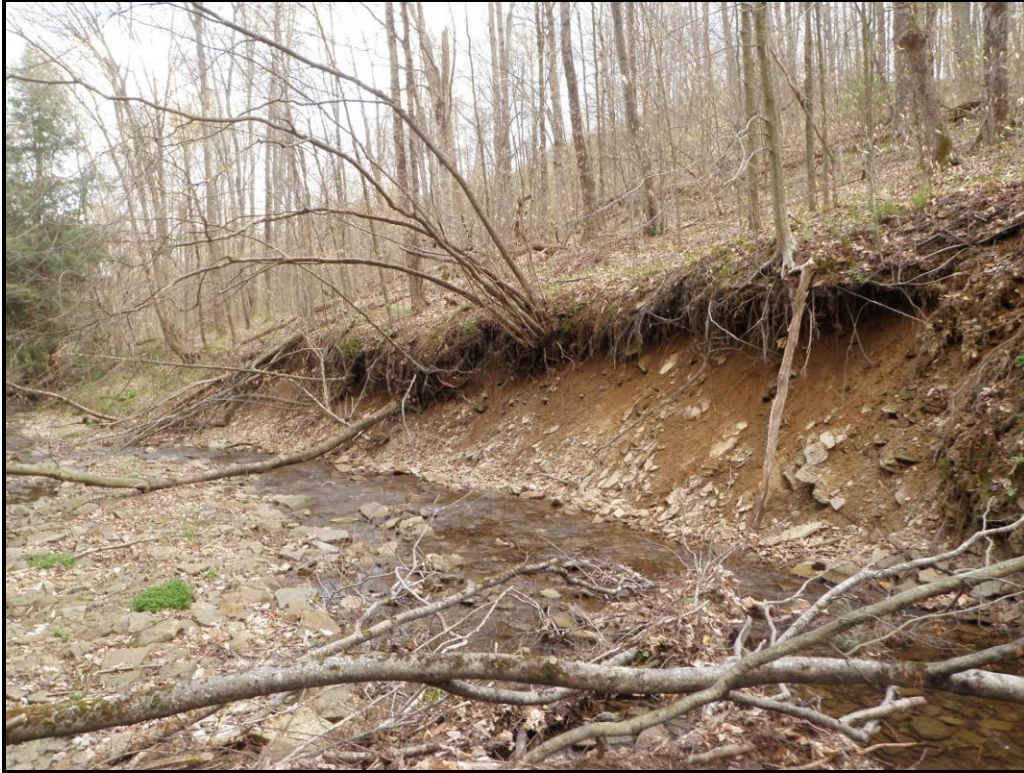
Bank stability and riparian vegetation scores for the subwatershed were all in the Suboptimal or Optimal range. However, there was photographic documentation of eroding banks, the most severe being on segment 1236 (Figure 18).

Figure 18. Actively eroding bank on segment 1236

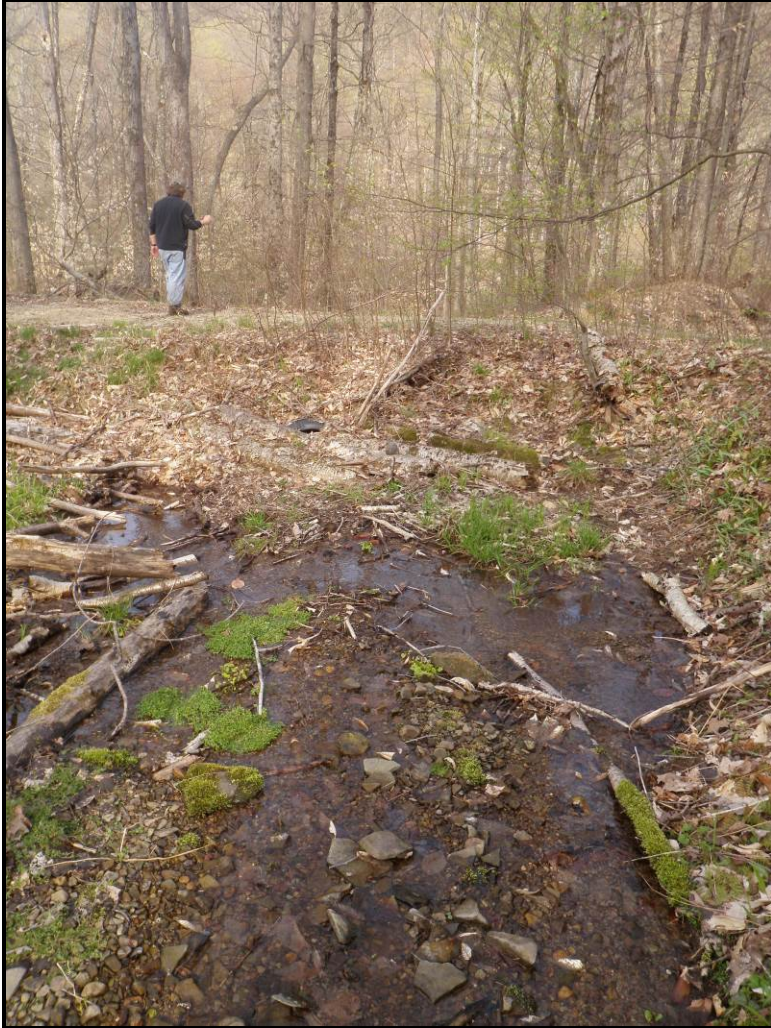
Figure 21. Debris choked culvert on segment 1149

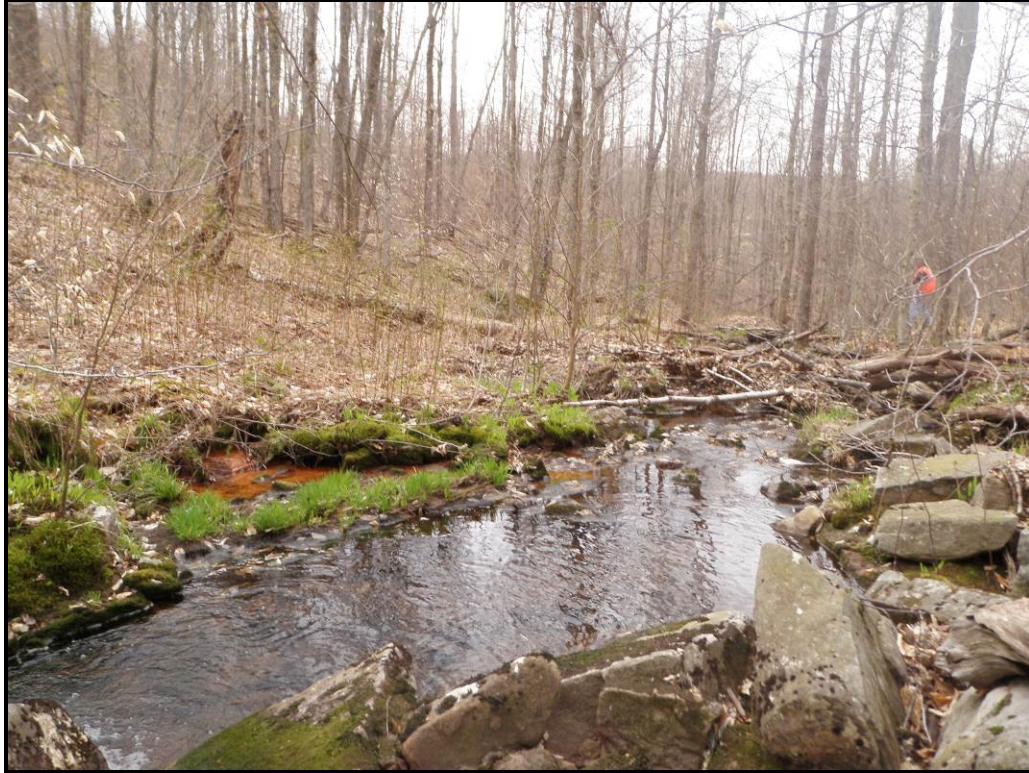
Figure 22. Iron seep in the headwaters of Parker Run, segment 1177

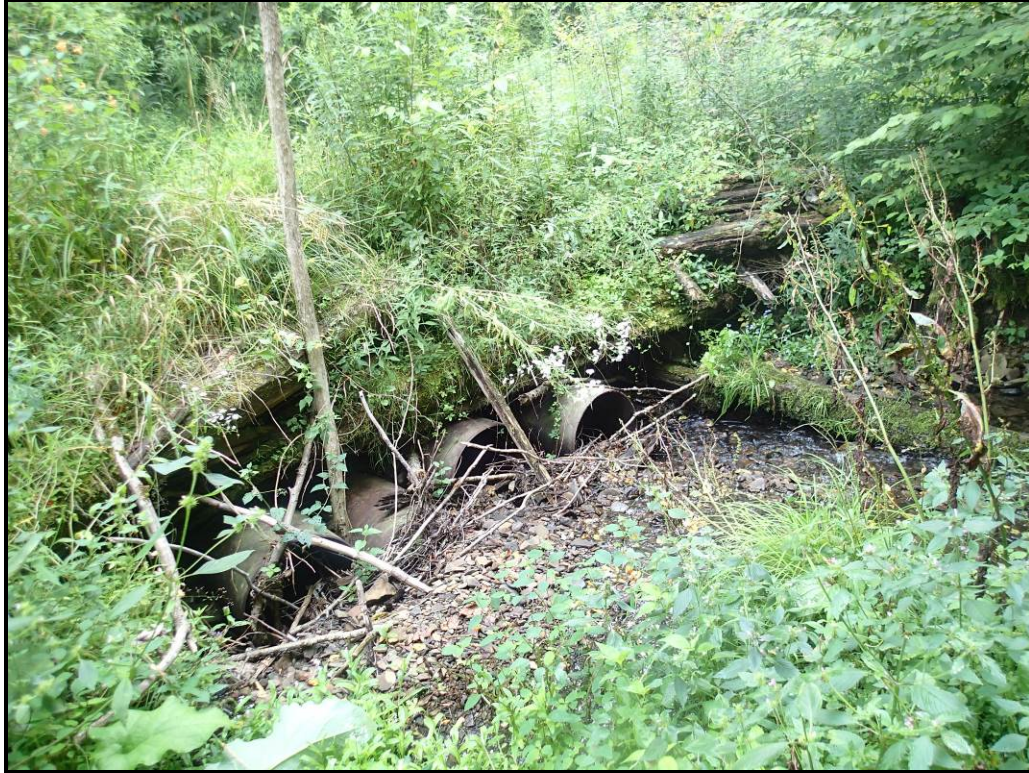
Figure 23. Debris choked culvert on Little Parker Run

The largest and likely most expensive project in the Parker Run subwatershed is the replacement of culverts on Little Parker Run. This location is the site of multiple pipe culverts underneath a road crossing that is collapsing, is poorly aligned and is choked with debris (Figure 23). Replacing this culvert will improve aquatic organism passage to more than three miles of upstream habitat. WPC has been in contact with the landowner and received permission to pursue funding to replace this culvert and will likely do so during the summer of 2014. Additional locations were noted throughout the watershed that could benefit from culvert improvements or upgrades. McKean County Conservation District is planning to implement dirt & gravel roads improvements in the watershed and will be a valuable partner in completing these projects.

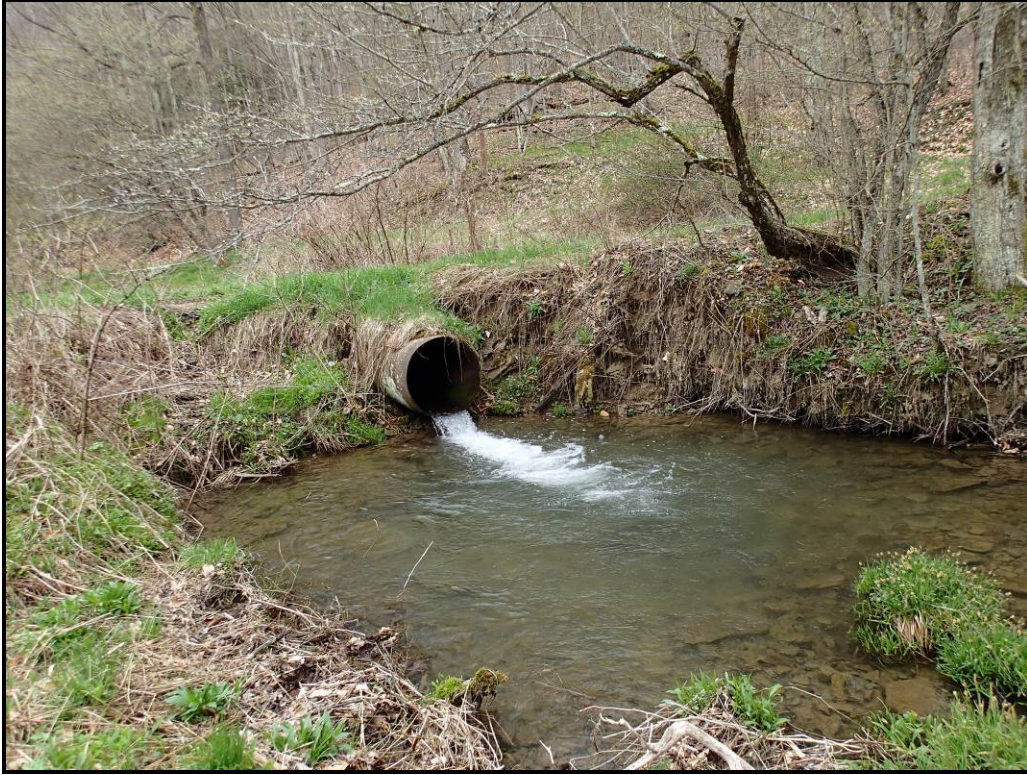
Figure 24. Potential culvert replacement project on segment 1637

The North and South Branches of Indian Run, which enter Parker Run near its confluence with Sinnemahoning Portage Creek, is the site of two potential projects. Dirt & gravel roads in this section access areas away from the riparian zone but intersect the tributaries at two locations. One location is a ford that could be stabilized near the bottom of segment 1691. A culvert replacement project to enhance aquatic organism passage on segment 1637 (Figure 24) would also be feasible, especially due to easy access using the intersecting road. These roads are private, see limited vehicular traffic, and are used primarily by leasers to access the property. Due to the close proximity of these project sites, they could be completed at the same time, reducing sediment impacts to Indian Run and re-opening more than one mile of the North Branch of Indian Run for fish passage. Most of this property is managed by FORECON, Inc. out of Smethport, PA, and preliminary discussions regarding improvement projects were favorable.

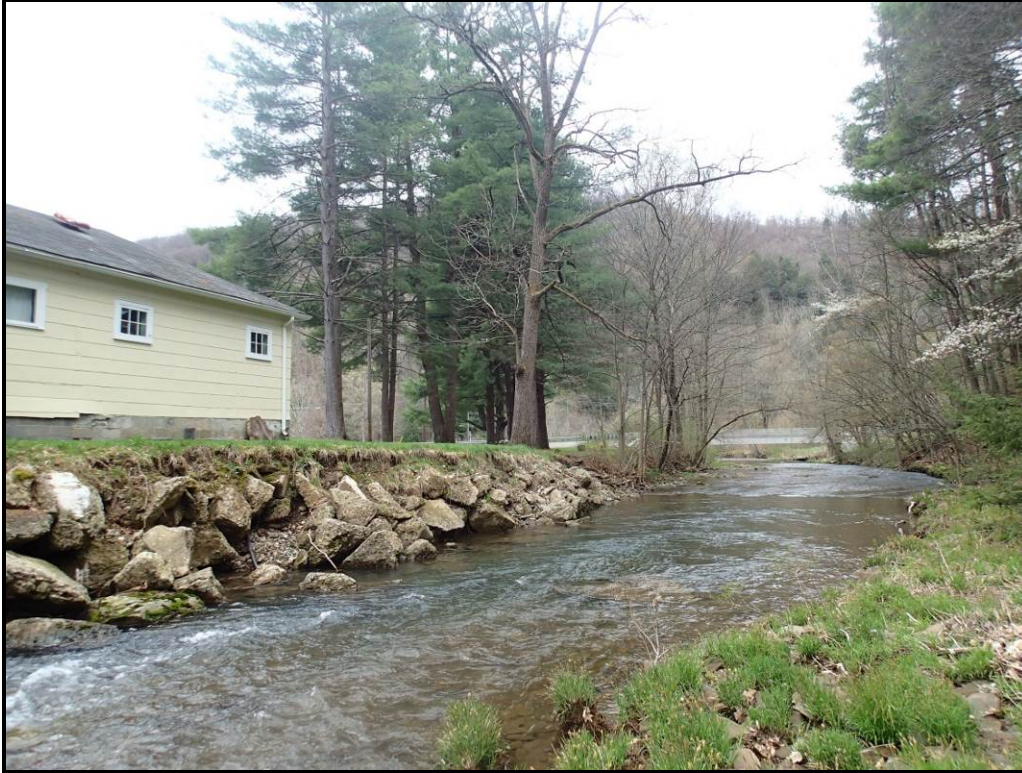
Bank stability impacts to Cowley Run are primarily related to upstream channelization and stream stabilization efforts on the East Branch of Cowley Run. Increased water velocity has been addressed by utilizing rip-rap along the banks of Cowley Run (Figure 27). This has reduced erosion to a degree; however, erosion remains a primary concern at locations that have not been stabilized in this fashion. Riparian zone encroachment is also an issue on Cowley Run mainstem due to residential and seasonal homes; however, it tends to be limited to the left descending bank of the stream on all three segments (1708, 1824, and 1946). During the assessment, landowners along these three segments expressed an interest in cooperating with local and agency interests in improving streamside and in-stream habitats. Section 1946 was noted as having significant LWD present throughout the reach; however, the property adjacent to the stream is for sale and could have an impact on this section in the future.

Figure 27. Rip-rap stabilization and riparian zone encroachment on Cowley Run, segment 1708

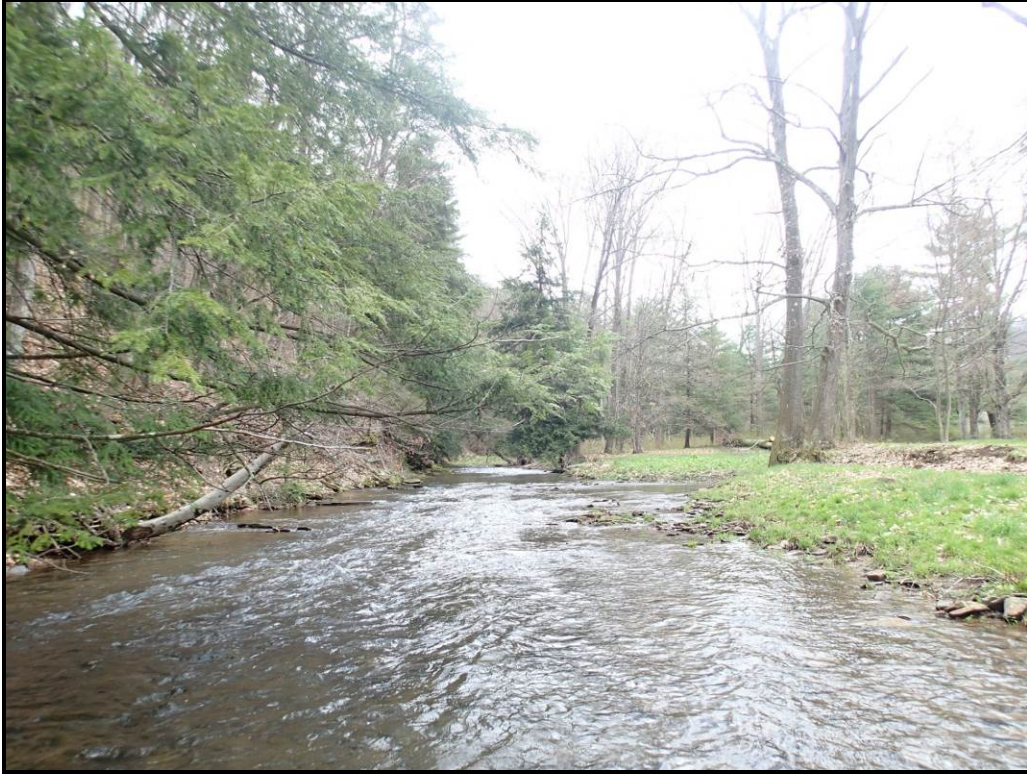
Figure 28, Potential riparian planting project site on Cowley Run, segment 1946

Streambank stabilization and restoration on section 1824 are recommended (Figure 30), with one caveat. Due to stabilization efforts and channelization on the East Branch of Cowley Run, improvements to streambanks on this section of Cowley Run can only be completely successful once upstream improvements are made. Riparian buffer plantings on sections 1708 and 1946 are recommended (Figure 28). An additional streambank protection project would be to consider the purchase of the land that is for sale along Cowley Run to ensure that the quality habitat on the section is protected into perpetuity. Additional in-stream habitat could also be improved within the shallow and wide segments within Cowley Run.

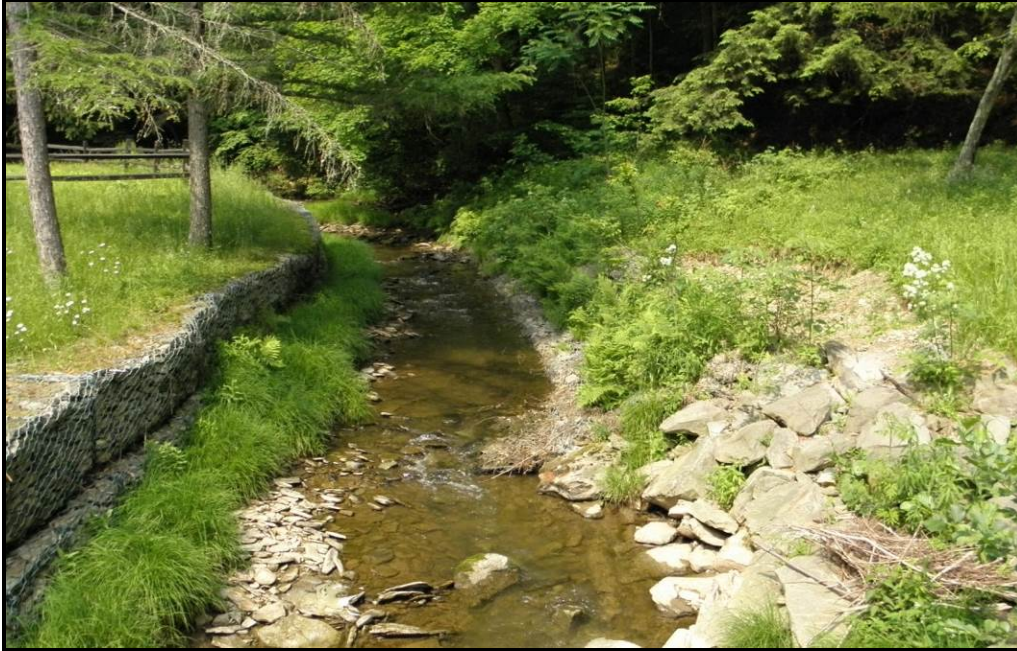
Figure 31. Gabion baskets and riprap serve as bank stabilization on segment 1002

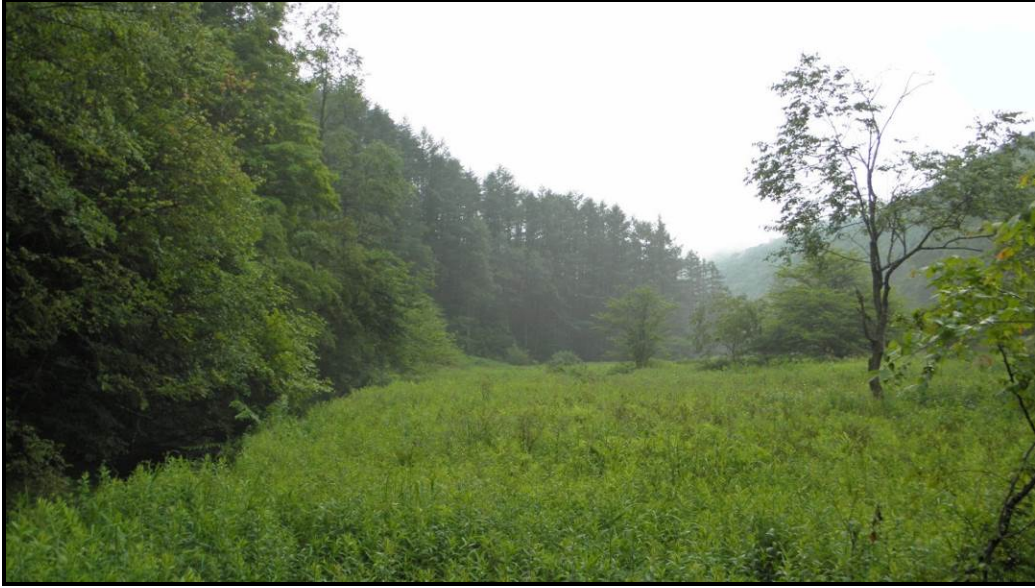
Figure 33. Segment 1927 would benefit from riparian buffer enhancement

Riparian buffer enhancement would benefit the West Branch along segments in the state park and on the private property upstream, segment 1985. Segment 1927 would be an excellent location for a riparian planting project due to the segment being wholly contained by state forest land (Figure 33). Access would be a challenge for the upper portion of the reach and would require that planting equipment and materials be packed in to complete the restoration project. This project is still recommended to the overall benefit it would have to this segment of the West Branch, as well as downstream reaches.

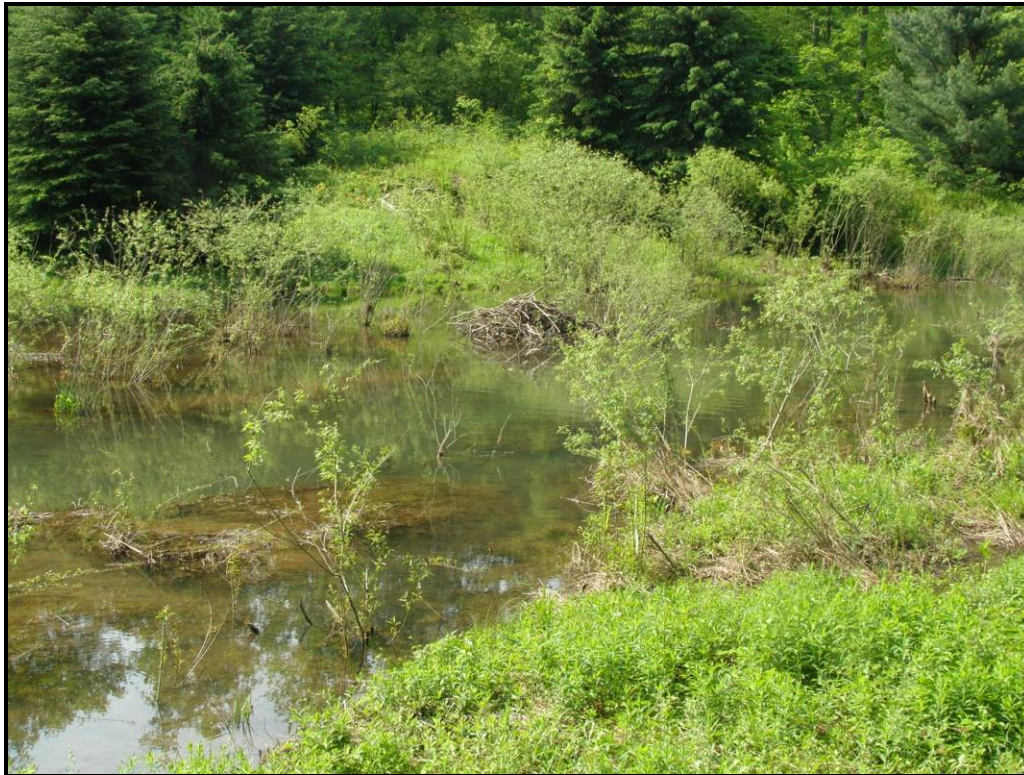
Figure 36. Beaver complex along segment 1633, East Branch Cowley Run

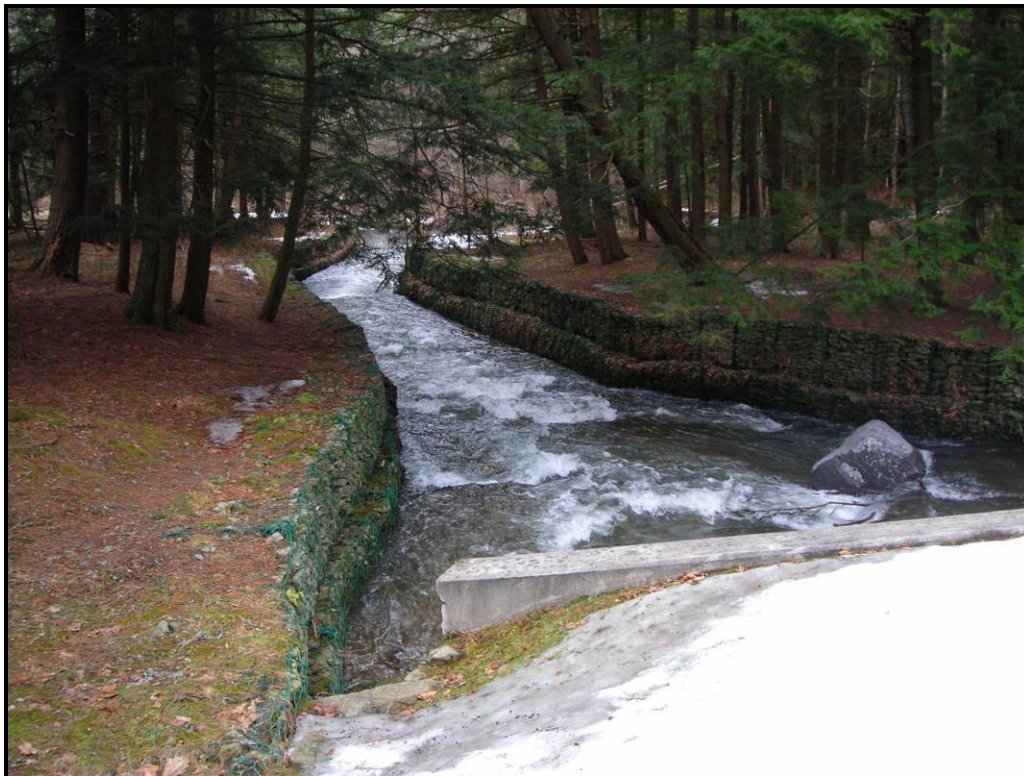
Figure 37. Streambank stabilization using gabion baskets in Sizerville State Park, segment 1090

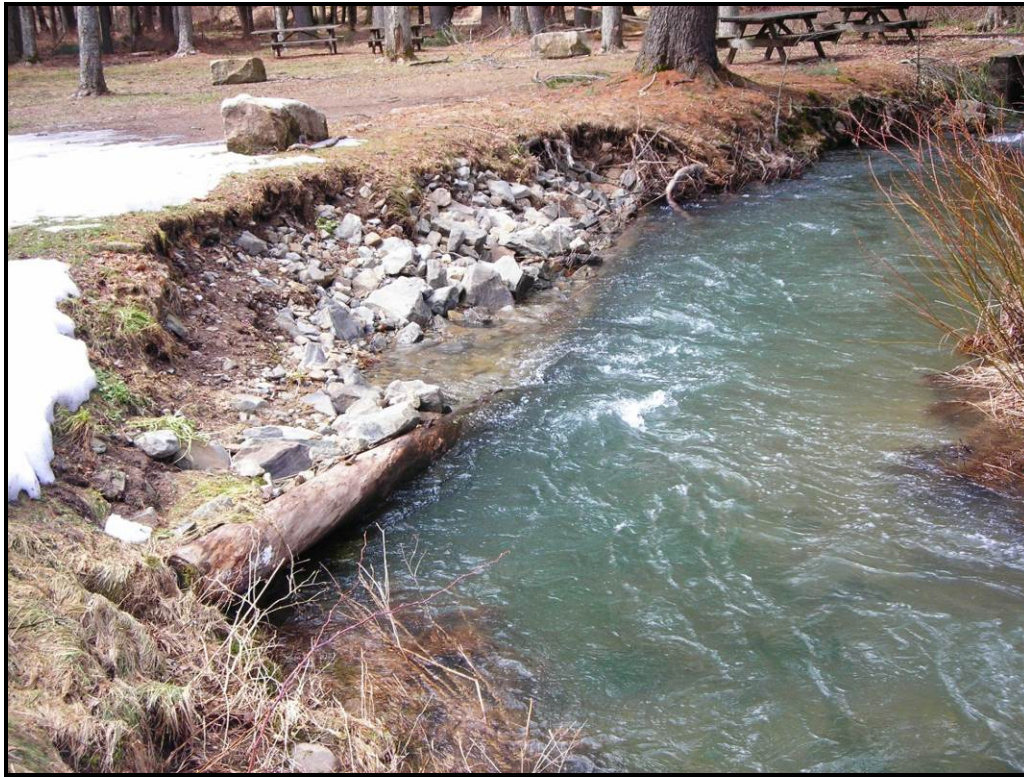
Figure 38. Severe bank stability issues evident with this failed mudsill along stream segment 1090

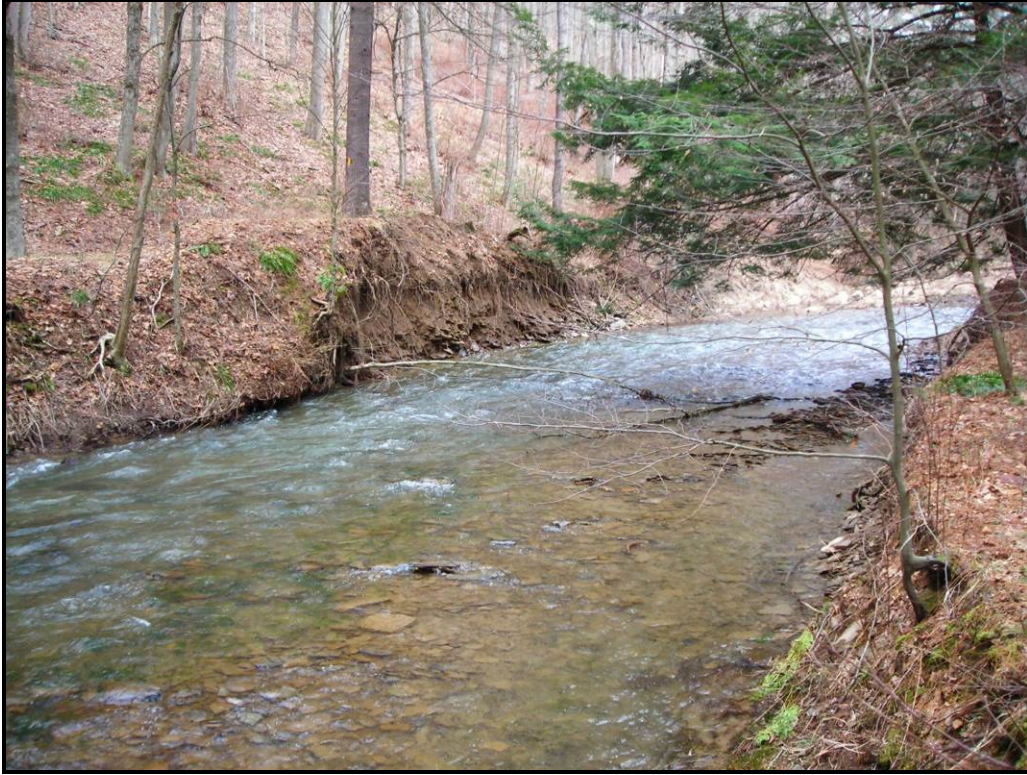
Upstream of the lower bridge on East Cowley Run, it appears the stream channel was moved at some point in time, perhaps to maximize recreational use for picnics. An apparent unnatural berm can be observed along this section of stream. Several areas against the high bank and on the opposite bank toward the picnic area were eroding. Within this section of the park, the stream appears to jump its channel at several locations during high flows, causing additional erosion in areas away from the normal flow channel (Figure 39). It appears the stream may be trying to re-establish a more meandering pattern within the floodplain. The park uses the area for picnicking, and therefore, competition for space exists.

Figure 39. Evidence of stream channelization and resulting erosion on segment

Re-establishment of a natural stream channel and reconnection of the stream to the floodplain near the mouth of the East Branch is recommended. Addressing erosion areas upstream of the bridge to the camping area (downstream most bridge over East Cowley Run) will reduce the amount of sediment in the stream. Some channel blocking structures or additional measures to better control or redirect the stream during high flow could also likely be constructed to help reduce erosion at high flow. Construction of devices that allow the stream channel to meander more naturally would reduce erosion outside the present channel at high flows. There may also be opportunities to reduce runoff from the road and adjacent drainage ways within this section.

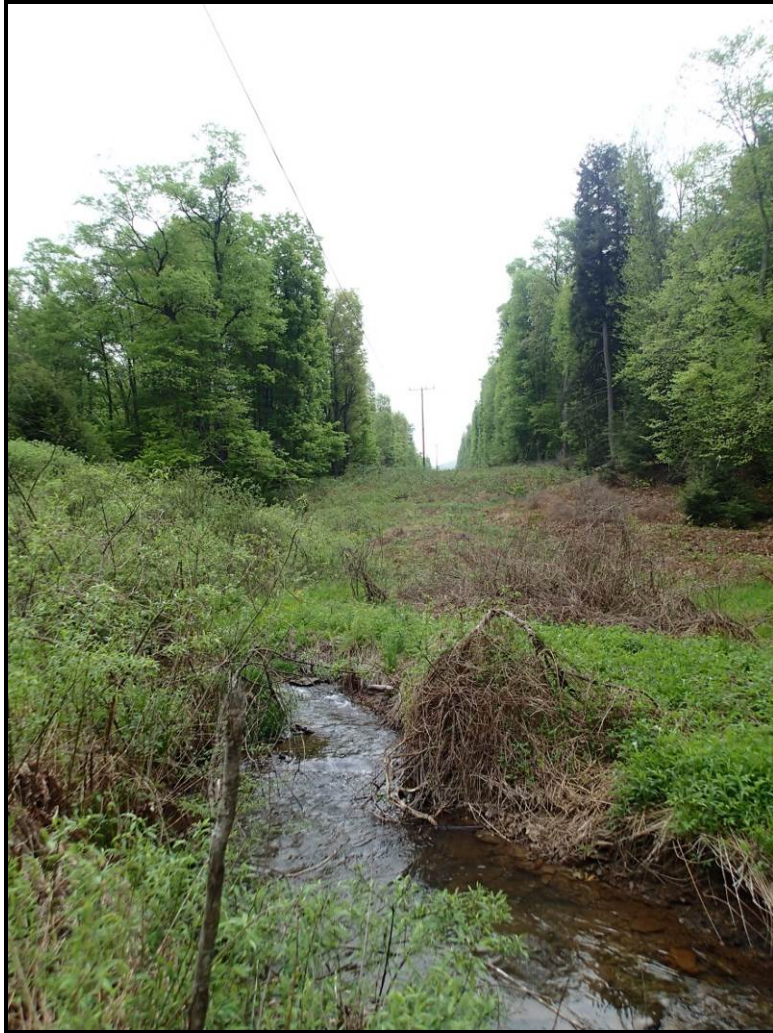
Beyond the boundary of the state park, the most prevalent issue is the presence of the power line that runs along the mainstem of East Cowley Run. The utility line and subsequent maintenance have limited the width of the riparian zone. This is notable on segments 1181, 1362, 1375, 1559 and 1633, but most apparent on segment 1481 where the wide power line right-of-way completely intersects the stream before continuing uphill towards Ridge Road (Figure 40). Segment 1481 has an overall score of Marginal due to the effects of the power line on the riparian area and resulting impacts to in-stream habitat. Canopy cover is limited, epifaunal substrate lacking, embeddedness abundant and the channel is very mobile, due to the lack of stabilizing elements.

Figure 40. Power line right-of-way maintenance has a significant impact on segment 1481

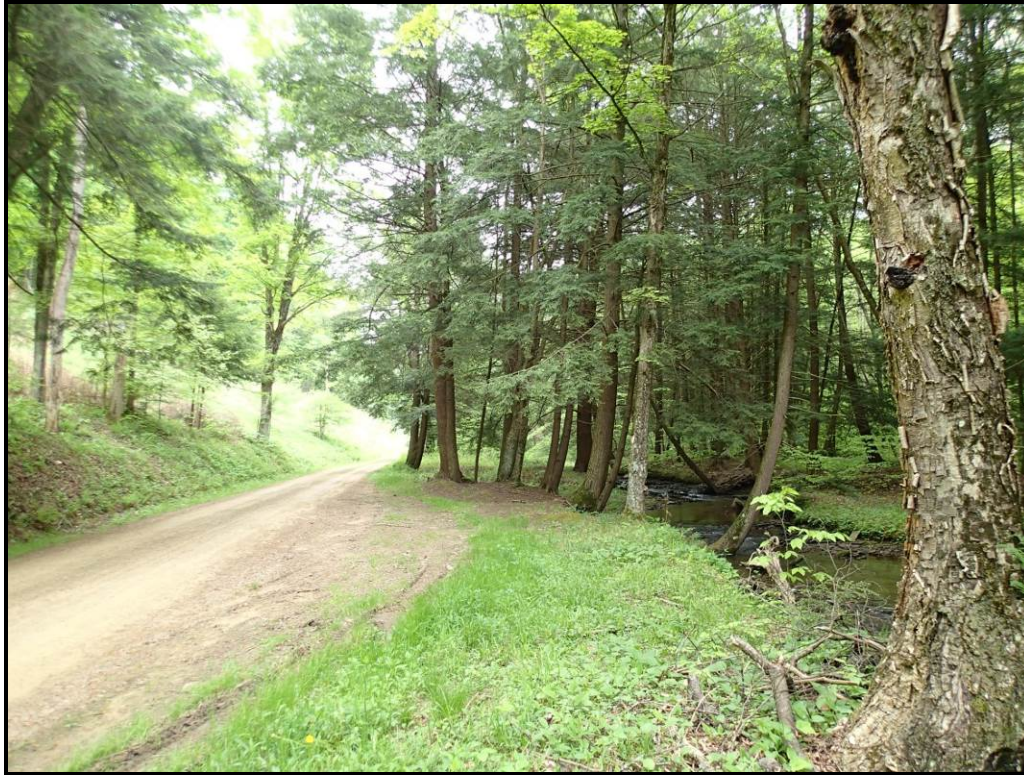
Dirt & gravel road impacts are notable on the East branch of Cowley Run. On the lower segments, there are a number of locations where the stream and road are in close proximity (Figure 41), within several feet in some cases. This increases sedimentation of the stream as the riparian buffer has been compromised; streambank stability is also a concern. Stream flow undercutting the roadbed was noted along segment 1362. Segment 1559 received a Marginal overall score due to the proximity of the road and utility line. Resulting impacts to riparian buffer width, in-stream habitat and bank stability due to the adjacent road were identified by field staff.

Figure 41. Dirt & gravel road impacts on riparian zone width, stream segment 1559

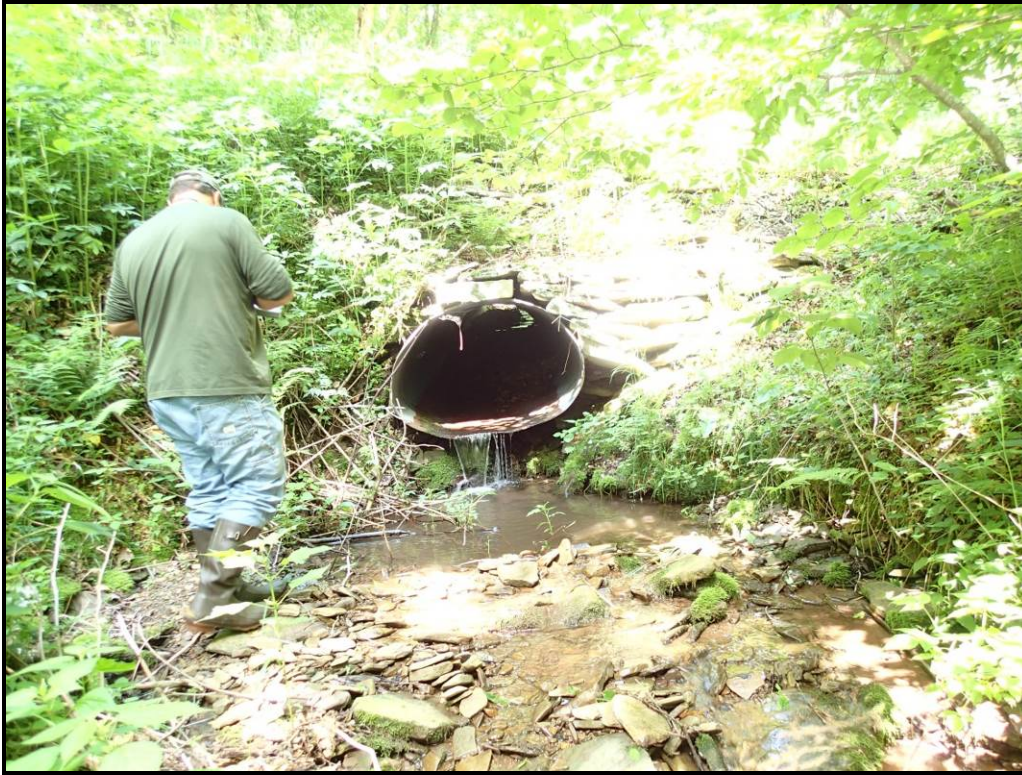
Figure 42. WPC staff evaluate a potential culvert replacement project on segment 1838

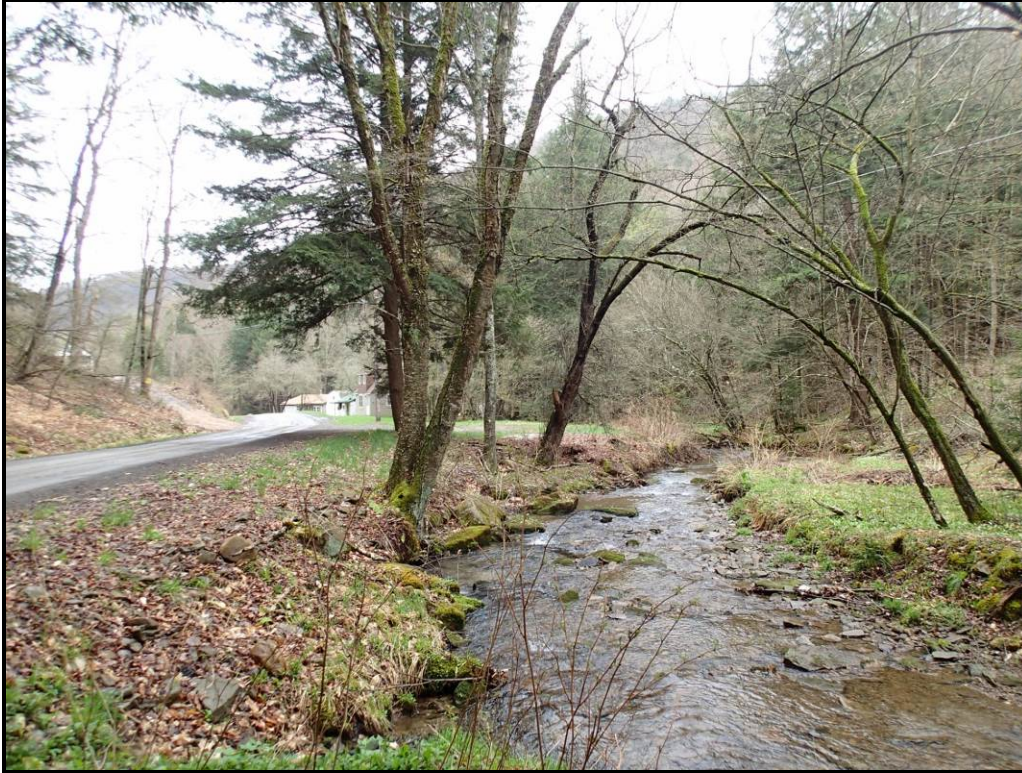
Figure 45. Sizer Run Road limits riparian zone width on the upper portion of segment 1949

Sizer Run would benefit from improved road drainage. Large amounts of deposited sediment were noted on segment 1380, which parallels Sizer Run Road. Additional heavy sediment accumulation was noted along segment 1949 at the location where the stream runs close to the road along its left bank before being culverted under the road. While this culvert was likely sized properly and does not create a fish barrier, the pool at its outlet had significant amounts of fine sediment deposition. One culvert that does create a significant fish barrier is located just upstream of the mouth of Sizer Run (Figure 46). This culvert passes under Sizer Run Road, which at this location is still paved. The culvert is quite large and a replacement project would likely be challenging and costly; however, improving fish passage at this location would benefit the entire Sizer Run subwatershed. Sizer Run watershed, while small, could certainly benefit from restoration projects along its mainstem (Figure 48).

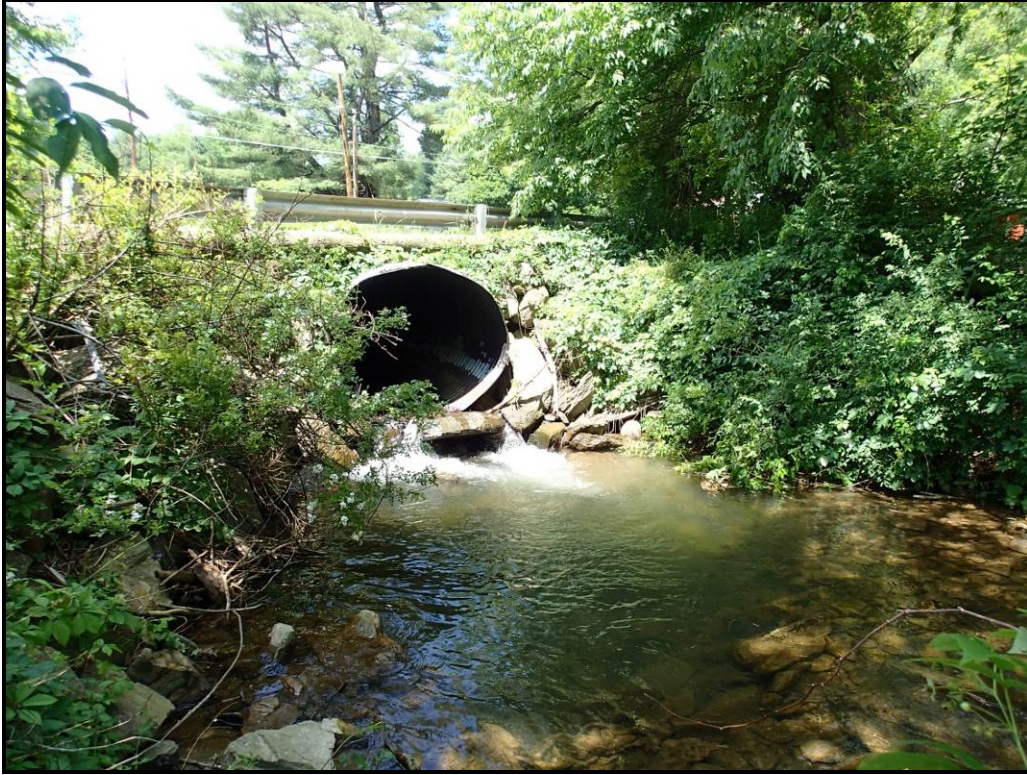
Figure 46. Potential aquatic organism passage improvement project on segment 1347

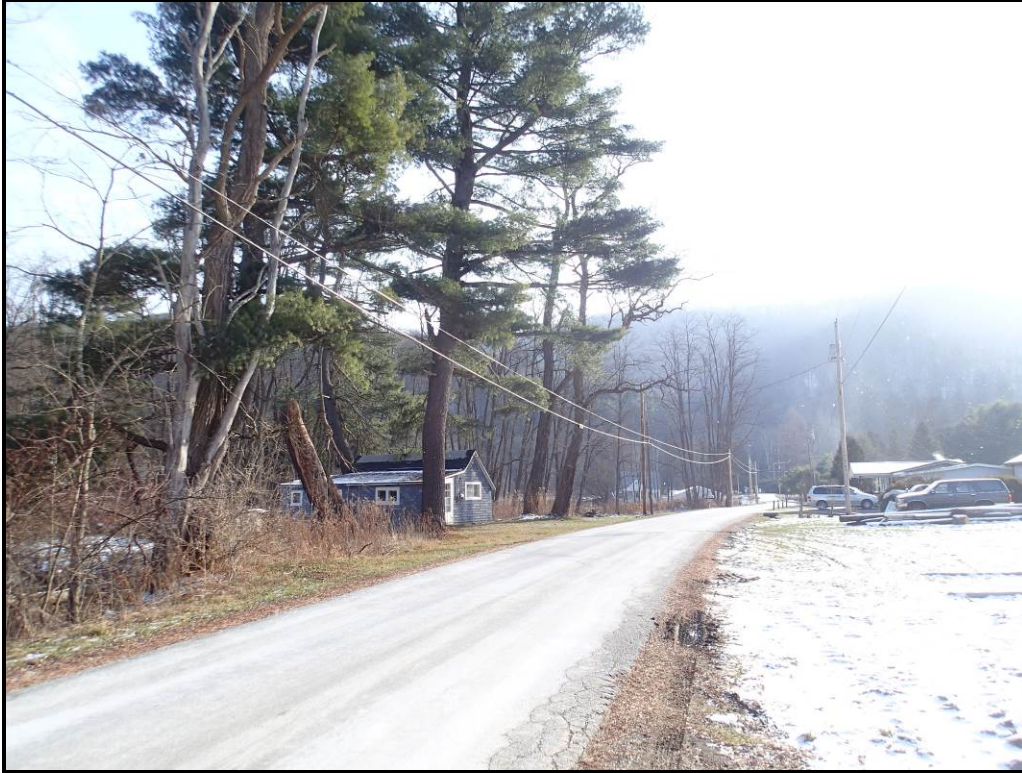
Residential land use is one of the primary contributors to this subwatershed. Access lanes, driveways and small bridges constrict Fourmile Run at locations throughout its length from headwaters to mouth (Figure 49). The majority of residential use near the mouth appears to be year-round, trending towards seasonal hunting and fishing camps as one progresses upstream. Concrete has been used throughout the lower reaches as a means of bank stabilization on segments 1932, 1847 and 1250. Evidence of channelization was noted throughout the subwatershed as well.

Figure 49. Development impacts near the mouth of Fourmile Run

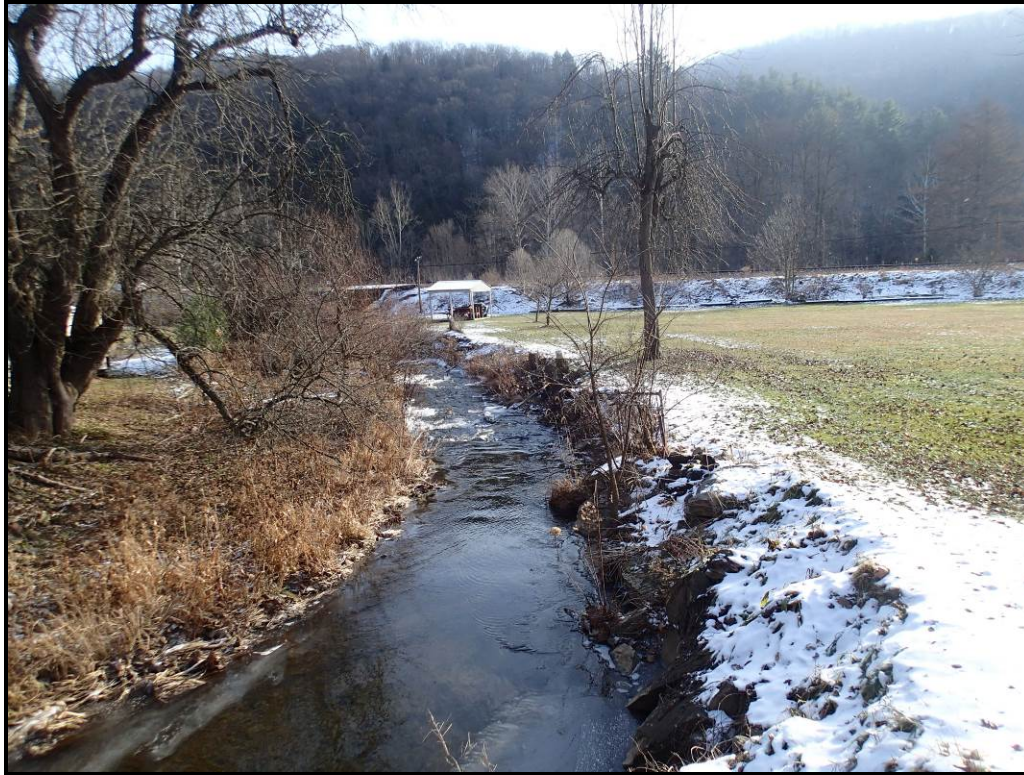
Figure 50. Minimized riparian buffer and railroad encroachment on segment 1932

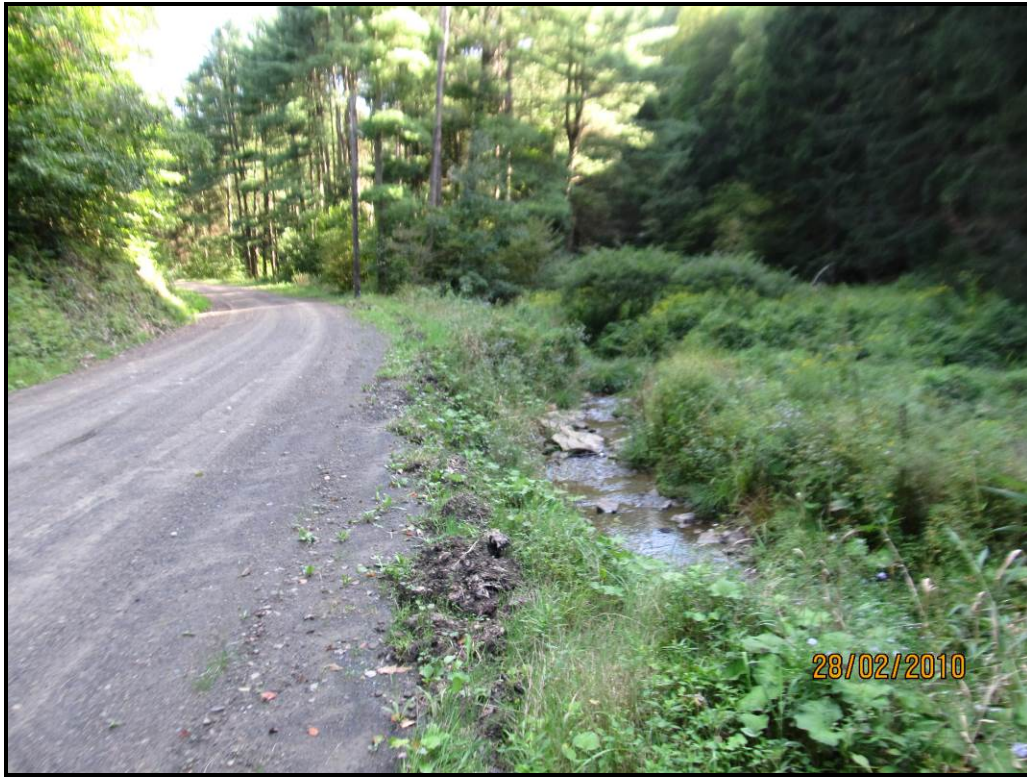
Figure 51. Improving riparian buffers and dirt & gravel road sites is essential in the Fourmile Run subwatershed

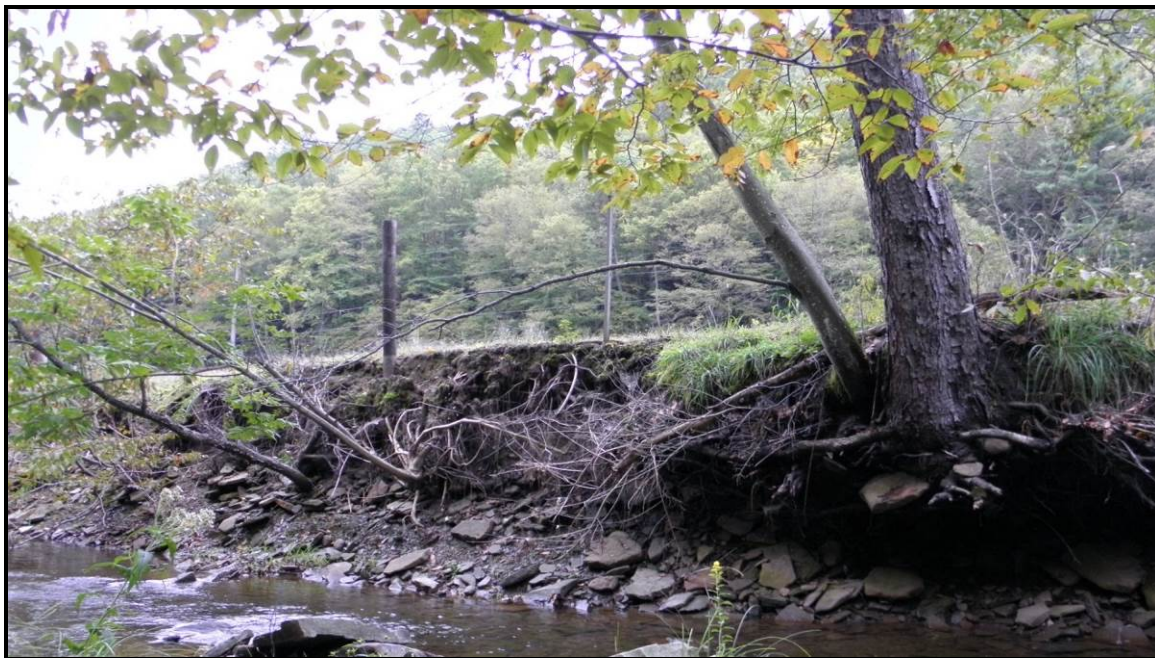
Overall, the Salt Run watershed is in great condition. Salt Run is impacted primarily by the dirt & gravel road network that accesses different regions of the subwatershed. These roads aren't necessarily in poor condition; however, as built infrastructure, they do contribute sediment to the stream, constrain tributary flow when put into culverts under the road and limit the riparian buffer width. The bulk of these impacts are concentrated on the lower reaches of the watershed. As the stream reaches go into the headwaters, roads are fewer as well as being further from the stream. Of the in-stream habitat parameters scored, sediment deposition was the one category with consistently Suboptimal scores. Segment 1721 has evidence of being channelized in the past and streambank erosion is still an issue on the reach (Figure 55).

Figure 55. Segment 1721 has in-stream devices to create pools, but streambank erosion is still an issue

Riparian buffer plantings would also be recommended on locations in the upper reaches, but especially along segment 1721. Some planting has been completed there, but more trees or shrubs could be added while still allowing access to the stream for fishing. The Emporium Water Company has been very cooperative with the completion of this assessment, both on their property and with developing contacts with other landowners. They will be an excellent and willing partner for future projects in the Salt Run watershed (Figure 58).

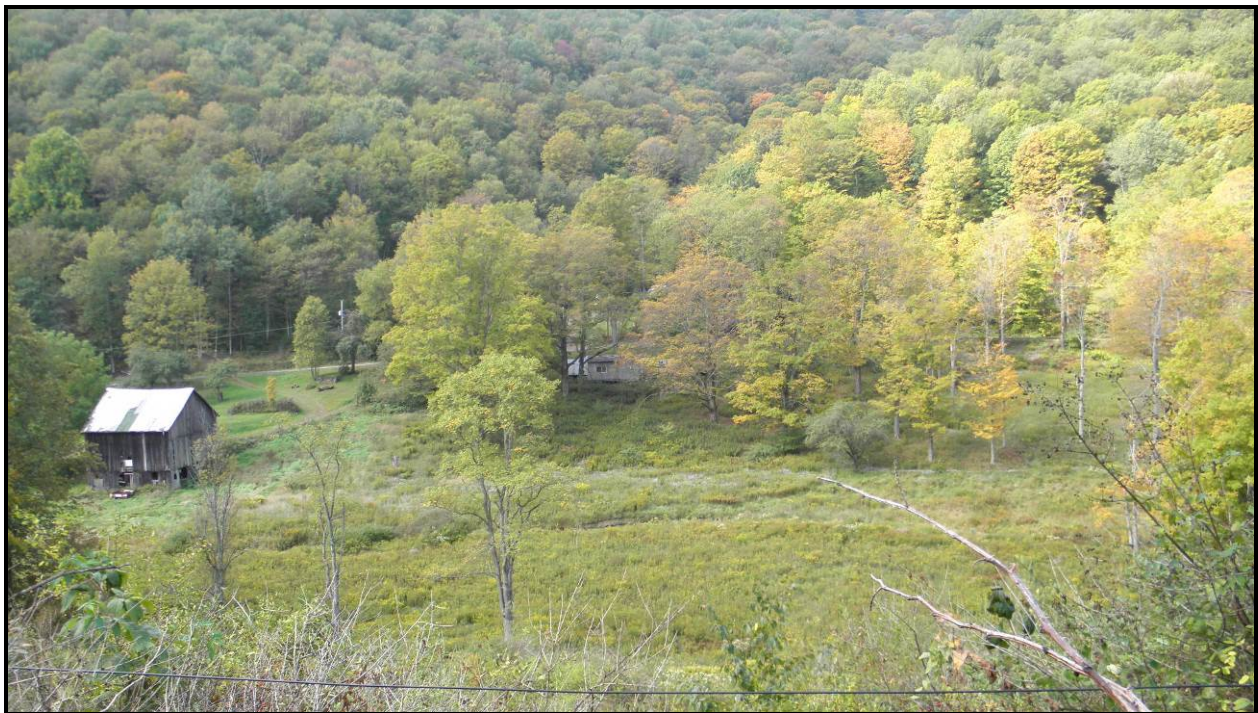
Figure 59. Open fields provide limited riparian vegetation or canopy cover along segment 1431
