Sinnemahoning Portage Creek In-Stream Habitat Assessment

December 2013

Western Pennsylvania
Conservancy

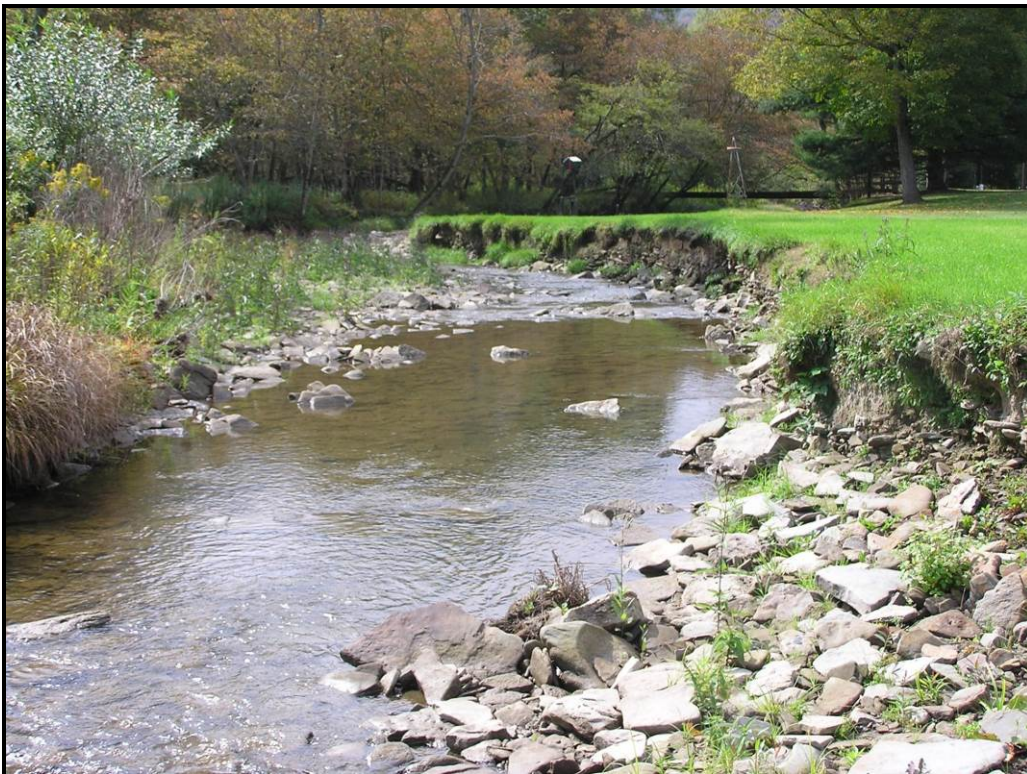
Figure 60. Erosion issues and riparian devegetation on segment 1804

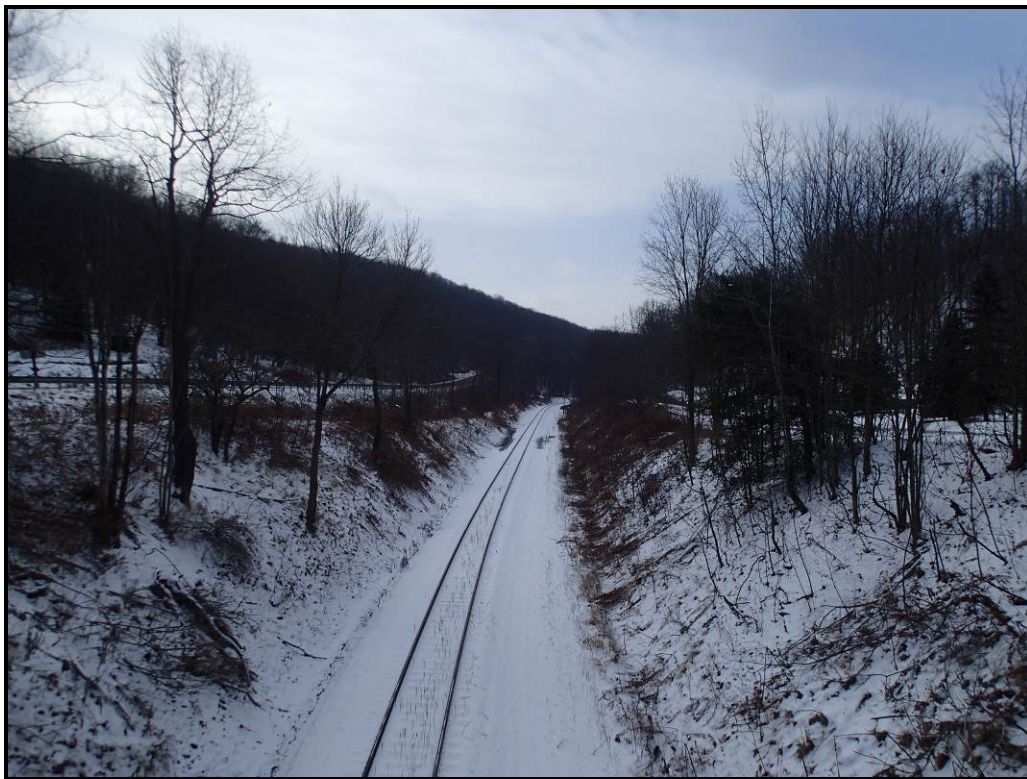
The upper-most stream of the watershed, segment 1094, was scored as Marginal and could certainly benefit from a comprehensive improvement effort (Figure 61). The parcels on this reach are small and primarily residential. Road ditches, access road and driveway culverts are prevalent, as well as channelization of the stream. Excessive algae presence was noted on the substrate, as well as significant embeddedness and sediment deposition, especially for a location in the immediate headwaters. Mitigating these effects establish a precedent of high quality in-stream habitat projects but may not be a top priority due to its location at the very top of the watershed (Figure 63).

Figure 61. Sinnemahoning Portage Creek begins as a ditch that runs adjacent to the rail line

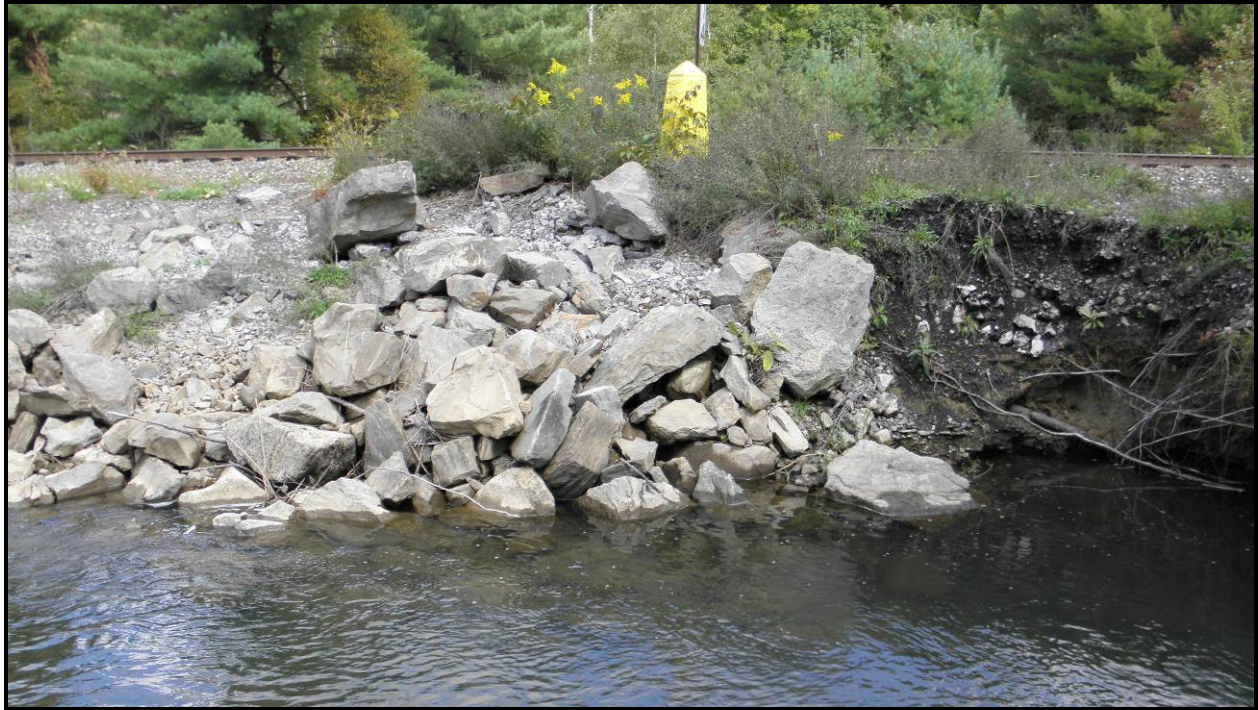
Figure 64. Rip rap stabilization measures along the railroad grade on segment 1269

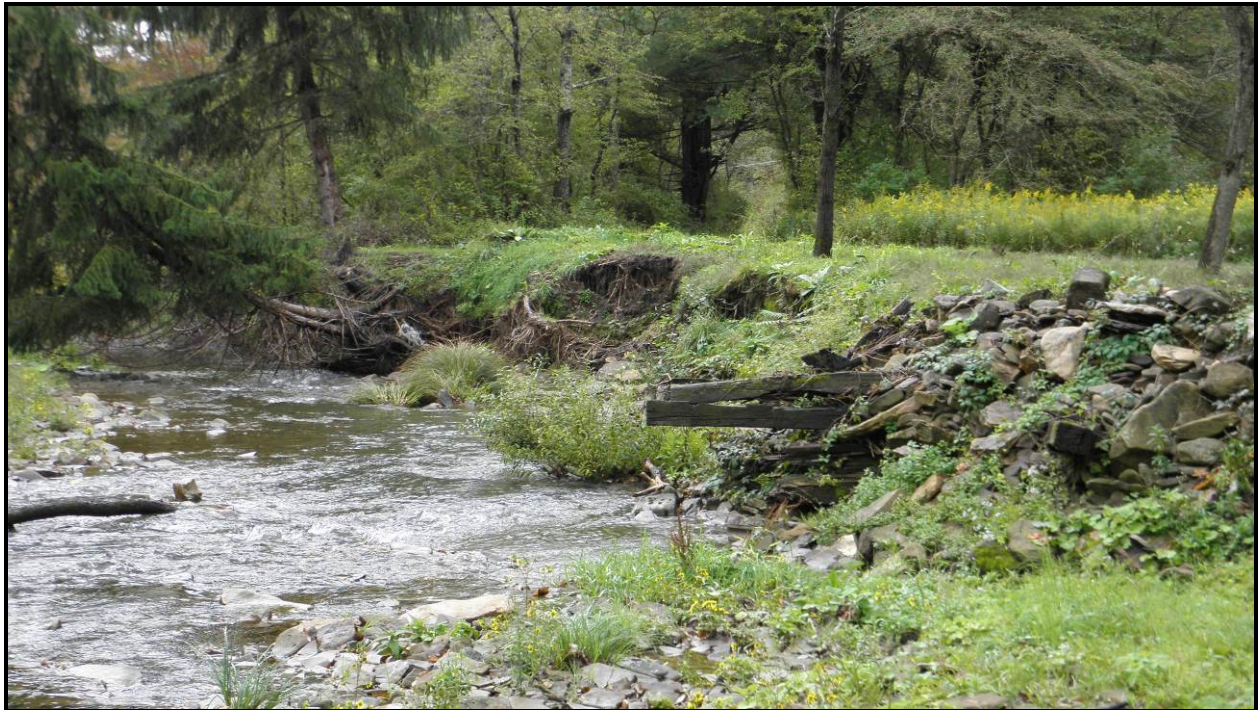
Figure 65. Streambank erosion and failed stabilization efforts on segment 1693

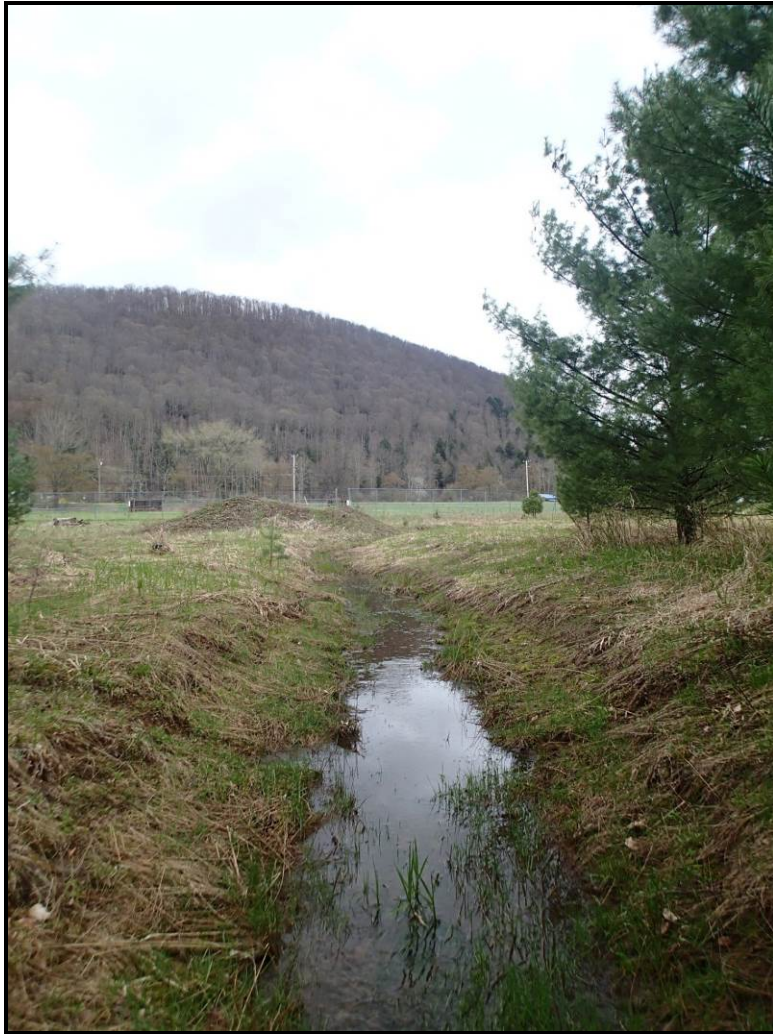
Figure 68. Stream channelization and riparian buffer removal on segment 1382

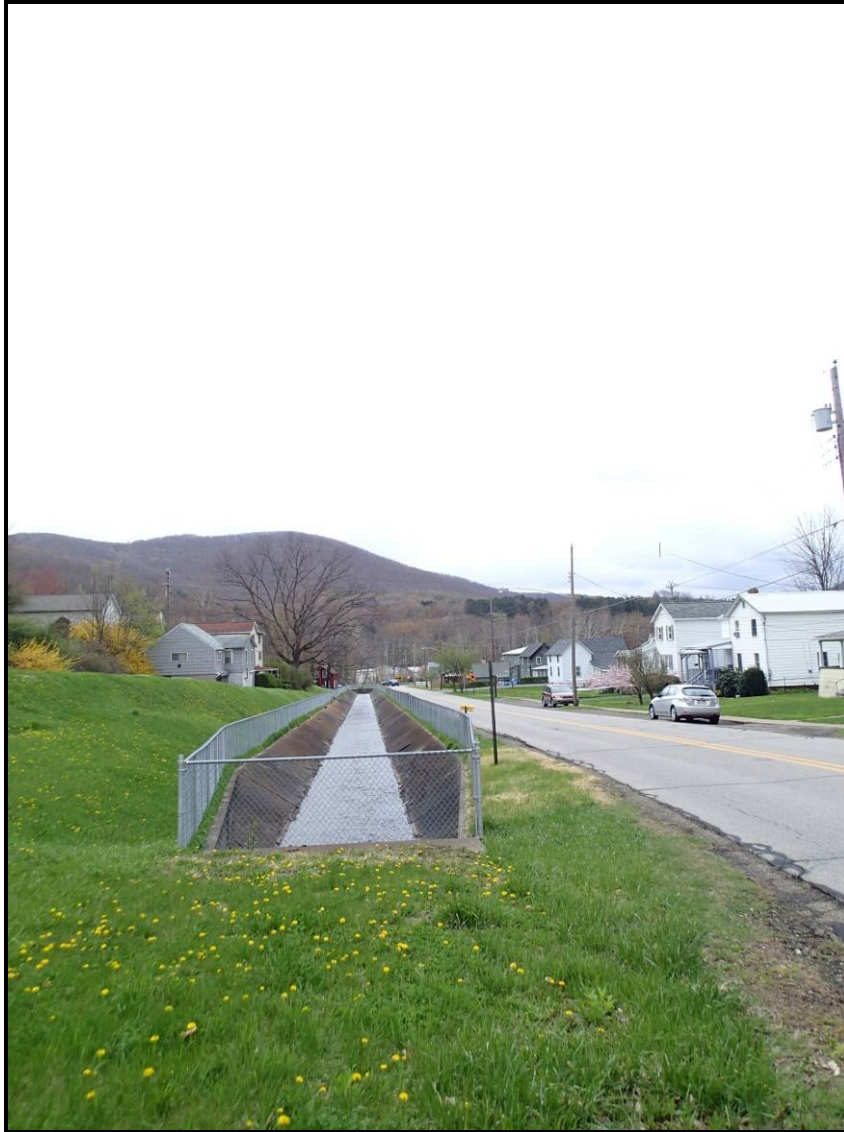
Figure 69. The Plank Road Hollow Flood Control Project has created a straight, unnatural channel on segment
