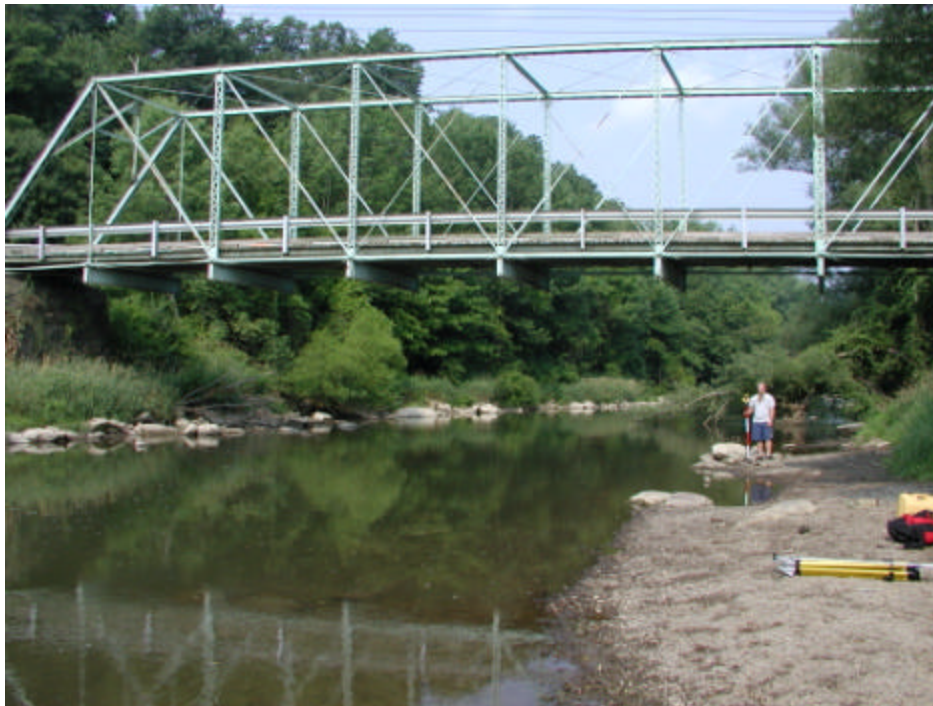
Figure 5. Photograph of French Creek channel at cross section location #1. View is looking downstream (west).

of sandstone/conglomeratic bedrock from the Venango Formation, as well as stone rip-rap. Bedrock from the Chadakoin Formation is partially exposed along the channel bottom, and many locally derived boulders are present (see Figure 5). The northern bank of the channel flanks a Holocene terrace and artificial fill around the bridge, which includes gravel and sand. A portion of the bridgeworks and older alluvial deposits are shallowly buried by minor accumulations of recently deposited sand. The natural bank-full elevation is approximately 2 meters above the channel base. Land use surrounding the riparian zone is characterized as urban/row crop, following the classification scheme of Schnier (2002). The riparian/bank zone classification for each channel cross section is summarized in Table 2.

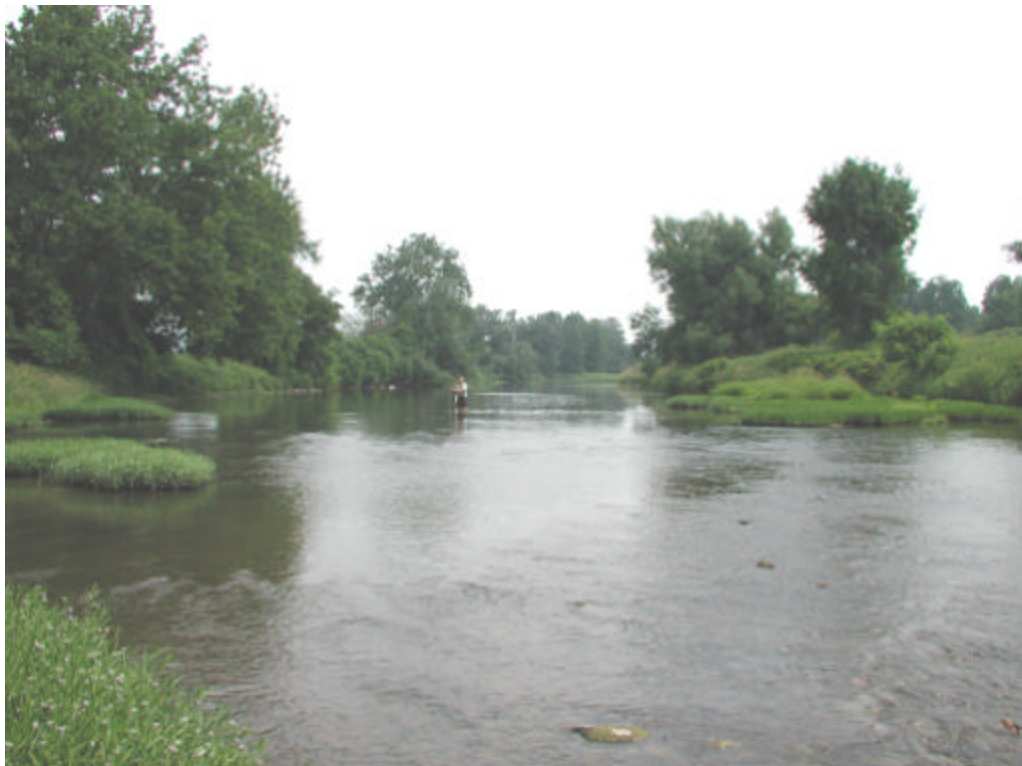
Figure 7. Photograph of channel at cross section locations 2 and 3. View is looking upstream (east). Cross section #2 was measured across the riffle in the foreground, and section 3 upstream where person (for scale) is standing in the background.

Cross section #2 was located approximately 300 meters upstream from cross section #1. At this site, the banks are composed of Holocene age meandering stream deposits, which include coarse channel gravel overlain by overbank sand and silt. The natural banks are 3 meters above the channel base, and a well developed soil is present in the upper sediments. Land-use on the surrounding floodplain is primarily agricultural land on the north bank, and mixed scrub/forest vegetation on the south bank. Grass and brambles covers much of the channel banks and exposed bar surfaces (Figure 7).

A riffle is formed at this site, due to the construction of a natural transverse channel bar, composed primarily of gravel and cobbles (see Figure 7). The maximum water depth across the riffle was 0.75 meters, and the average mid-channel velocity was 0.16 meters per second. The low-flow channel was 36 meters wide. The stream has developed a wide, shallow channel here (Figure 8), most likely due to the loose nature of sediment comprising the bed and banks.

Cross section #3 was located at the beginning of a channel bar (described above, see Figure 7), 10 meters upstream from section #2. At this site, the banks are 2 meters above the channel

The channel at site #3 is wide and shallow (Figure 10). Exposed and vegetated gravel bars line the sides of the channel (Figure 7). The average mid-channel velocity was 0.31 meters per second, maximum depth 0.2 meters, and channel width at low flow was 27 meters.
