Street Tree Management Plan

City of Pittsburgh, Pennsylvania

July 2015

Davey Resource Group
A Division of The Davey Tree Expert Company
1500 North Mantua Street
Kent, Ohio 44240
800-828-8312

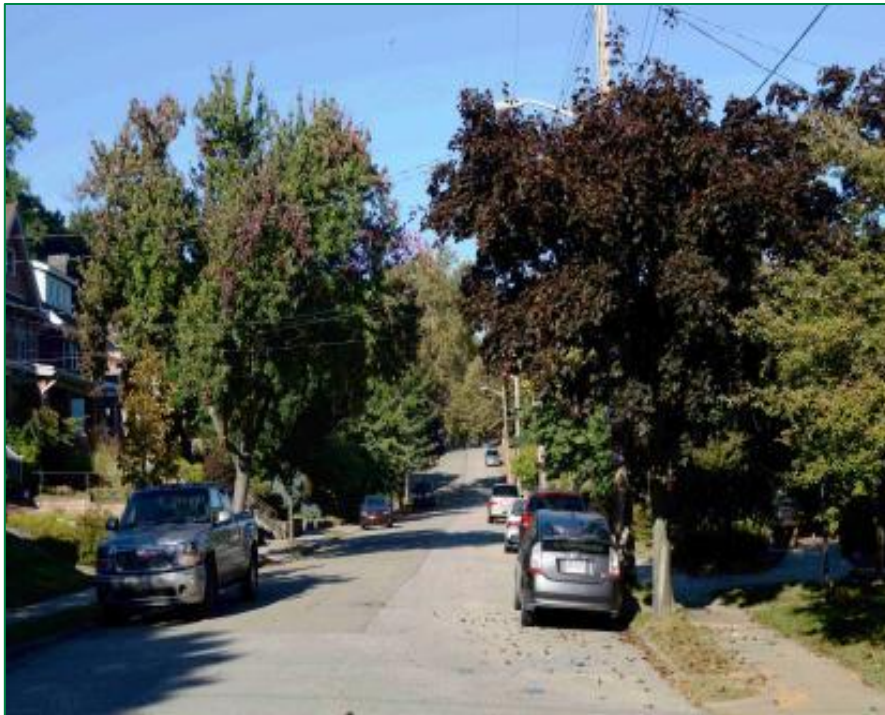
Photograph 2. The Acer rubrum (red maple) on the left and Acer platanoides (Norway maple) on the right are beautiful examples of their species. However, an abundance in past planting of both species has challenged diversity goals today. Steps have been taken to ensure that these populations will be reduced over time.

Considering the large quantity of maple already present in the population, combined with its susceptibility to ALB, the planting of maple should be limited to minimize the potential for loss should any exotic pests or diseases threaten Pittsburgh's urban tree population. This is especially true for both Norway maple and red maple, which are highly prevalent on the species level. The city has already taken steps to reduce the proportion of these species present on the streets. Of the five most abundant species, *Acer platanoides* (Norway maple), *Pyrus calleryana* (Callery pear), and *Tilia cordata* (little-leaf linden) are restricted species and shall not be planted according to the diversity guidelines in Appendix D of the *Pittsburgh Urban Forest Master Plan*. Furthermore, the master plan also reduces the proportion of maple to 5% or less for any new planting project.

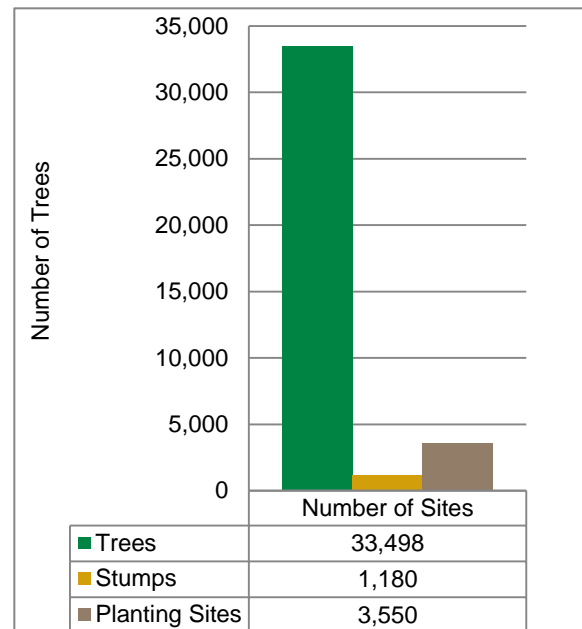
Figure 1. Sites recorded during the 2014 inventory.

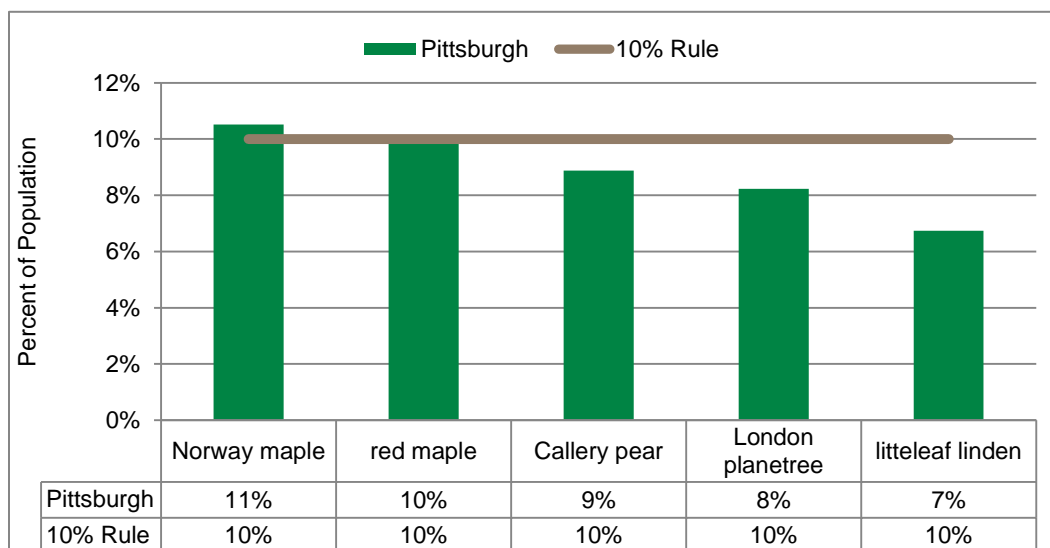
Figure 2 compares the percentages of the most common species identified during the inventory to the 10% Rule. Both Norway maple (11%) and red maple (10%) exceed the recommended 10% maximum for a single species in a population.

Figure 2. Five most abundant species of street ROW trees during the 2014 inventory.

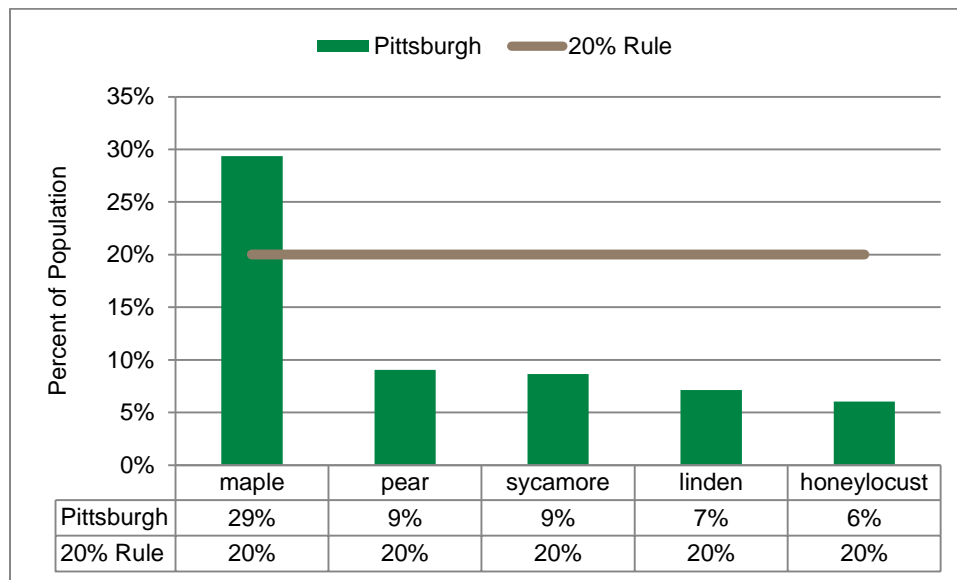
Figure 3 compares the percentages of the most common genera on the street ROW to the 20% Rule. Maple comprises 29% of the inventoried tree population, which far exceeds the recommended 20% maximum for a single genus in a population.

Figure 3. Five most abundant genera of street ROW trees during the 2014 inventory.

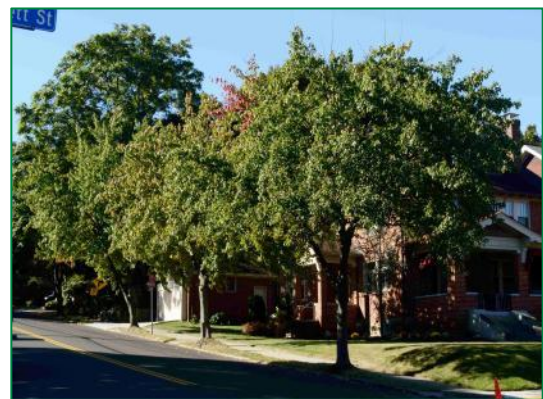
Photograph 8. Heavy past planting of *Acer rubrum* (red maple) has led to overabundance of the species on Pittsburgh's streets. Moratorium of this species should be in effect until its proportion falls well below 10%.

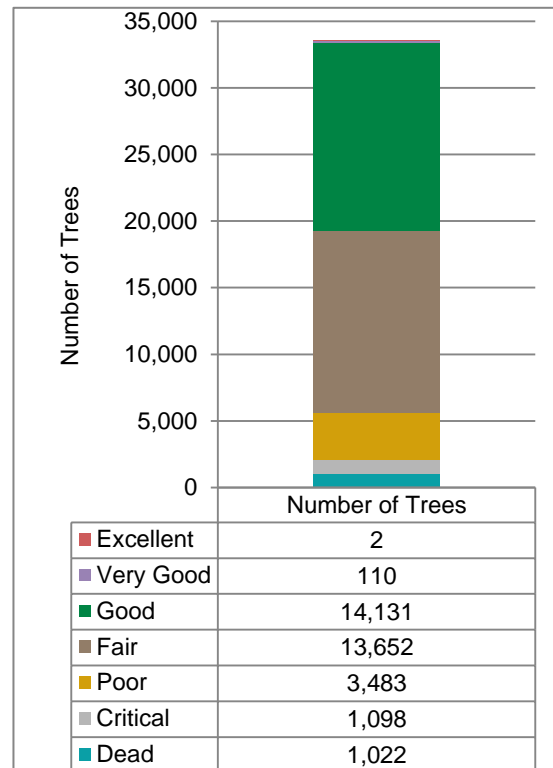
Most of the inventoried trees were found to be in Good or Fair condition, 42% and 41%, respectively (Figure 5). Based on these data, the general health of the overall inventoried tree population is rated Good. Figure 6 illustrates that most of the young trees were rated to be in Good condition, while most of the established, maturing, and mature trees were rated to be in Fair condition.

Figure 5. Tree condition of all inventoried trees.

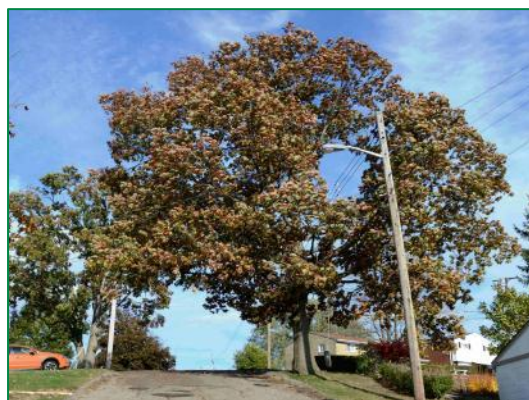
Photograph 10. This *Quercus alba* (white oak) in the Hays neighborhood is an example of a tree in Good condition.

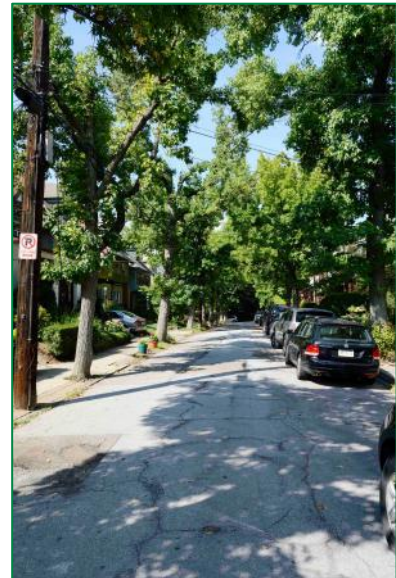
Photograph 11. This Highland Park neighborhood street is an example of a fully stocked block.

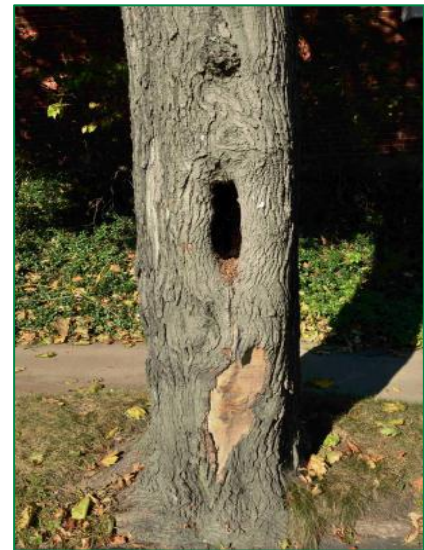
Photograph 12. The cavity in this Squirrel Hill Acer saccharum (sugar maple) is not yet severe enough to warrant removal. However, this tree should be regularly inspected so that it can be removed when the risk of failure exceeds the benefits it provides.

Trees noted as having poor structure (264 trees) or cavity or decay (763 trees) should be regularly inspected. Corrective actions should be taken when warranted. If trees that are not already marked for removal continue to decline, removal may be required.

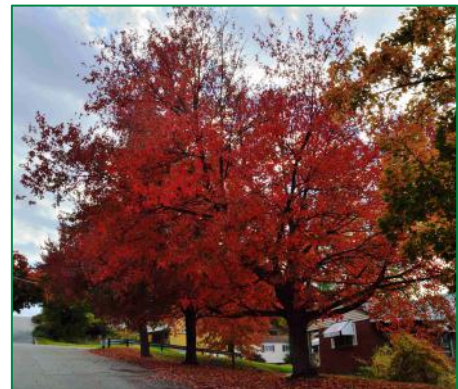
Photograph 13. The beauty of these Acer rubrum (red maple) is undeniable. However, their lowest branches are impinging on the roadway. This can lead to vehicle damage and can negatively affect tree health, since limbs are likely to be torn off. Road-side branches should be no lower than 14 feet.

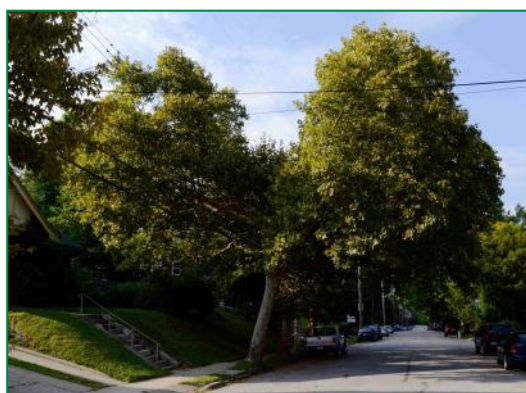
Photographs 14 and 15. The *Platanus × acerifolia* (London planetree) shown here is an example of a large-statured tree species that has been planted directly underneath utility wires. The drastic pruning required can often lead to health problems, as evidenced by the decay and heavy sprouting in one of its remaining limbs.

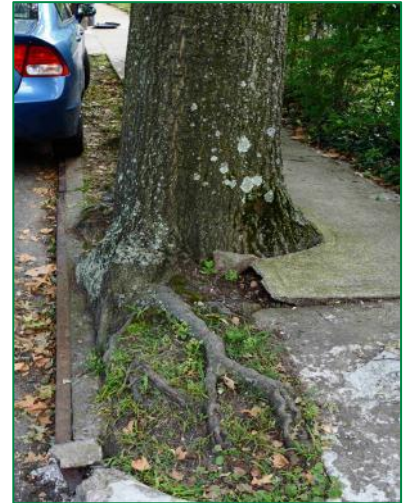
Photograph 16. Large tree species planted in small spaces, such as this pin oak, can lead to sidewalk damage.

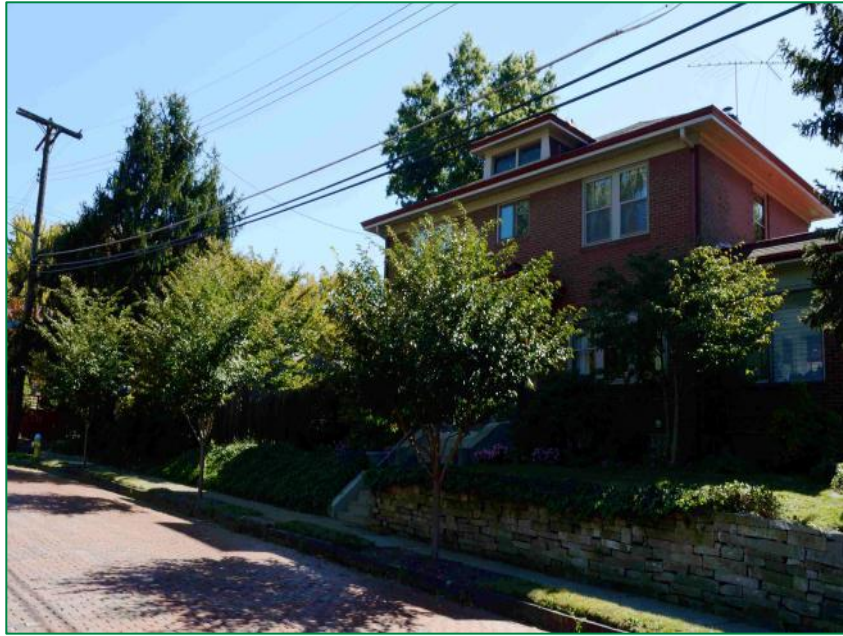
*Photograph 17. These **Prunus serrulata** (Kwanzan cherry) are the proper-sized trees to plant in this 3-foot tree-lawn with electric wires overhead.*

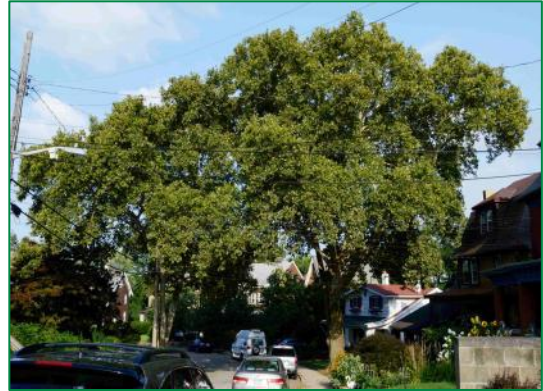
Photograph 20. These two magnificent *Platanus × acerifolia* (London planetree) were grown in an open/unrestricted environment. Most of the city's largest and healthiest trees were grown in this type of site.

In some neighborhoods the city easement actually significantly extends beyond the sidewalk. This leaves open and unrestricted space for trees to grow. Although trees growing in such sites were collected, vacant planting sites in open and unrestricted space were not. Efforts should be made to identify more of these sites since they create very high potential for the growth of large, healthy trees.

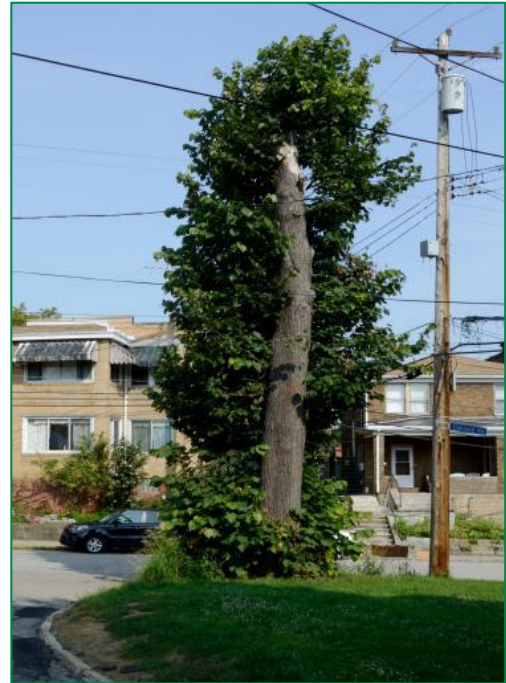
Photograph 23. This Tilia americana (American basswood) is a priority removal. In its current state, this tree is providing limited benefits and is large enough to cause significant damage if it were to fail.

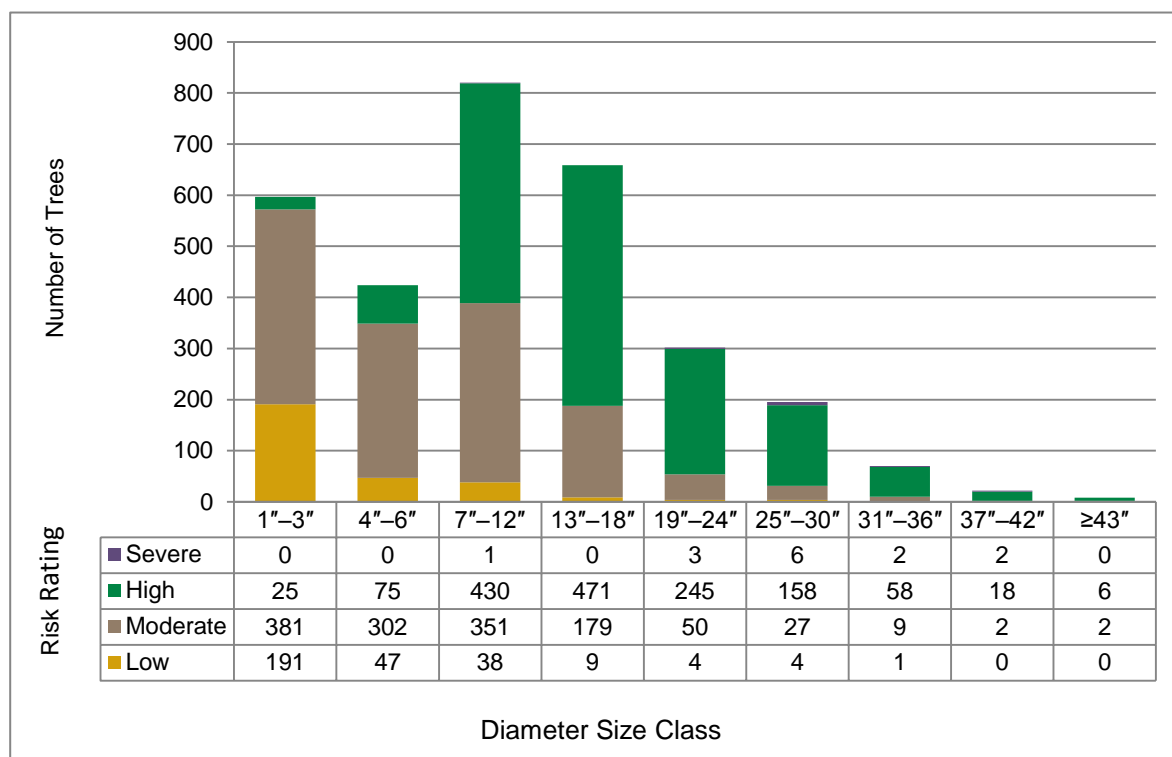
Figure 7. Tree removals by risk rating and diameter size class.

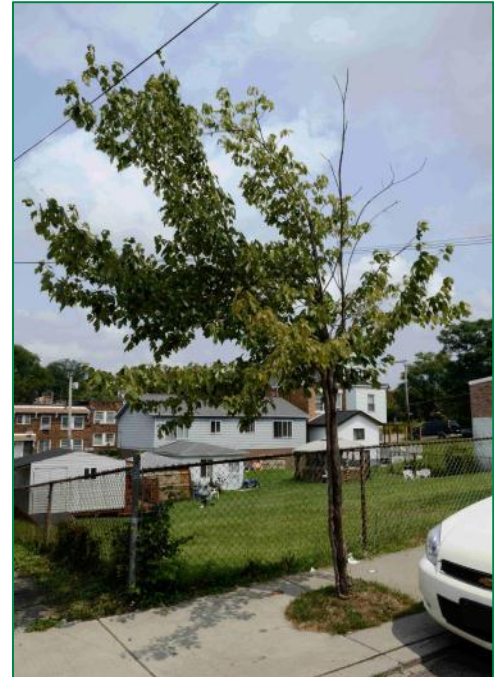
Photograph 24. This Hill District Acer rubrum (red maple) is an example of a tree designated for Low Risk removal. Disease progression means that this tree is no longer viable; however, the tree is unlikely to cause significant damage if it were to fail.

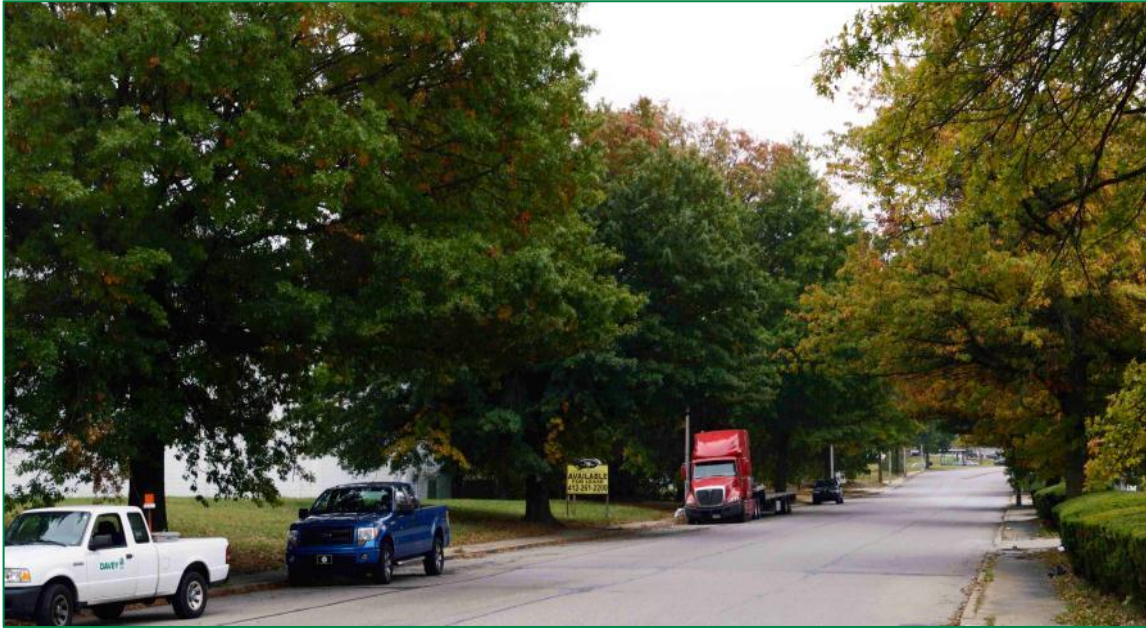
Photograph 25. These Quercus palustris (pin oak) in a southwest side industrial park would benefit from inclusion in a regular pruning cycle. Such proactive maintenance can lead to lower property damage liability claims for the city, while continuing to soften the visual impact of industrial areas.

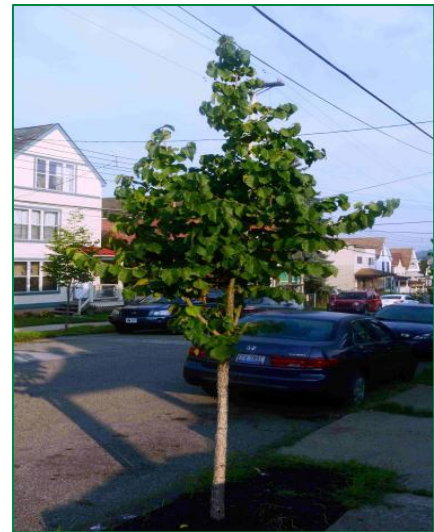
Photograph 26. This young *Corylus columna* (Turkish filbert) will benefit from inclusion in the young tree training cycle. Pruning at an early age improves tree structure, enhances the benefits a tree provides, and lengthens the useful life of a tree.

YTT pruning is performed to improve tree form or structure; the recommended length of an YTT Cycle is three years because young trees tend to grow at faster rates (on average) than more mature trees.

The YTT Cycle differs from the RP Cycle in that these trees generally can be pruned from the ground with a pole pruner or pruning shear. The objective is to increase structural integrity by pruning for one dominant leader. Of course, this is species-specific, since many trees such as *Betula nigra* (river birch) may naturally have more than one leader. For these and similar trees, YTT pruning is used to develop a strong structural architecture of branches so that future growth will lead to a healthy, structurally sound tree.

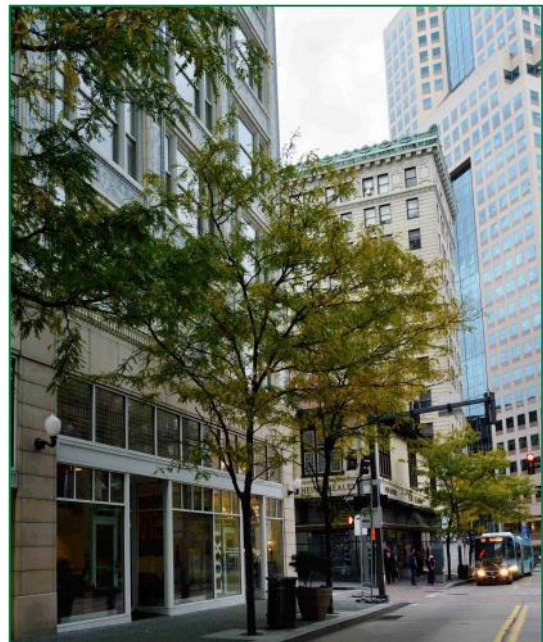
Photograph 27. Including these Gleditsia tricanthos (honeylocust) in the regular pruning cycle will help them continue to provide an aesthetic accent to the downtown business district, while avoiding undue risk.

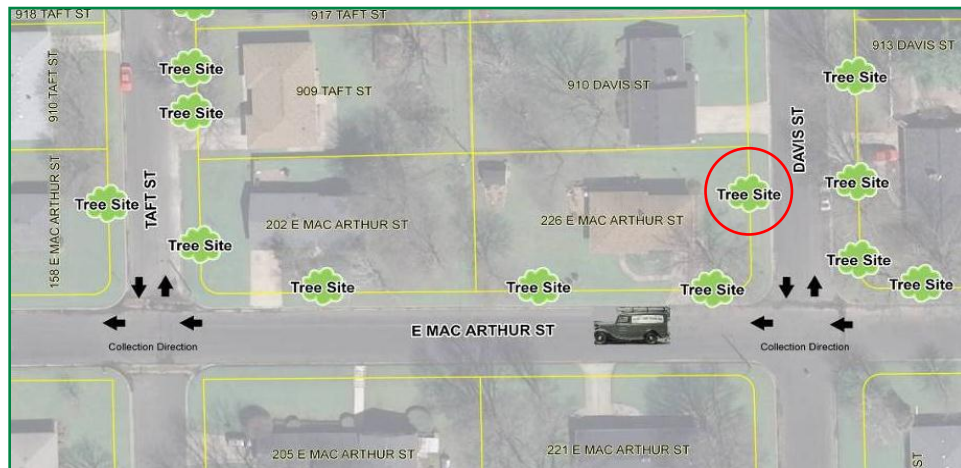
Figure 2. The tree trimming crew in the truck traveling westbound on E Mac Arthur Street is trying to locate an inventoried tree with the following location information:

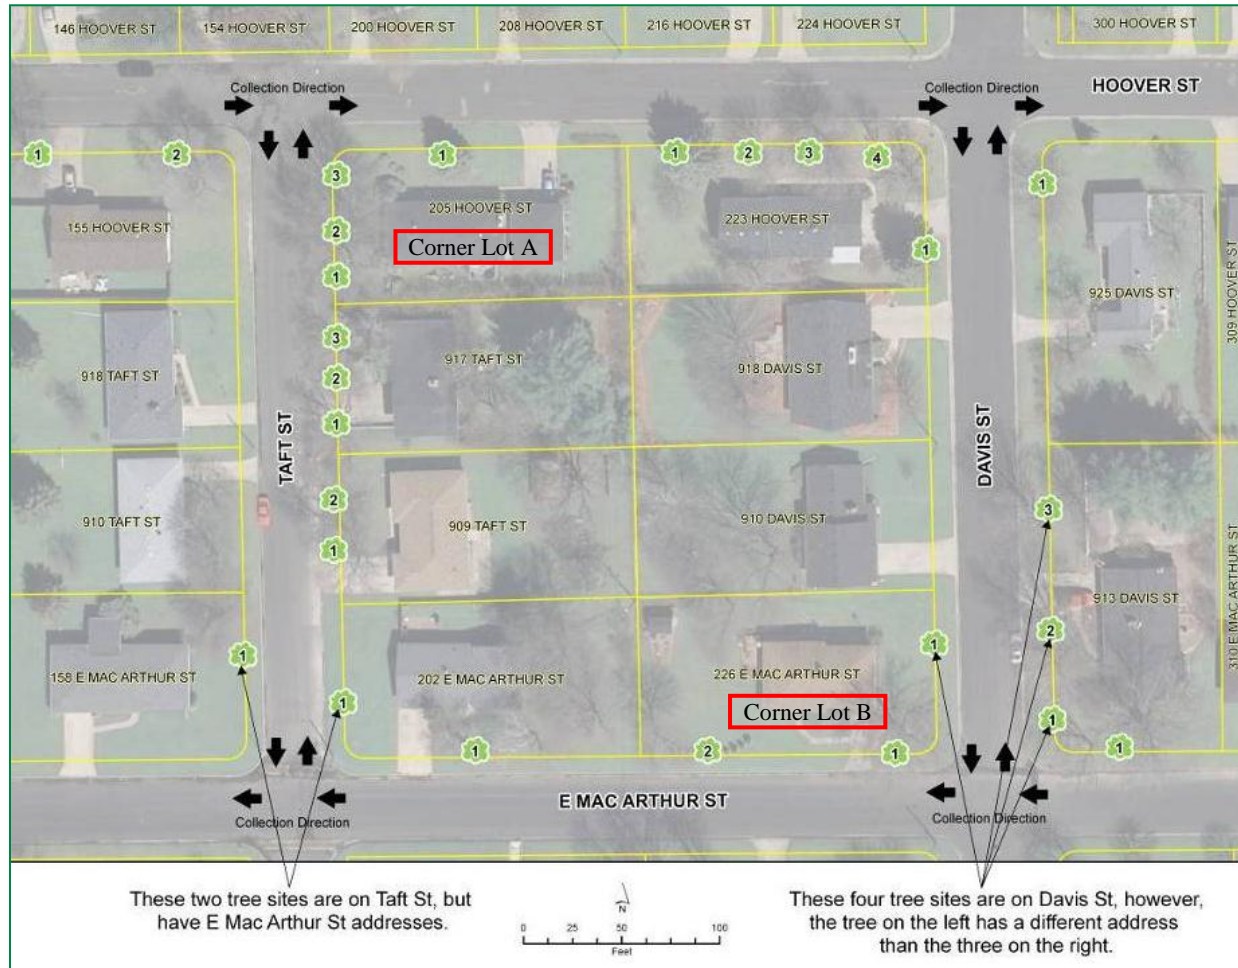
Figure 3. Location information collected for inventoried trees at Corner Lots A and B.
