Sewickley Creek Watershed Assessment, Restoration, and Implementation Plan

Sewickley Creek Watershed Assessment, Restoration and Implementation Plan

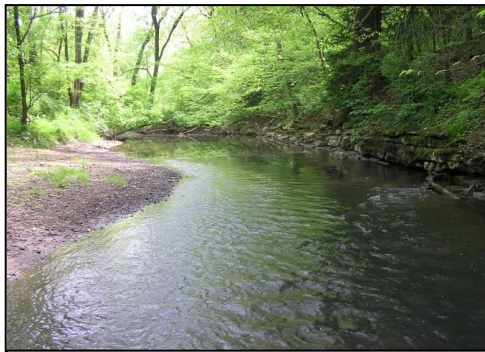
Sewickley Creek main stem within the Upper Sewickley subwatershed.

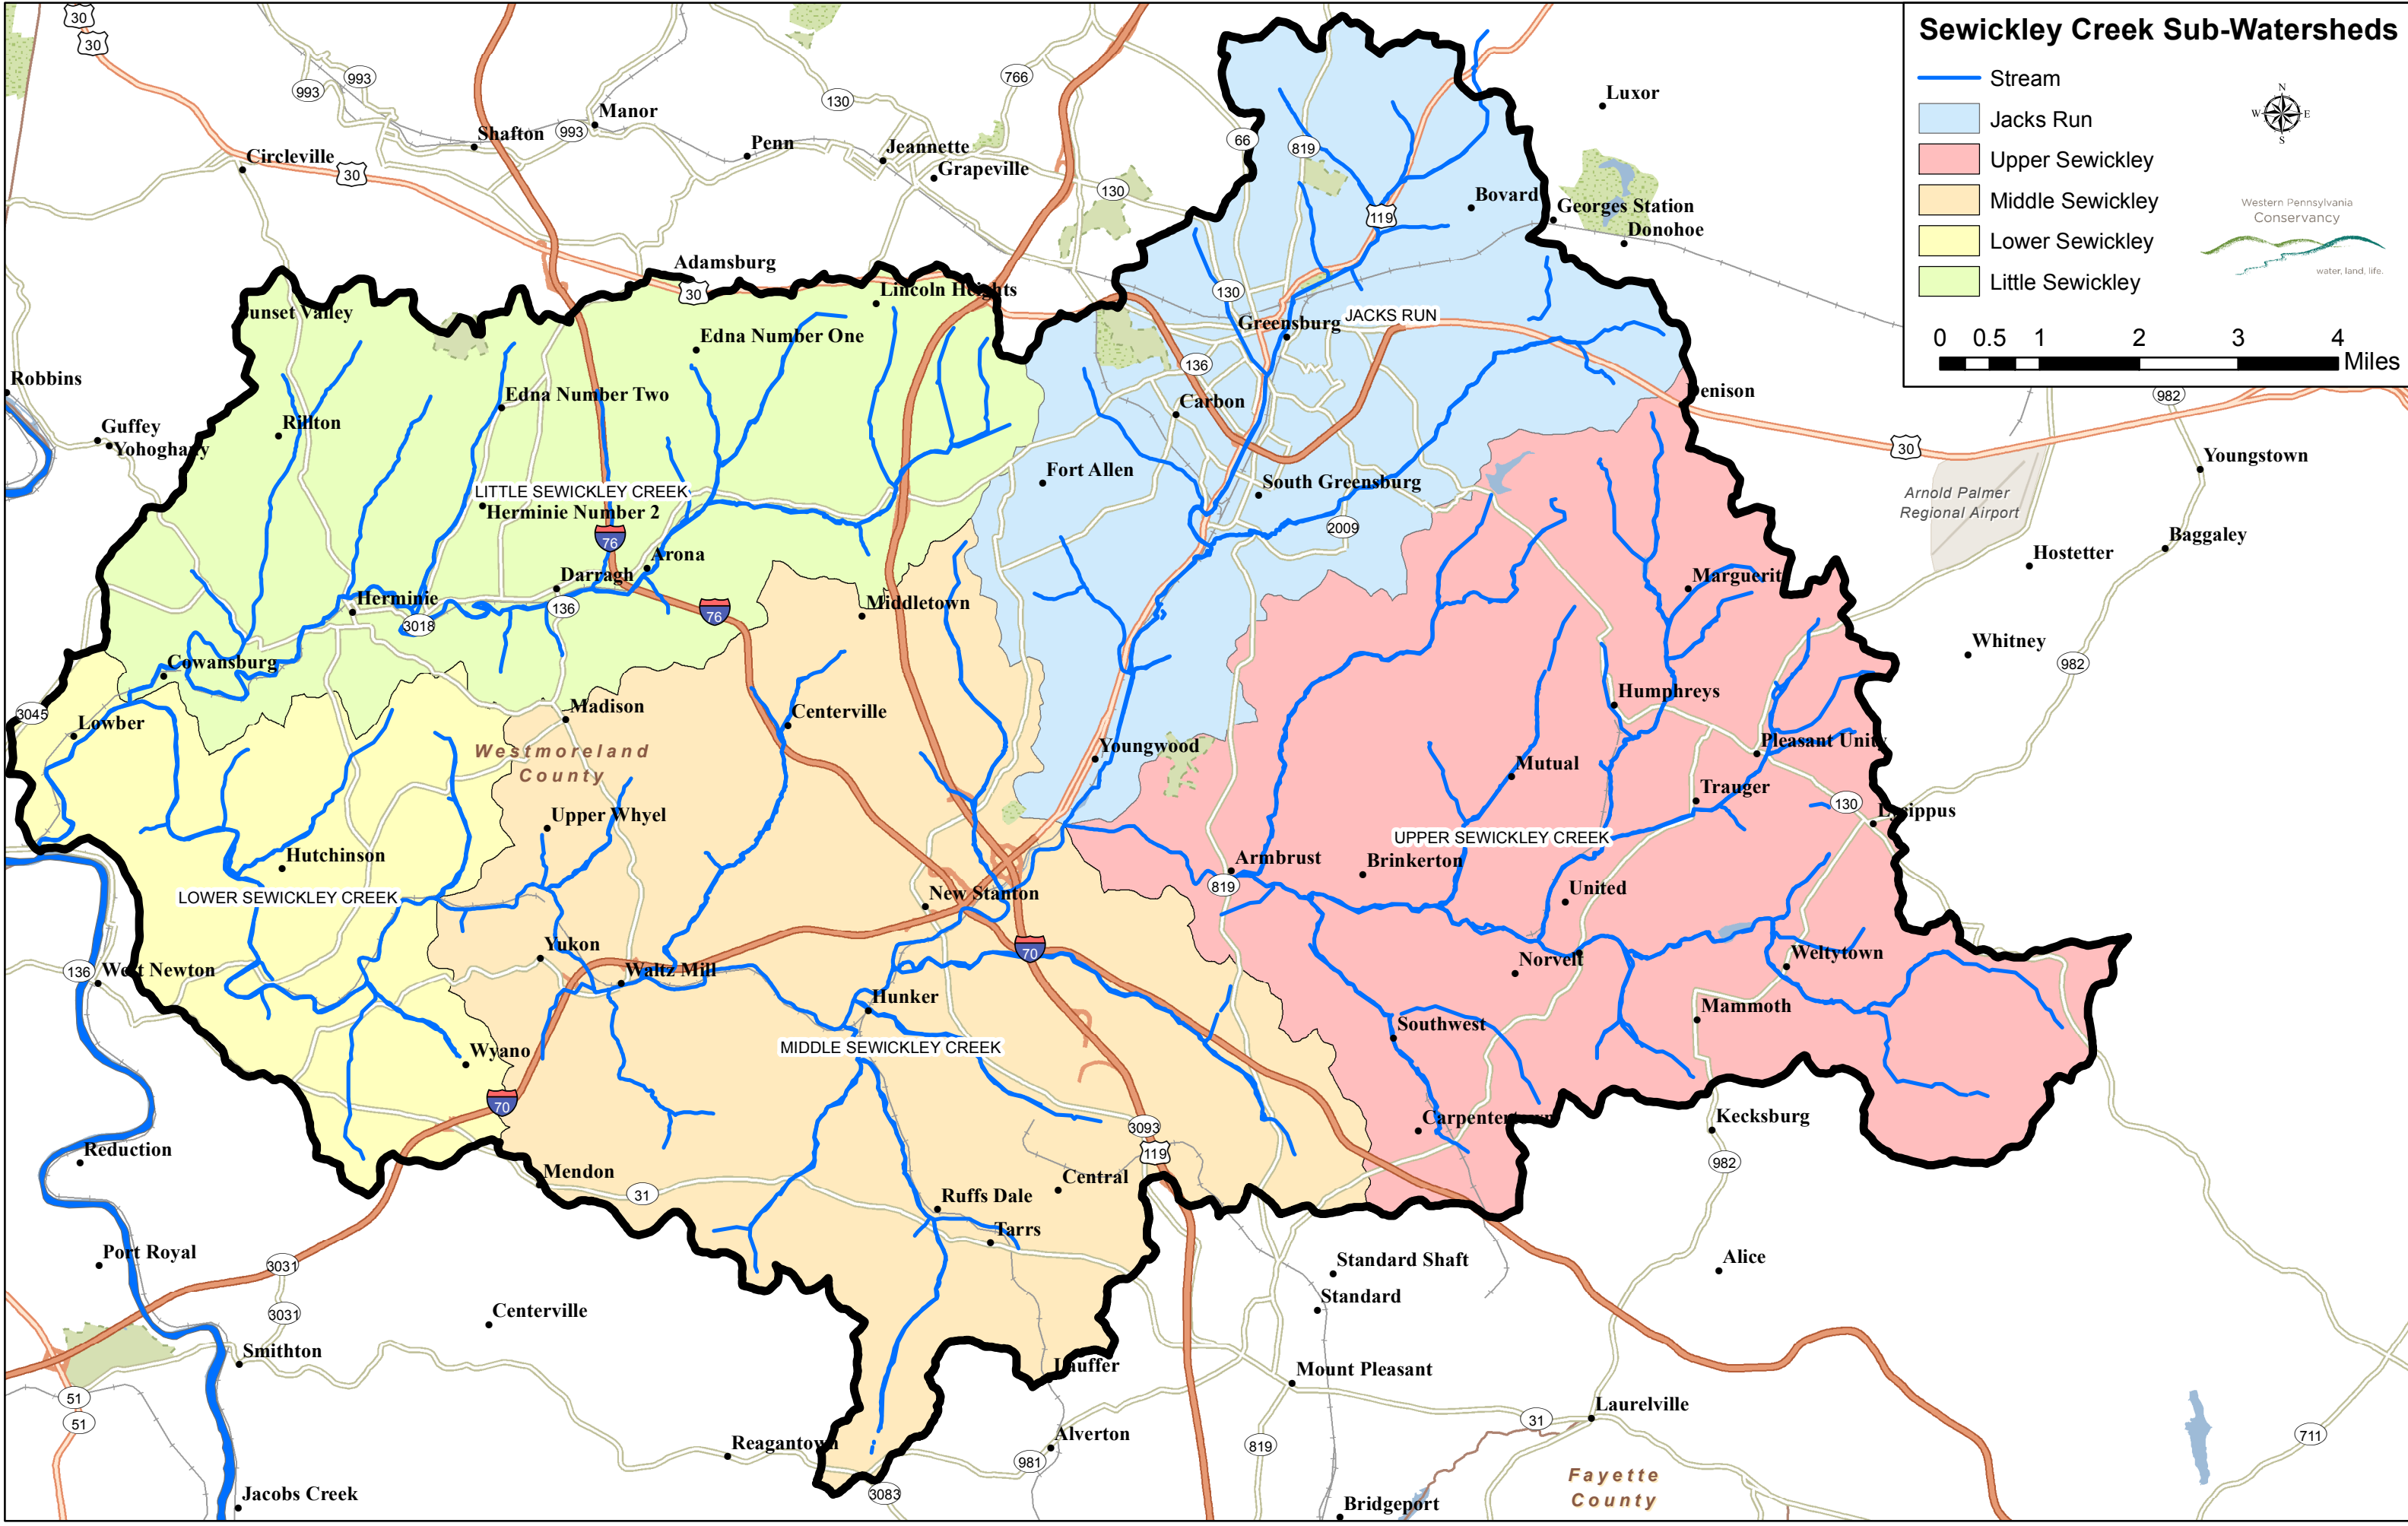
Sewickley Creek Sub-Watersheds

In order to assist in maintaining order of the collected data, the Sewickley Creek watershed was broken into five sub-watersheds for the purpose of this assessment. They are, starting at the headwaters and working downstream:

- Upper Sewickley
- Jack's Run
- Middle Sewickley
- Little Sewickley
- Lower Sewickley

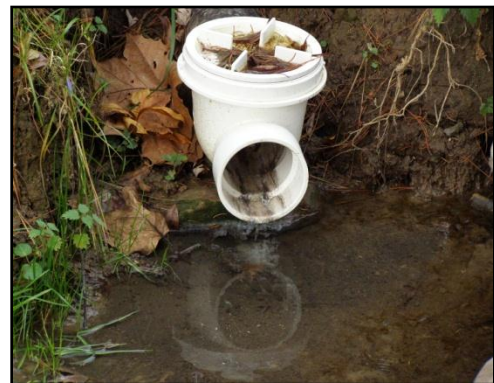
Nutrient pollution from faulty septic systems is a potential source of excessive phosphorus to streams.

Each of the five subwatersheds of Sewickley Creek show signs of having nutrient pollution concerns. Evidence of faulty septic systems at rural homes as well as broken wastewater lines in communities was present throughout the watershed.

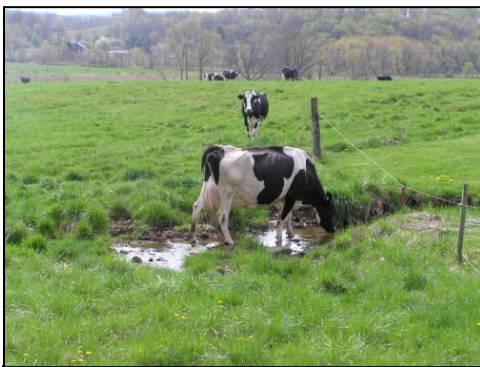
Unrestricted livestock access to streams can cause sedimentation, erosion, and nutrient pollution.

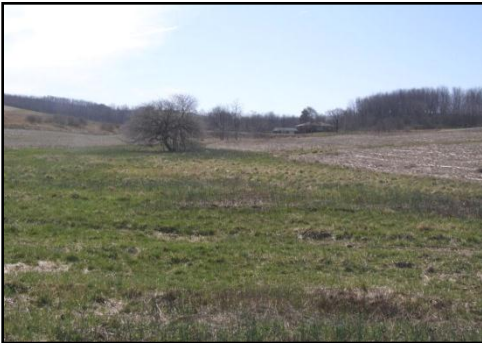
Subsurface “tile” drainage installed to “control” the flow of headwater tributaries alter stream character and act as a conduit for nutrients to enter waterways.

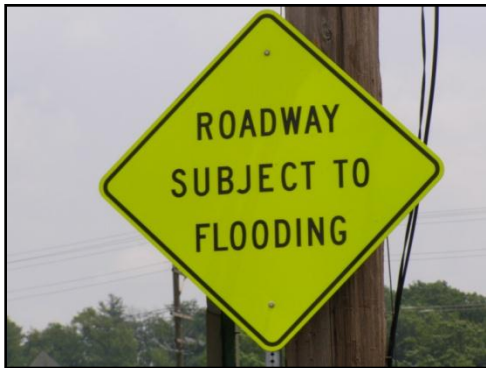
The watershed's topography pattern of headwater steep slopes and multiple valleys makes stormwater flooding issues a prevalent and repeating occurrence in multiple communities throughout the watershed. Water velocities can become quite high during periods of very high flow and many areas of the watershed show signs of flood damage. Most of the flooding disturbance is located in areas where streams are parallel to roadways or where a stream has been altered by a bridge and at the end of a channelized section.

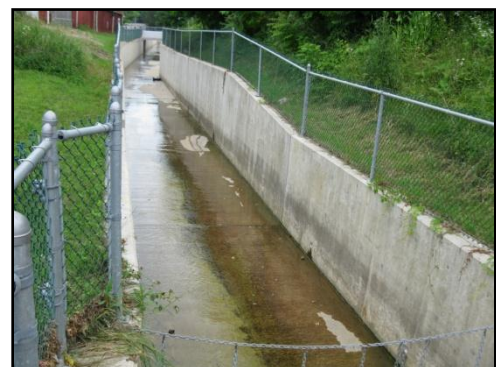
Jack's Run, a subwatershed of Sewickley Creek, is enclosed within concrete channels in multiple sections throughout its drainage.

have been channelized with solid, usually concrete structures, for flood control to protect homes and businesses that have been built within the flood plain. Although these structures control water during periods of high flow, they are detrimental to natural stream conditions and functions. It is highly unlikely, though, that these concrete lined sections will be returned to their natural stream conditions so, for this assessment, these areas are solely noted as impacted sources.

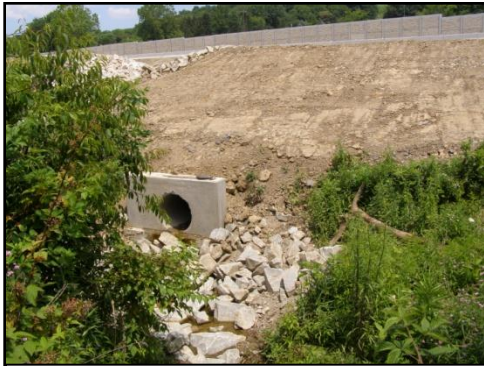
Highway construction can have direct sediment impacts to streams when proper erosion and sediment plans are not followed.

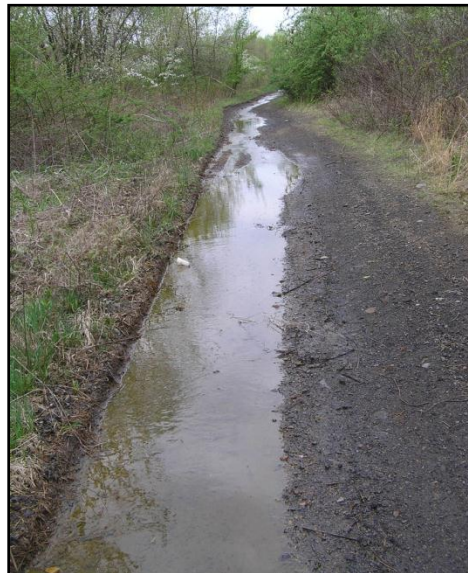
A headwater tributary of the North Fork of Sewickley has eroded its bank and travels along a paralleling mining site access road for several hundred feet before entering back into its original channel.

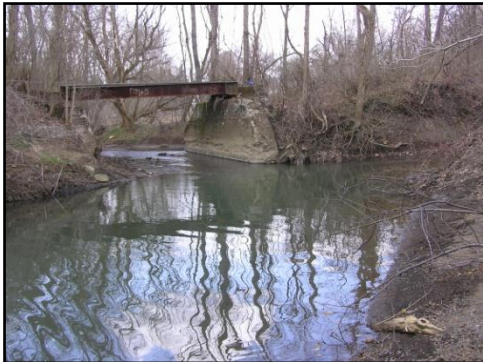
An abandoned railroad line can be seen at the confluence of Sewickley Creek and Welty Run.

In addition to the many dirt and gravel roads, historic railroad lines also interlace the watershed, often paralleling Sewickley Creek and its major tributaries. These lines were the primary transportation system to move coal and coke from sites within the watershed to Pittsburgh and rail placement along waterways allowed for easier transfer of materials to barges. With the decline of the coal industry, the railways have been gradually abandoned over the decades. These abandoned railways have had the metal rails and most of the wooden ties removed from the foundation bed and have been left

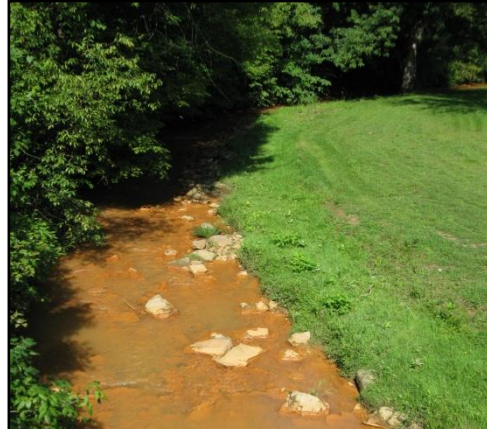
Several portions of the Sewickley Creek watershed exhibit the orange coloration that is indicative of AMD impairment.

Depending on the chemical makeup of the rock layers, highly acidic water can be produced. The acidic water often leaches toxic metals from the rock layers it migrates through, carrying them suspended in solution until it reaches stream water of more neutral pH. As these metals drop out of solution, they often discolor the waterway or streambed and become deposited in the stream channel.

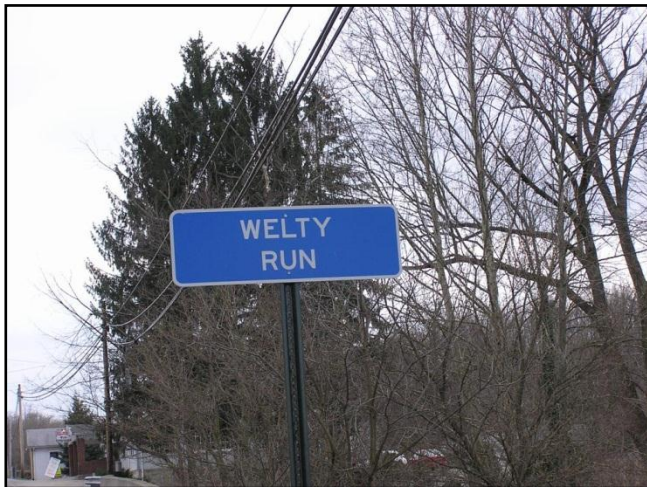
The upper sections of Welty Run are fast flowing mountainous tributaries with significant gradient changes. They are primarily surrounded by forest and have healthy, continuous cover and shading. Once reaching Kecksburg Sportsmen's Road near Welty Town, the gradient lessens and land use becomes more residential with some agricultural and pasture land, but a vegetative cover is still maintained. There are several dams of various sizes along Welty Run, including the one that creates

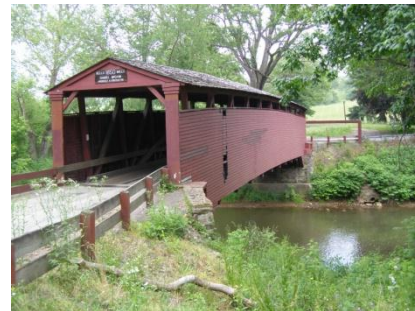
In the upper portions of the sub-watershed, Sewickley Creek main stem gently makes a gradient change and occasional bedrock formations can be seen.
