Sinnemahoning Portage Creek In-Stream Habitat Assessment

December 2013

Western Pennsylvania
Conservancy

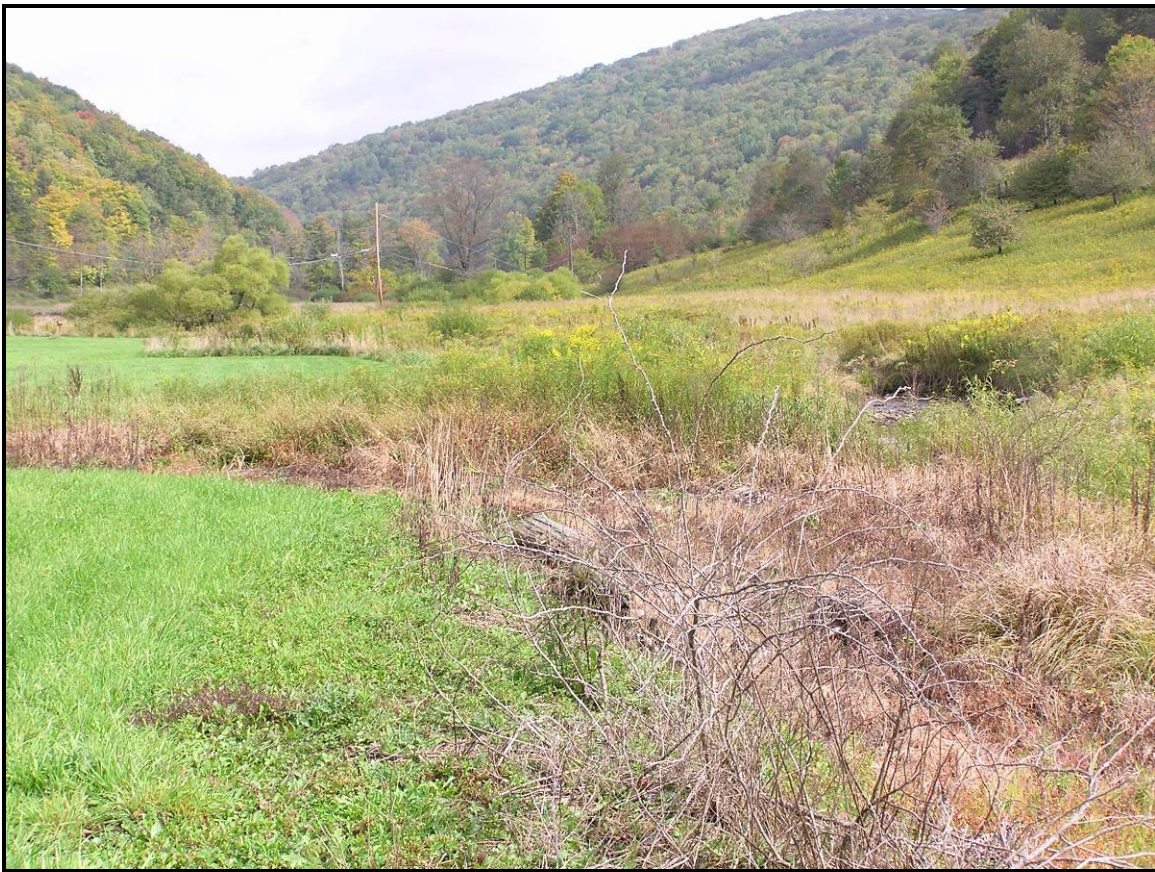
In the summer of 2006, a train derailment within the headwaters of Sinnemahoning Portage Creek near the village of Gardeau caused highly toxic levels of sodium hydroxide to enter the stream (Figure 1). A massive fish kill, along 11 miles of Sinnemahoning Portage Creek, an additional 20 miles of the Driftwood Branch of Sinnemahoning Creek, and several more miles of the Sinnemahoning Creek mainstem occurred. As part of the settlement with the railroad company for damages resulting from the spill, funding became available to address environmental concerns within Sinnemahoning Portage Creek and surrounding watersheds. It is part of that funding that provided for the visual assessment that was performed by Western Pennsylvania Conservancy on Sinnemahoning Portage Creek that is the focus of this report. The purpose of the assessment was to provide a baseline understanding of the physical in-stream habitat of the watershed and to document current water quality conditions.

Figure 1. Sinnemahoning Portage Creek valley near the location of the train derailment

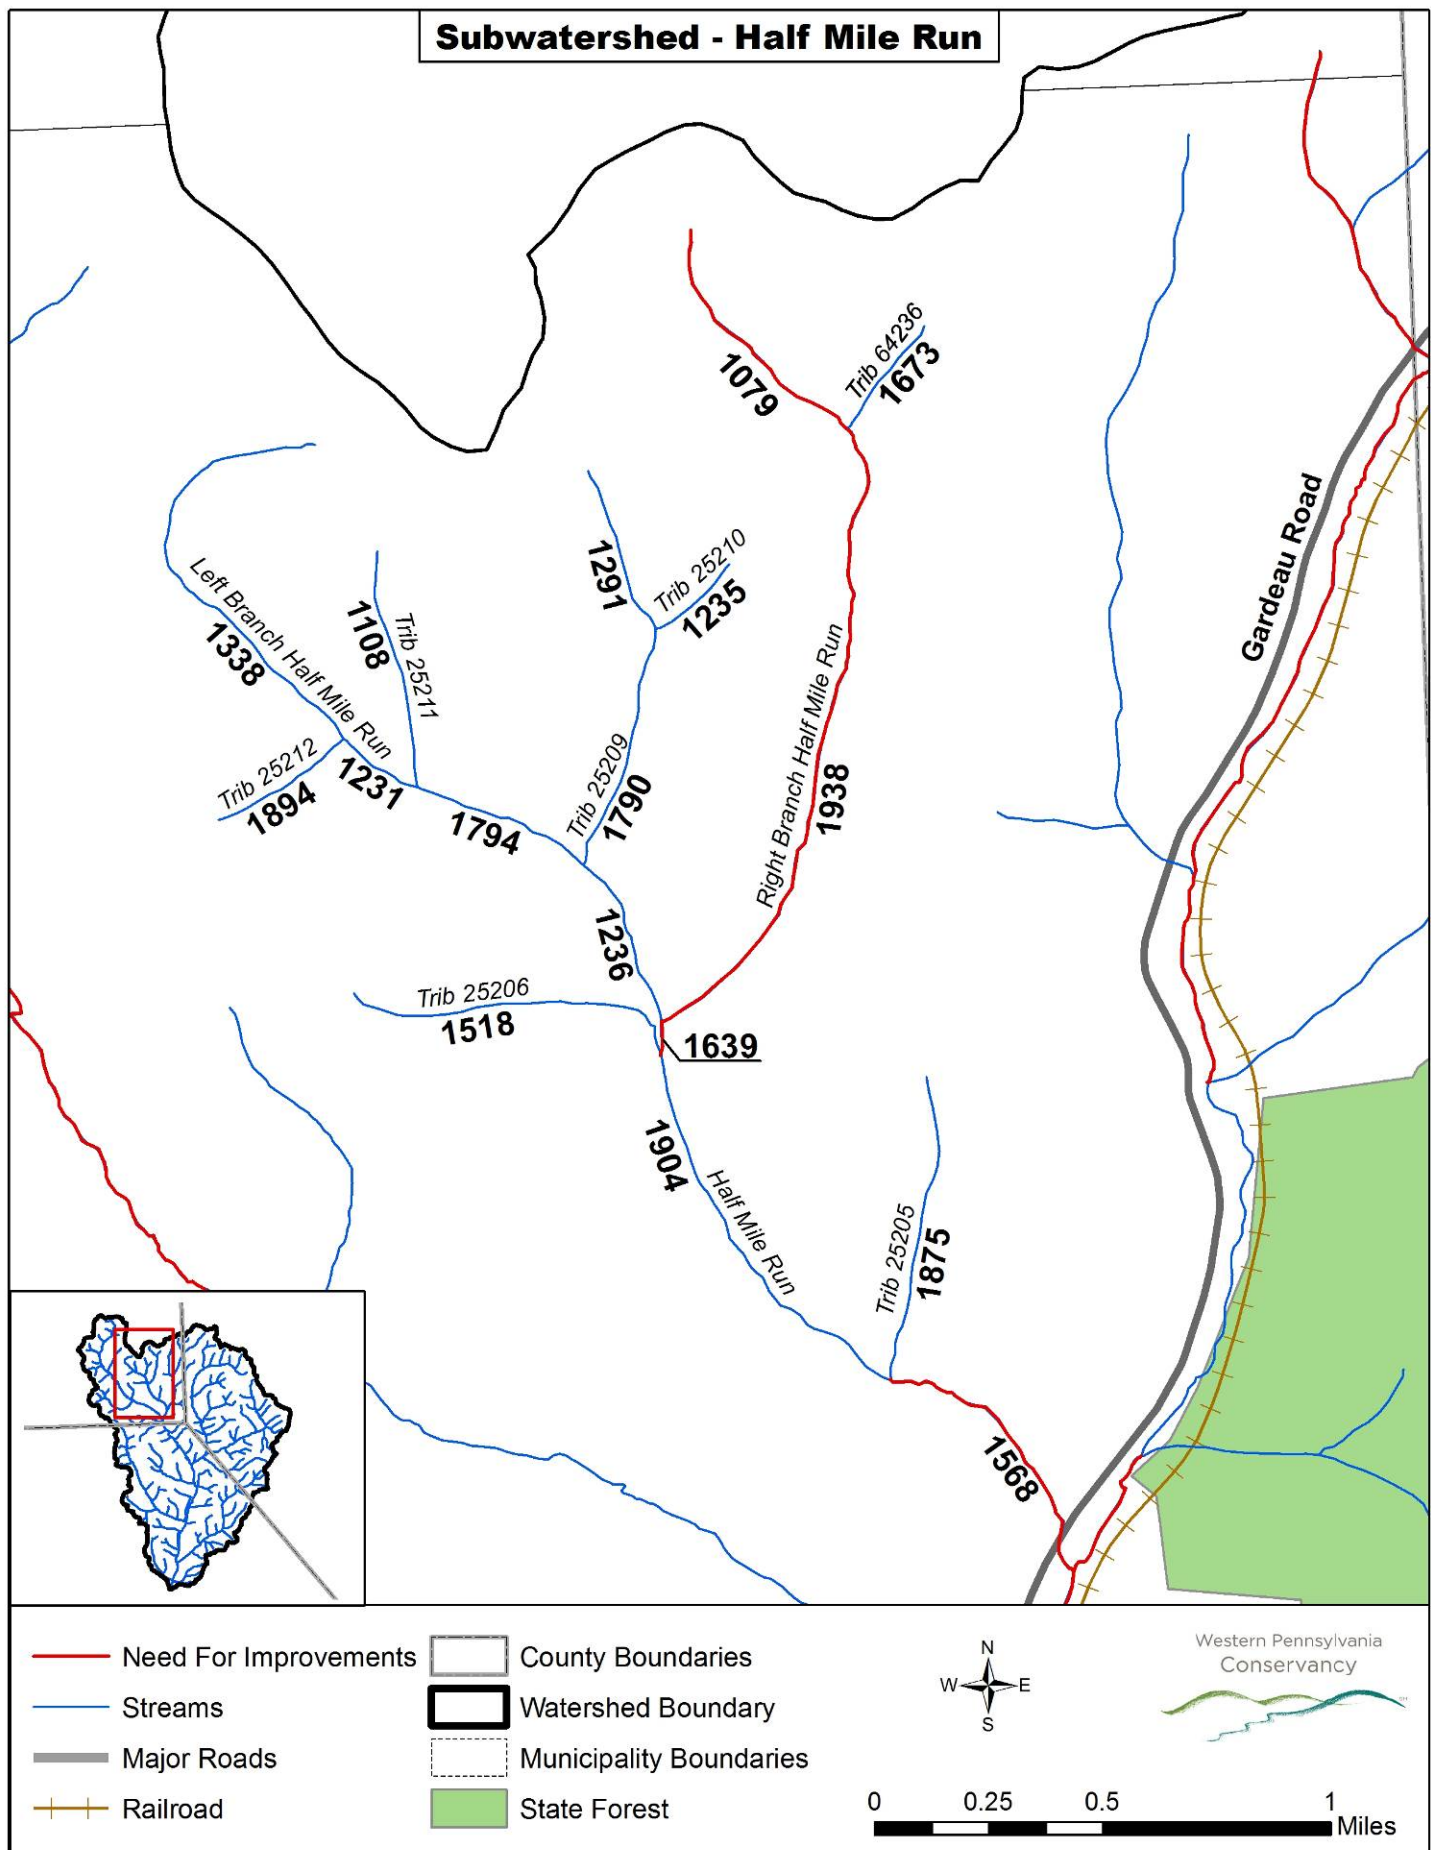
The categories that received the lowest scores were velocity/depth regimes and channel flow status, indicating potential habitat improvement projects. Channel braiding is a likely reason for these lower scores, as available flow struggles to fill overly-wide multiple channels. Potential habitat improvement projects could be related to increasing LWD in the stream. A lack of pool habitat or slow-deep/fast-deep depth regimes was noted on several segments (1236, 1338, and 1794). Due to an average stream width less than 12 feet for all segments in the subwatershed, large scale improvement projects are not probable until the first section of the stream before the mouth (1568). This section shows evidence of being channelized and is crossed by a road bridge approximately 400 feet upstream from the mouth. This segment would also be a good candidate for streambank stabilization projects, as there is evidence of erosion and stability issues as well as excellent access via Gardeau Road.

Segment 1079 had a small impoundment that forms a pond adjacent to a camp, increasing sediment deposition upstream. This segment also shows small signs of AMD seeps through iron build-up, but the impact of these seeps is local and minimal. Due to its location in the headwaters of the Right Branch of Half Mile Run, it is not likely to be a high priority project. This segment could also benefit from an improved riparian buffer, as the camp owners are mowing to the top of the streambank. Segments identified as having a need for improvement are shown on Figure 20.

Figure 20. Segments needing improvement in the Half Mile Run subwatershed.

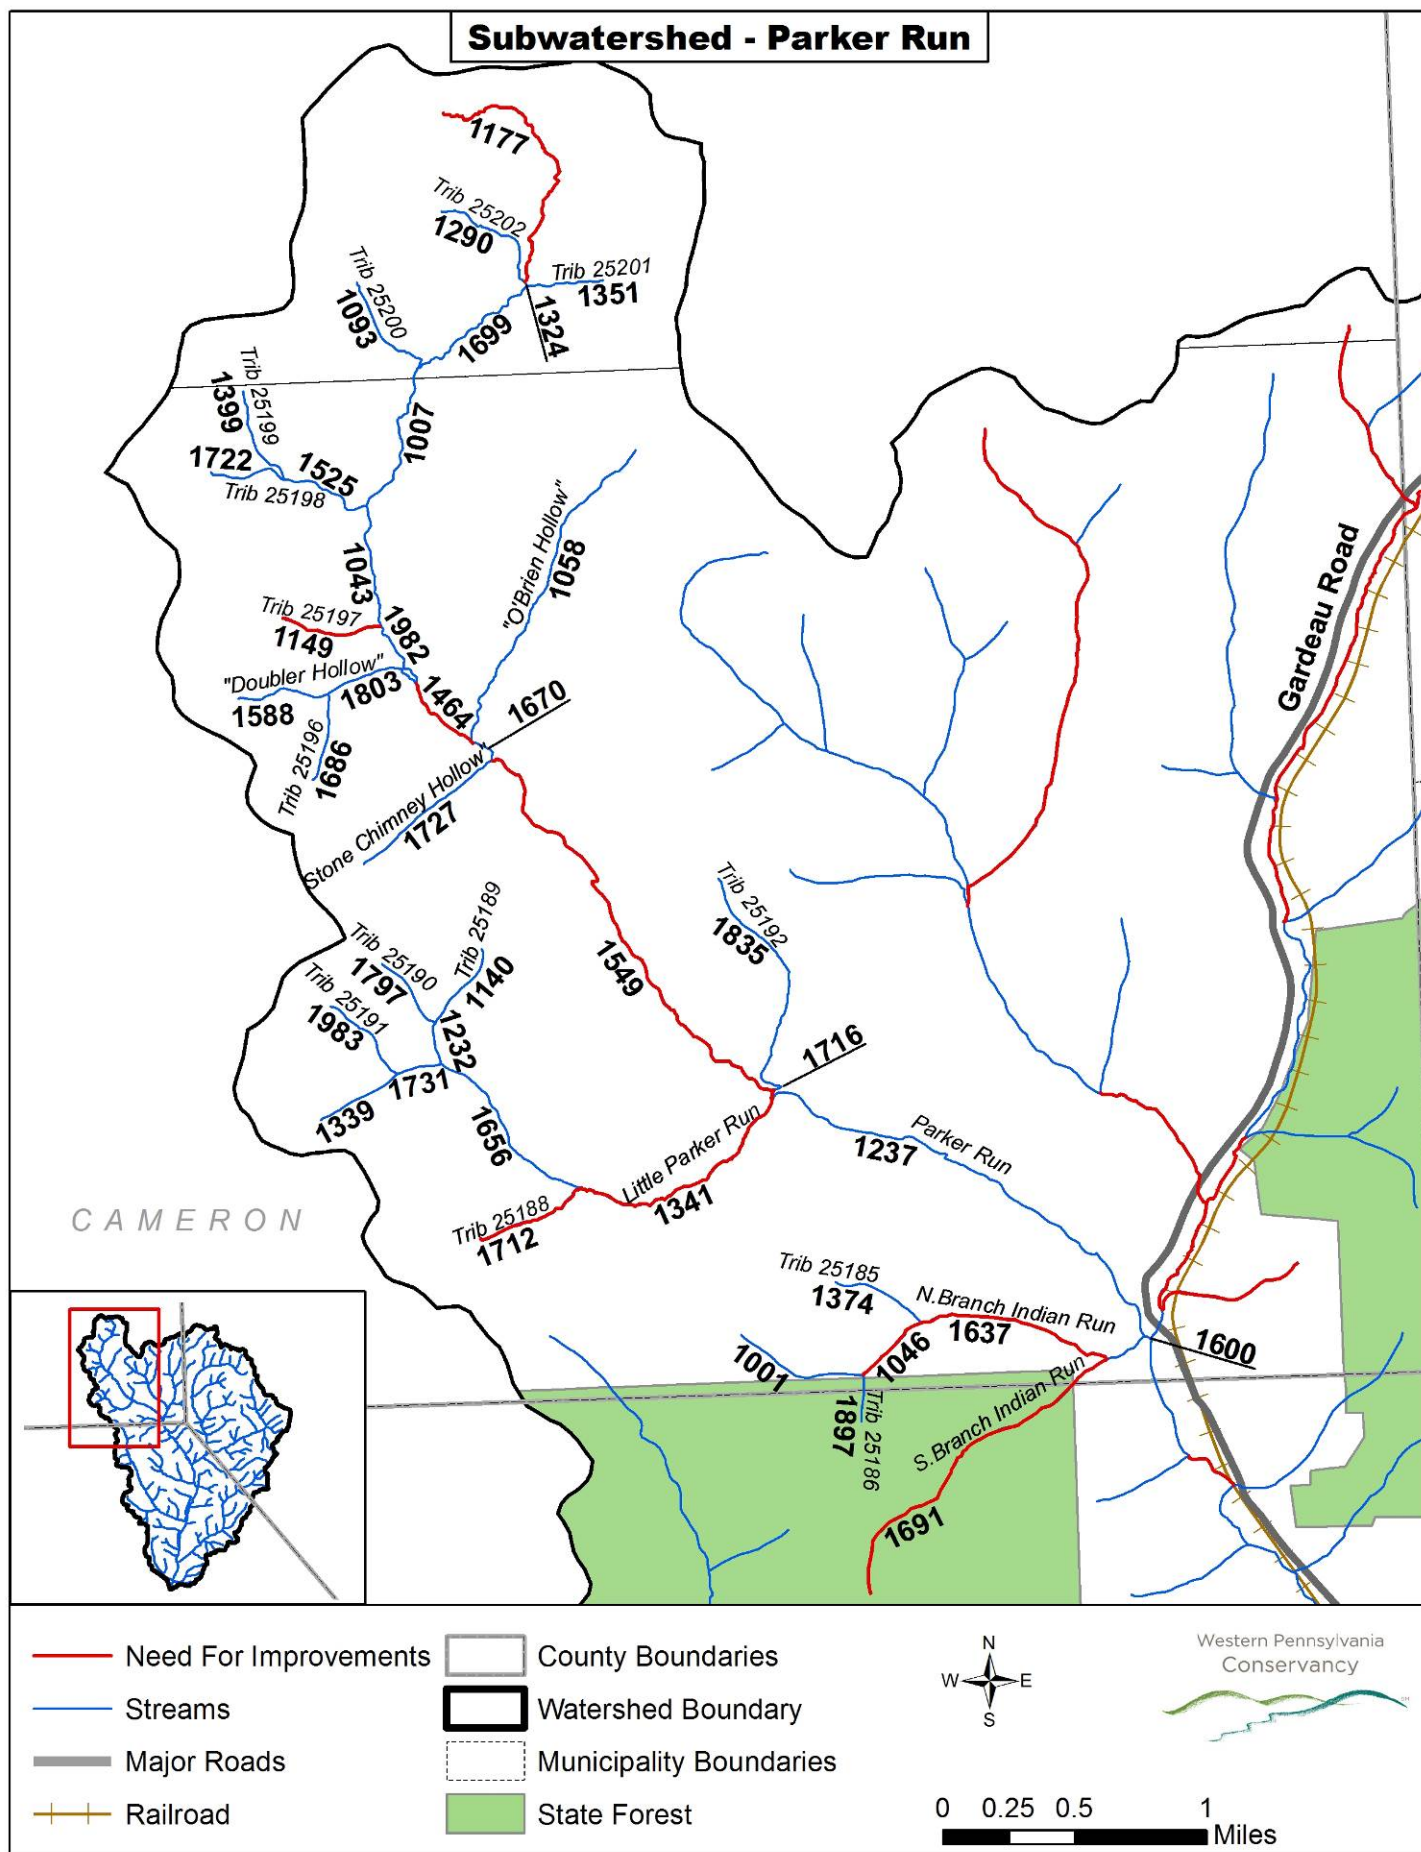
Figure 26. Segments needing improvement in the Parker Run subwatershed

The largest and likely most expensive project in the Parker Run subwatershed is the replacement of culverts on Little Parker Run. This location is the site of multiple pipe culverts underneath a road crossing that is collapsing, is poorly aligned and is choked with debris (Figure 23). Replacing this culvert will improve aquatic organism passage to more than three miles of upstream habitat. WPC has been in contact with the landowner and received permission to pursue funding to replace this culvert and will likely do so during the summer of 2014. Additional locations were noted throughout the watershed that could benefit from culvert improvements or upgrades. McKean County Conservation District is planning to implement dirt & gravel roads improvements in the watershed and will be a valuable partner in completing these projects.

The North and South Branches of Indian Run, which enter Parker Run near its confluence with Sinnemahoning Portage Creek, is the site of two potential projects. Dirt & gravel roads in this section access areas away from the riparian zone but intersect the tributaries at two locations. One location is a ford that could be stabilized near the bottom of segment 1691. A culvert replacement project to enhance aquatic organism passage on segment 1637 (Figure 24) would also be feasible, especially due to easy access using the intersecting road. These roads are private, see limited vehicular traffic, and are used primarily by leasers to access the property. Due to the close proximity of these project sites, they could be completed at the same time, reducing sediment impacts to Indian Run and re-opening more than one mile of the North Branch of Indian Run for fish passage. Most of this property is managed by FORECON, Inc. out of Smethport, PA, and preliminary discussions regarding improvement projects were favorable.

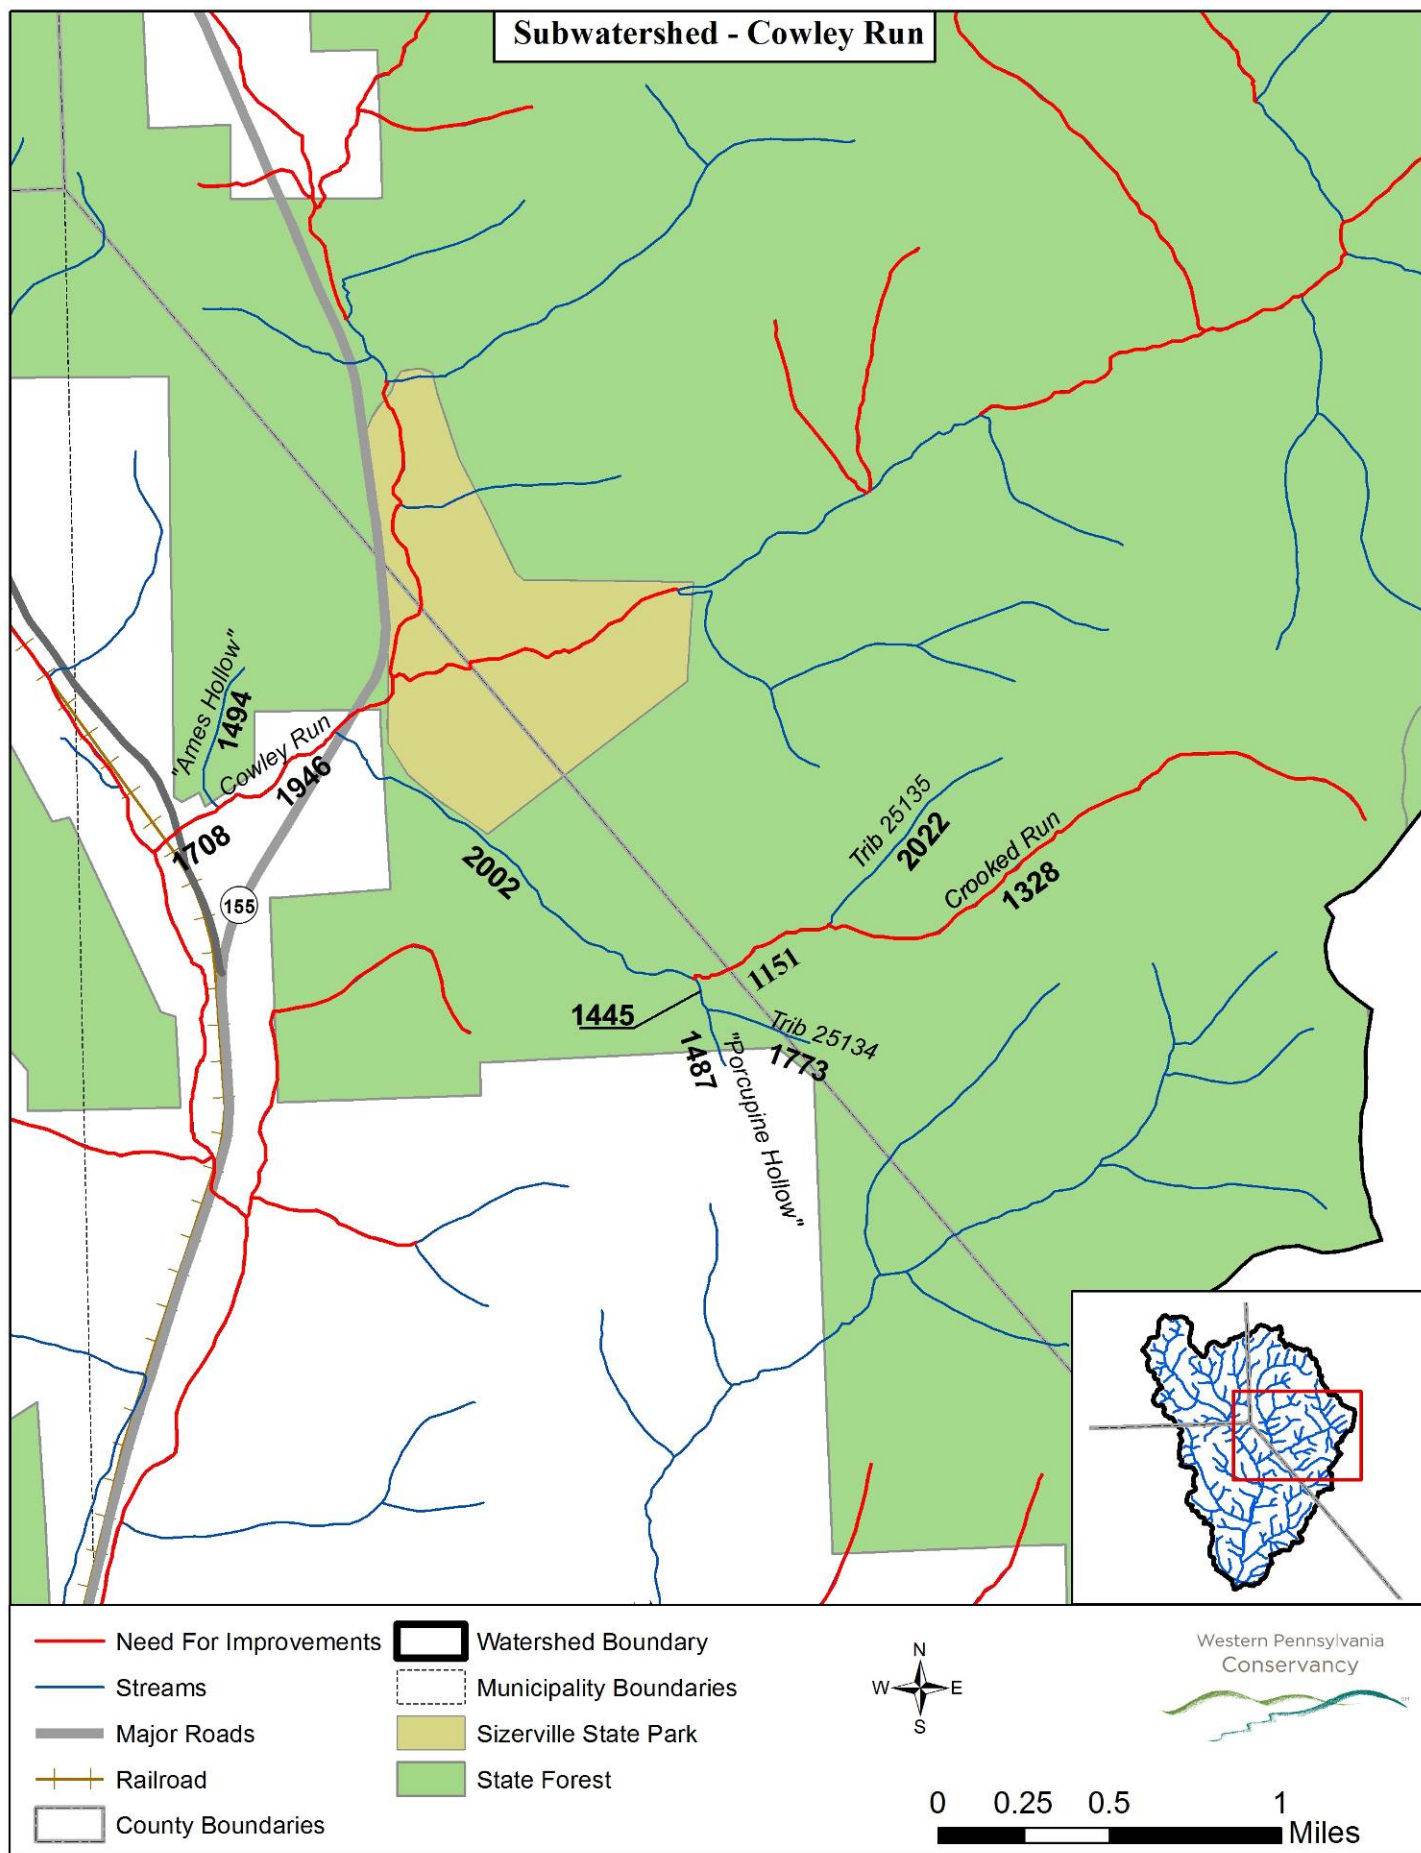
Figure 30. Segments needing improvement in the Cowley Run Creek subwatershed

Streambank stabilization and restoration on section 1824 are recommended (Figure 30), with one caveat. Due to stabilization efforts and channelization on the East Branch of Cowley Run, improvements to streambanks on this section of Cowley Run can only be completely successful once upstream improvements are made. Riparian buffer plantings on sections 1708 and 1946 are recommended (Figure 28). An additional streambank protection project would be to consider the purchase of the land that is for sale along Cowley Run to ensure that the quality habitat on the section is protected into perpetuity. Additional in-stream habitat could also be improved within the shallow and wide segments within Cowley Run.

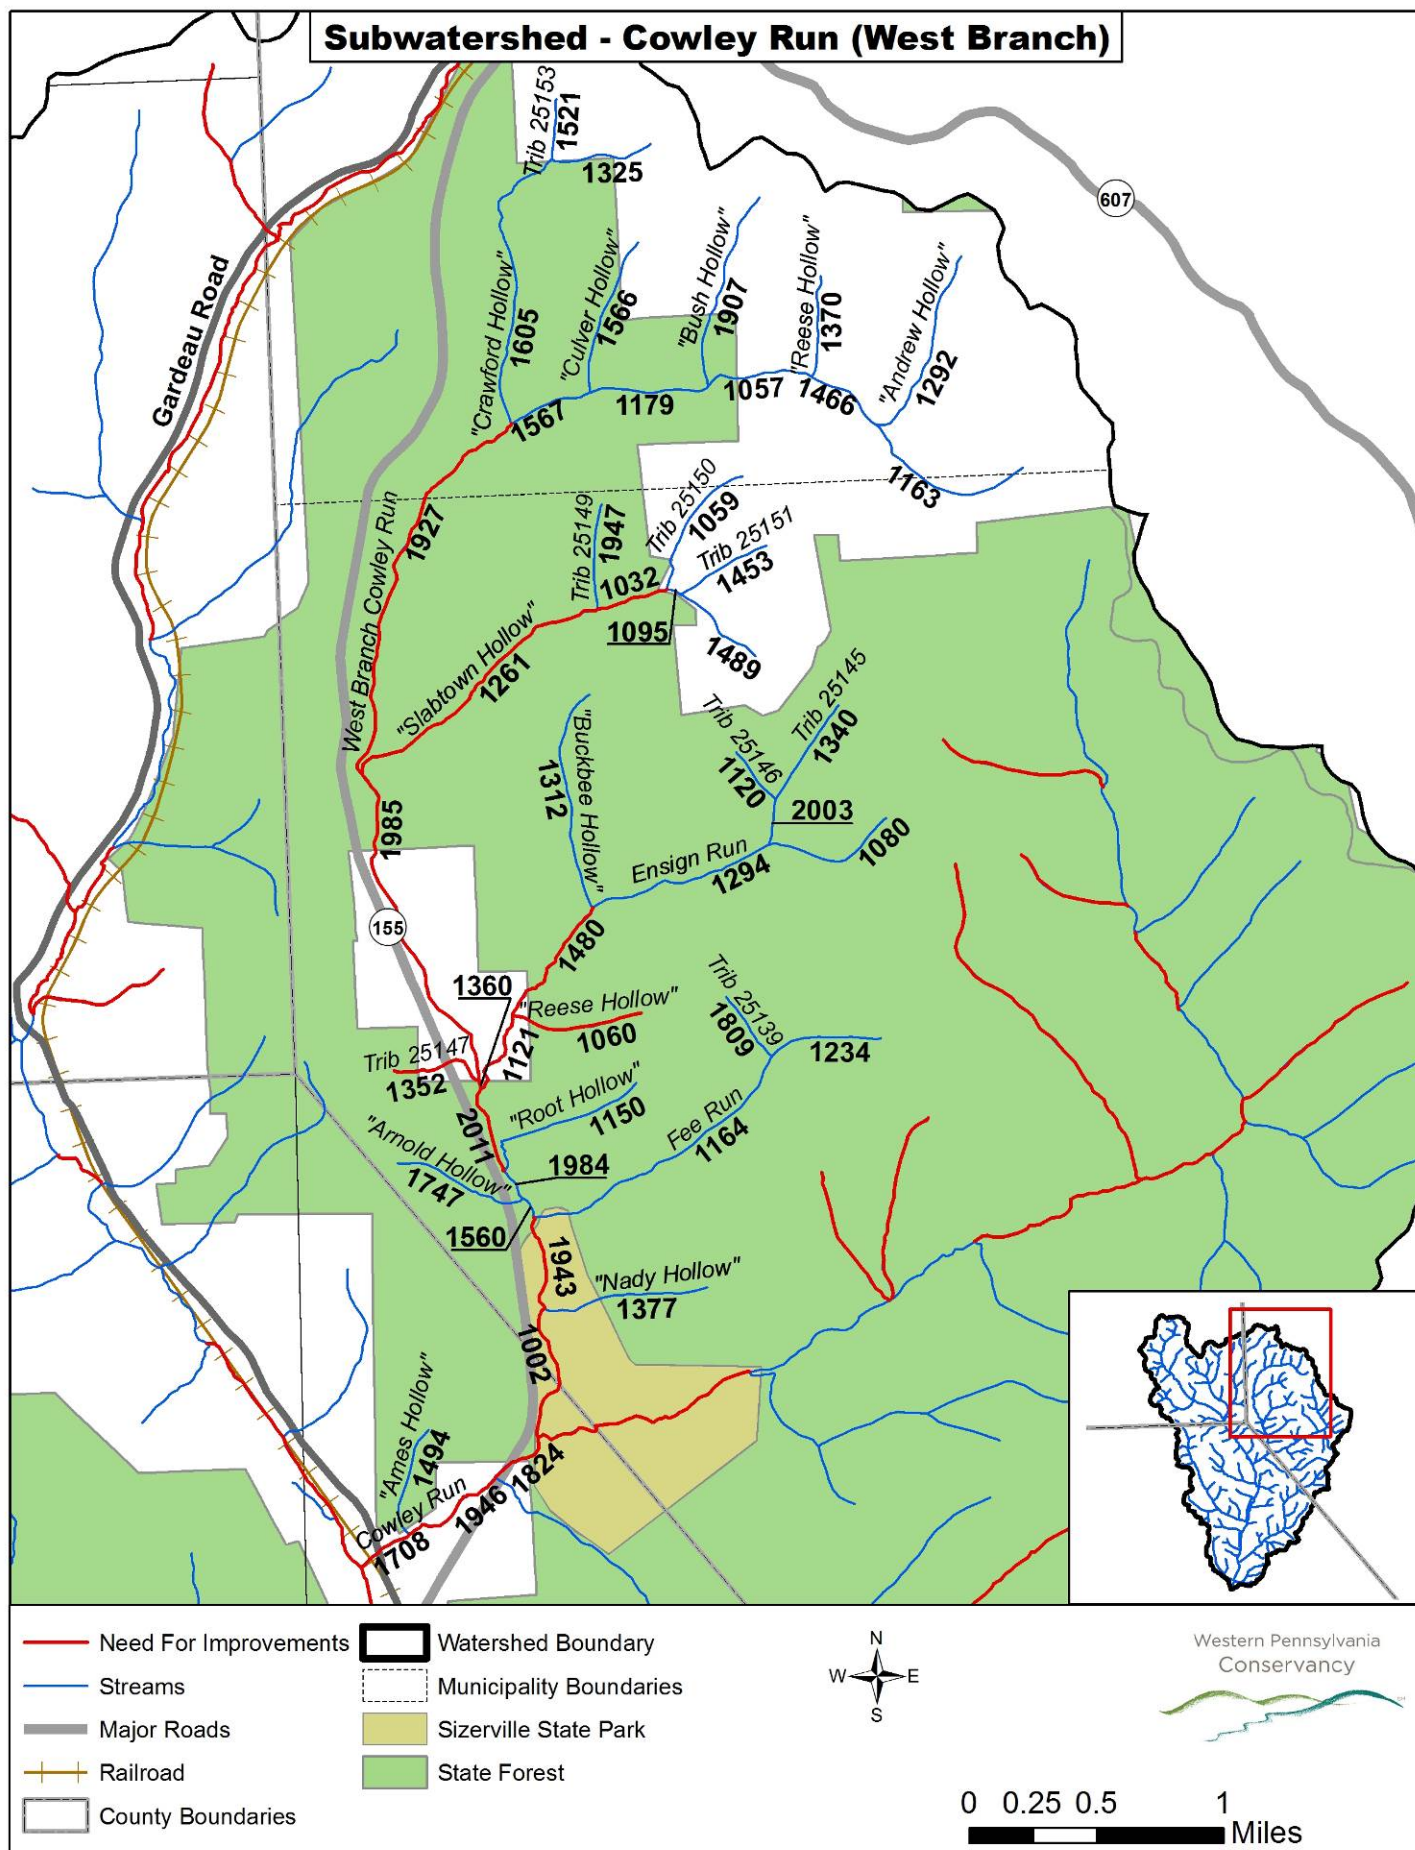
Figure 35. Segments needing improvement in the West Branch Cowley Run subwatershed

Bank stabilization efforts on the lower reaches of the West Branch of Cowley Run are the priority projects in this subwatershed. The Cameron County Conservation District is cooperating with Sizerville State Park to complete projects on segment 1943 near the park campground. Additional streambank restoration and stabilization is also recommended on segment 1002. Fish habitat being included as a component of the restoration efforts would greatly improve epifaunal substrate and available cover. Segments in need of improvement are identified on Figure 35.

Riparian buffer enhancement would benefit the West Branch along segments in the state park and on the private property upstream, segment 1985. Segment 1927 would be an excellent location for a riparian planting project due to the segment being wholly contained by state forest land (Figure 33). Access would be a challenge for the upper portion of the reach and would require that planting equipment and materials be packed in to complete the restoration project. This project is still recommended to the overall benefit it would have to this segment of the West Branch, as well as downstream reaches.

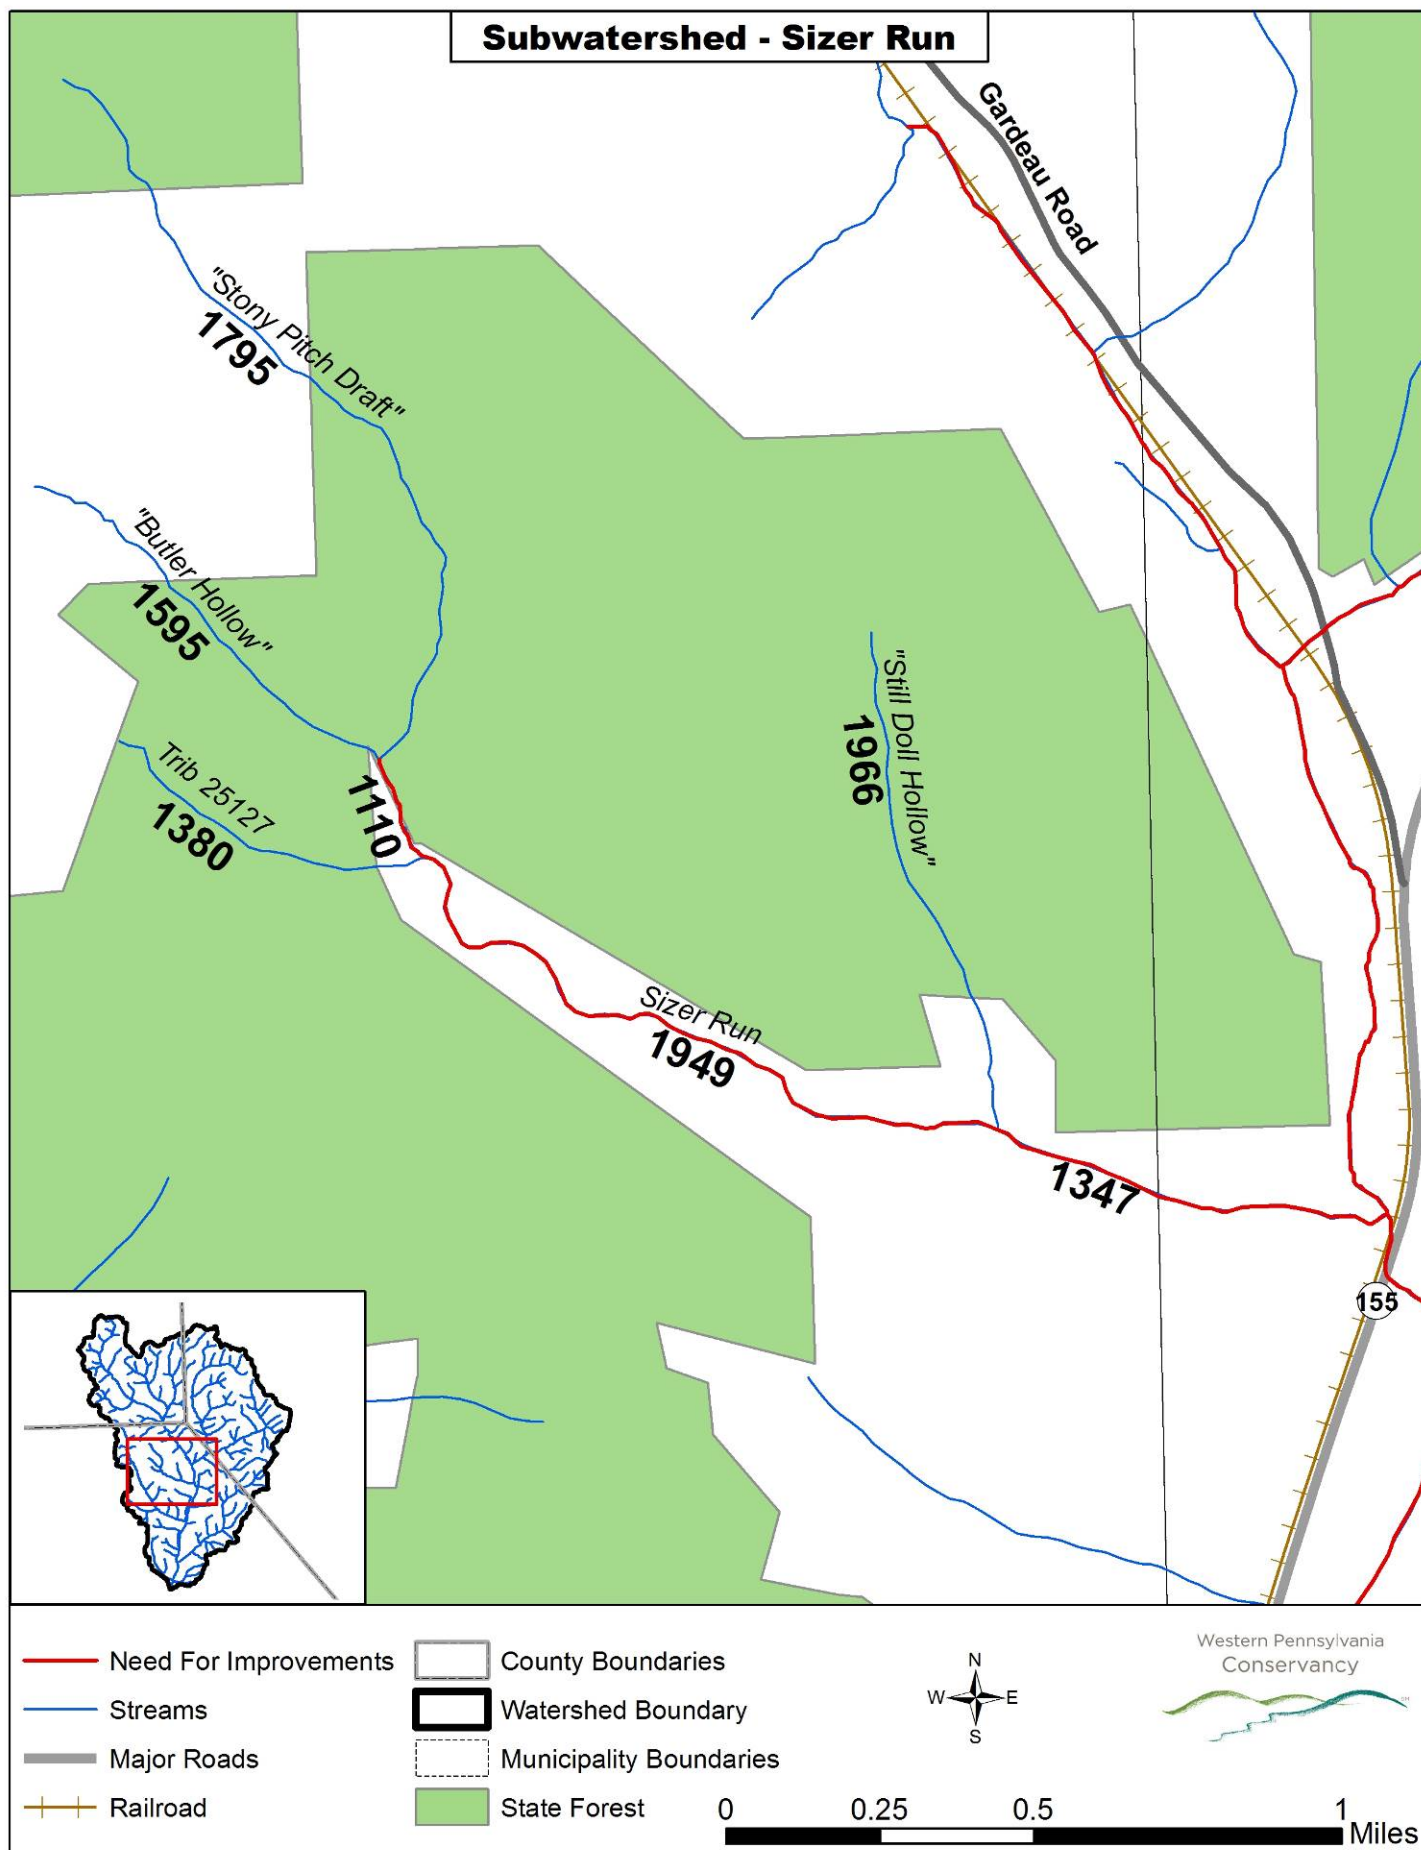
Sizer Run would benefit from improved road drainage. Large amounts of deposited sediment were noted on segment 1380, which parallels Sizer Run Road. Additional heavy sediment accumulation was noted along segment 1949 at the location where the stream runs close to the road along its left bank before being culverted under the road. While this culvert was likely sized properly and does not create a fish barrier, the pool at its outlet had significant amounts of fine sediment deposition. One culvert that does create a significant fish barrier is located just upstream of the mouth of Sizer Run (Figure 46). This culvert passes under Sizer Run Road, which at this location is still paved. The culvert is quite large and a replacement project would likely be challenging and costly; however, improving fish passage at this location would benefit the entire Sizer Run subwatershed. Sizer Run watershed, while small, could certainly benefit from restoration projects along its mainstem (Figure 48).

Figure 48. Segments needing improvement in the Sizer Run subwatershed

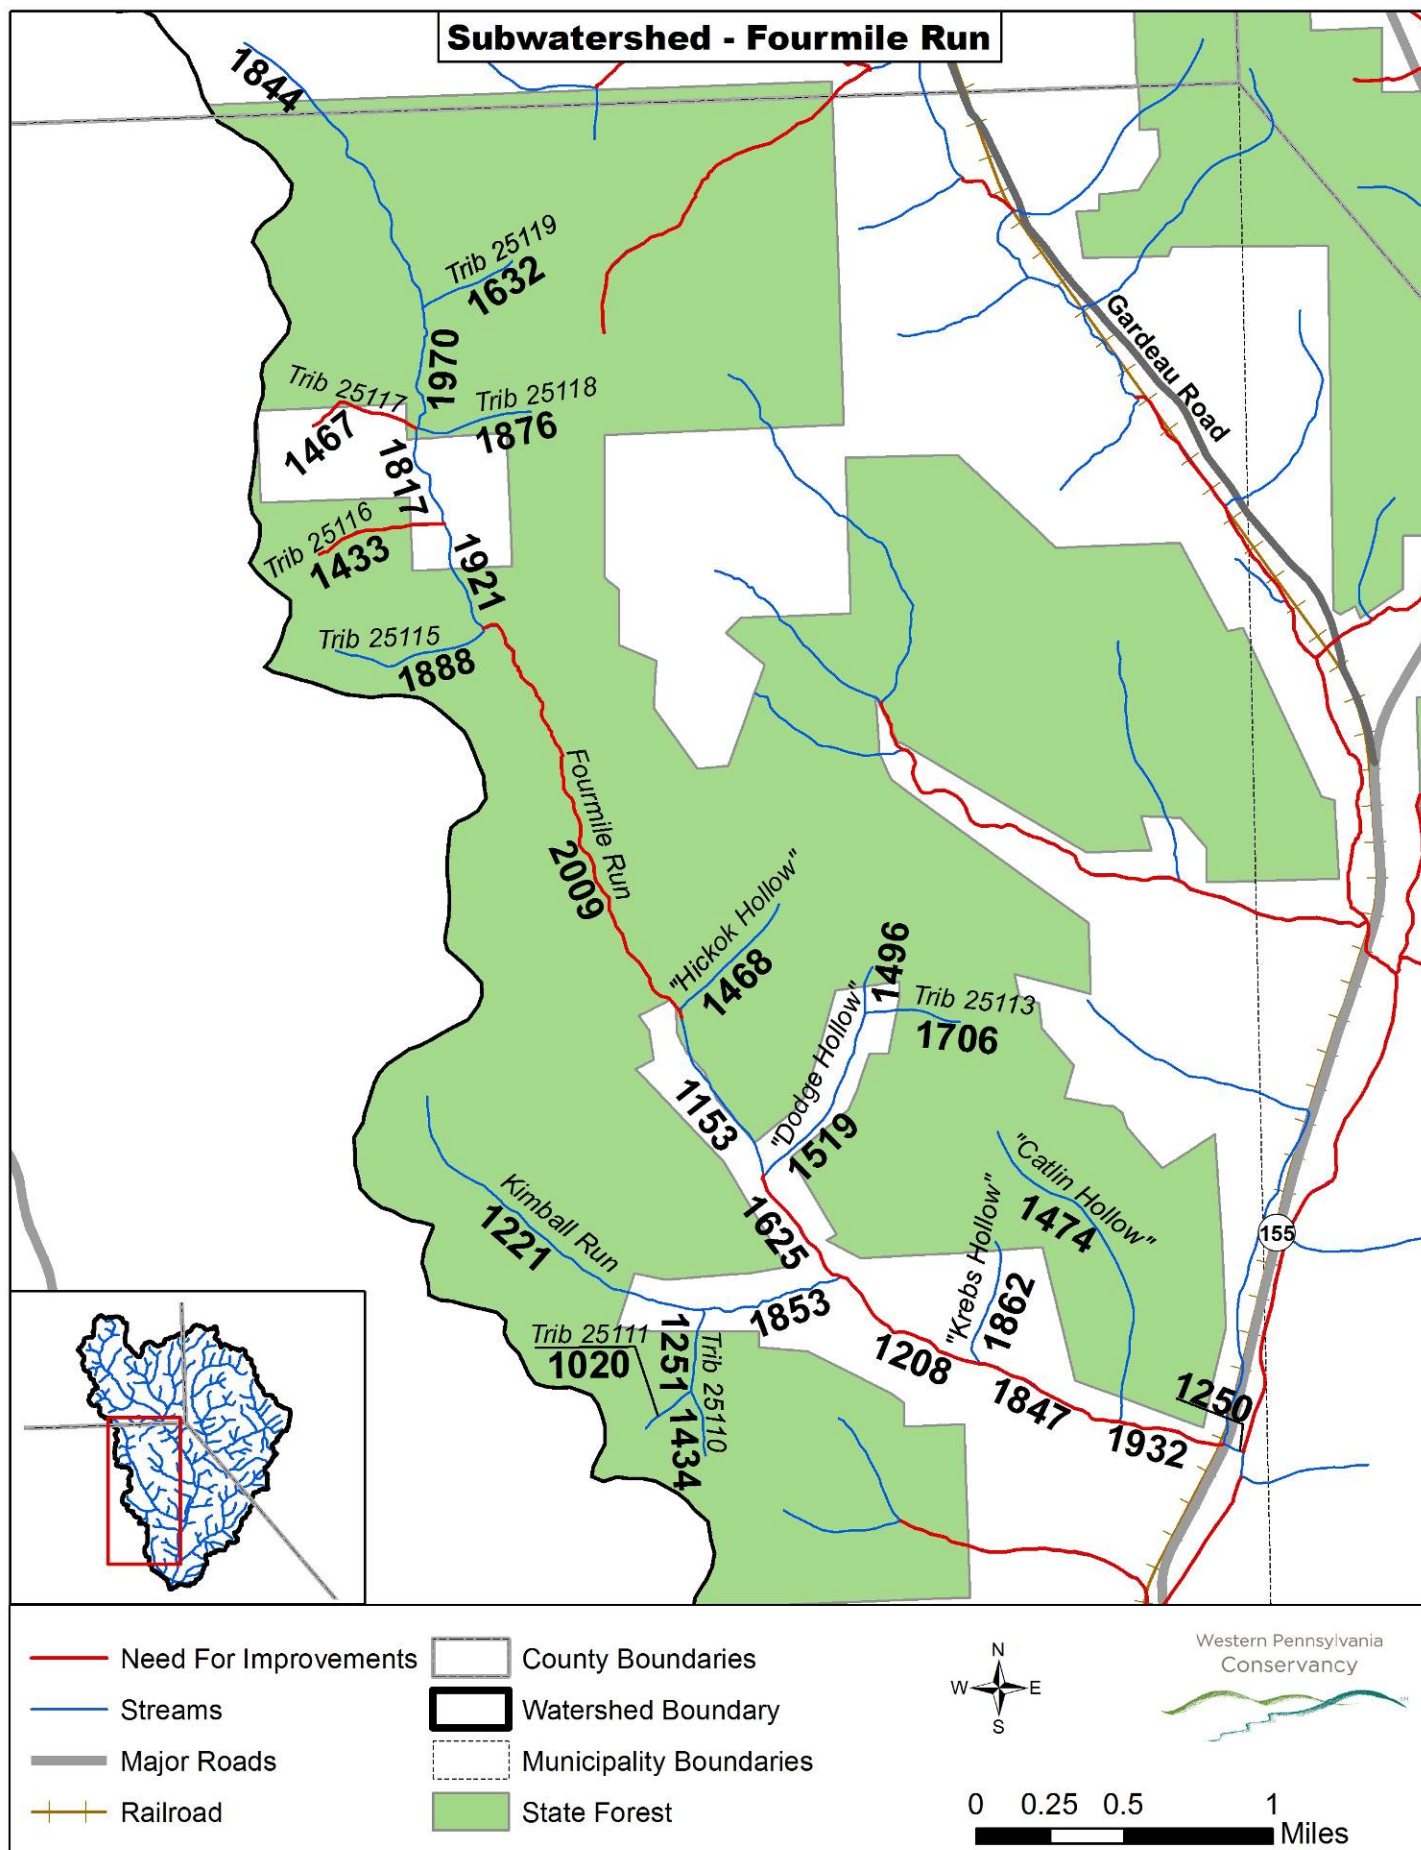
There are a number of impacts to Fourmile Run that vary primarily due to the segment location in the watershed. At the lower end of the subwatershed, closer to the mouth and Route 155, degradation is driven by residential land use. Lawn mowing and streambank “maintenance” have limited the riparian zone width. Roads and utility lines intersect the lower reaches, most notable on segment 1932. This segment is also intersected by the railroad bridge, which passes over the segment at its most downstream extent (Figure 50). Channelization of the stream channel has accelerated erosion. Some measures have been taken by landowners to combat the effects, but they are merely addressing the symptom and not the cause of the issue.

Figure 53. Segments needing improvement in the Fourmile Run subwatershed

Further evaluating these sites for both flood water capacity and aquatic organism passage is recommended.

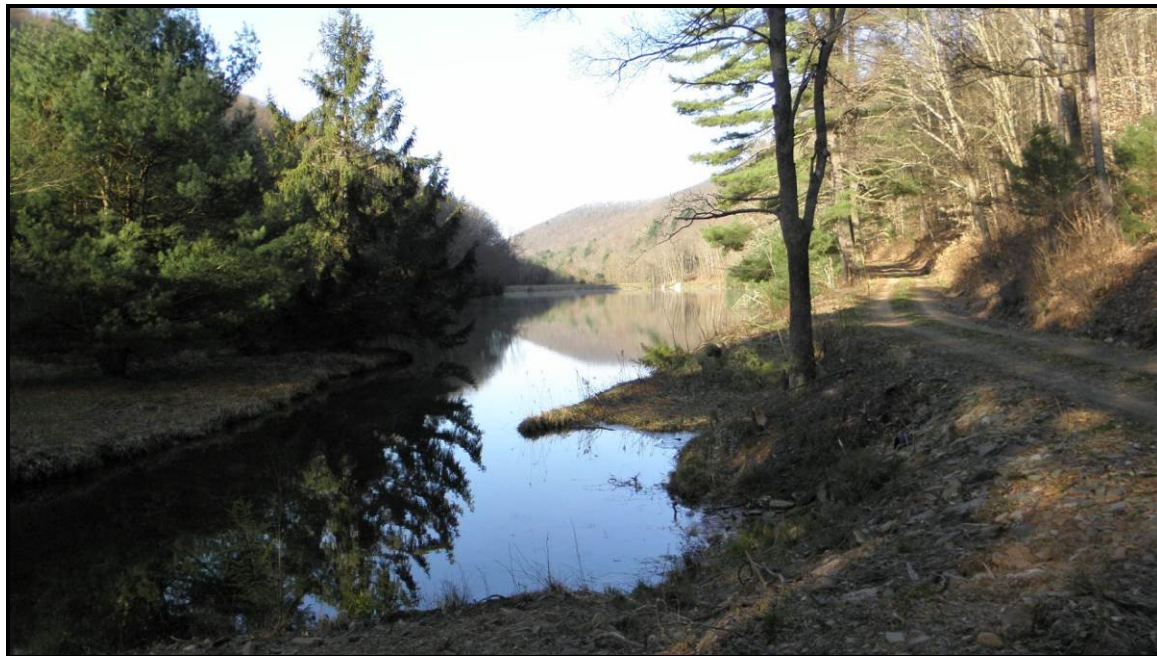
Twenty-eight segments were assessed in this subwatershed, totaling 15.2 miles of stream. All of the segments fell in the Optimal or Suboptimal category, with the average score being 15.3 or at the highest level of Suboptimal (Figure 57 and Table 8). The exception was stream segment 1530, which represents the reach encompassing Salt Run Reservoir. As the assessment protocol is developed with conditions for flowing water as the target, with a score of 9.1, this segment is forced into the Marginal category (Figure 54). Not including this segment brings the average score up to 15.5, so the reach is not a detriment to the overall subwatershed in-stream habitat and the reservoir is essential as a water supply for the town of Emporium.

Figure 54. Segment 1530 looking downstream towards the Salt Run Reservoir outlet
