Sinnemahoning Portage Creek In-Stream Habitat Assessment

December 2013

Western Pennsylvania
Conservancy

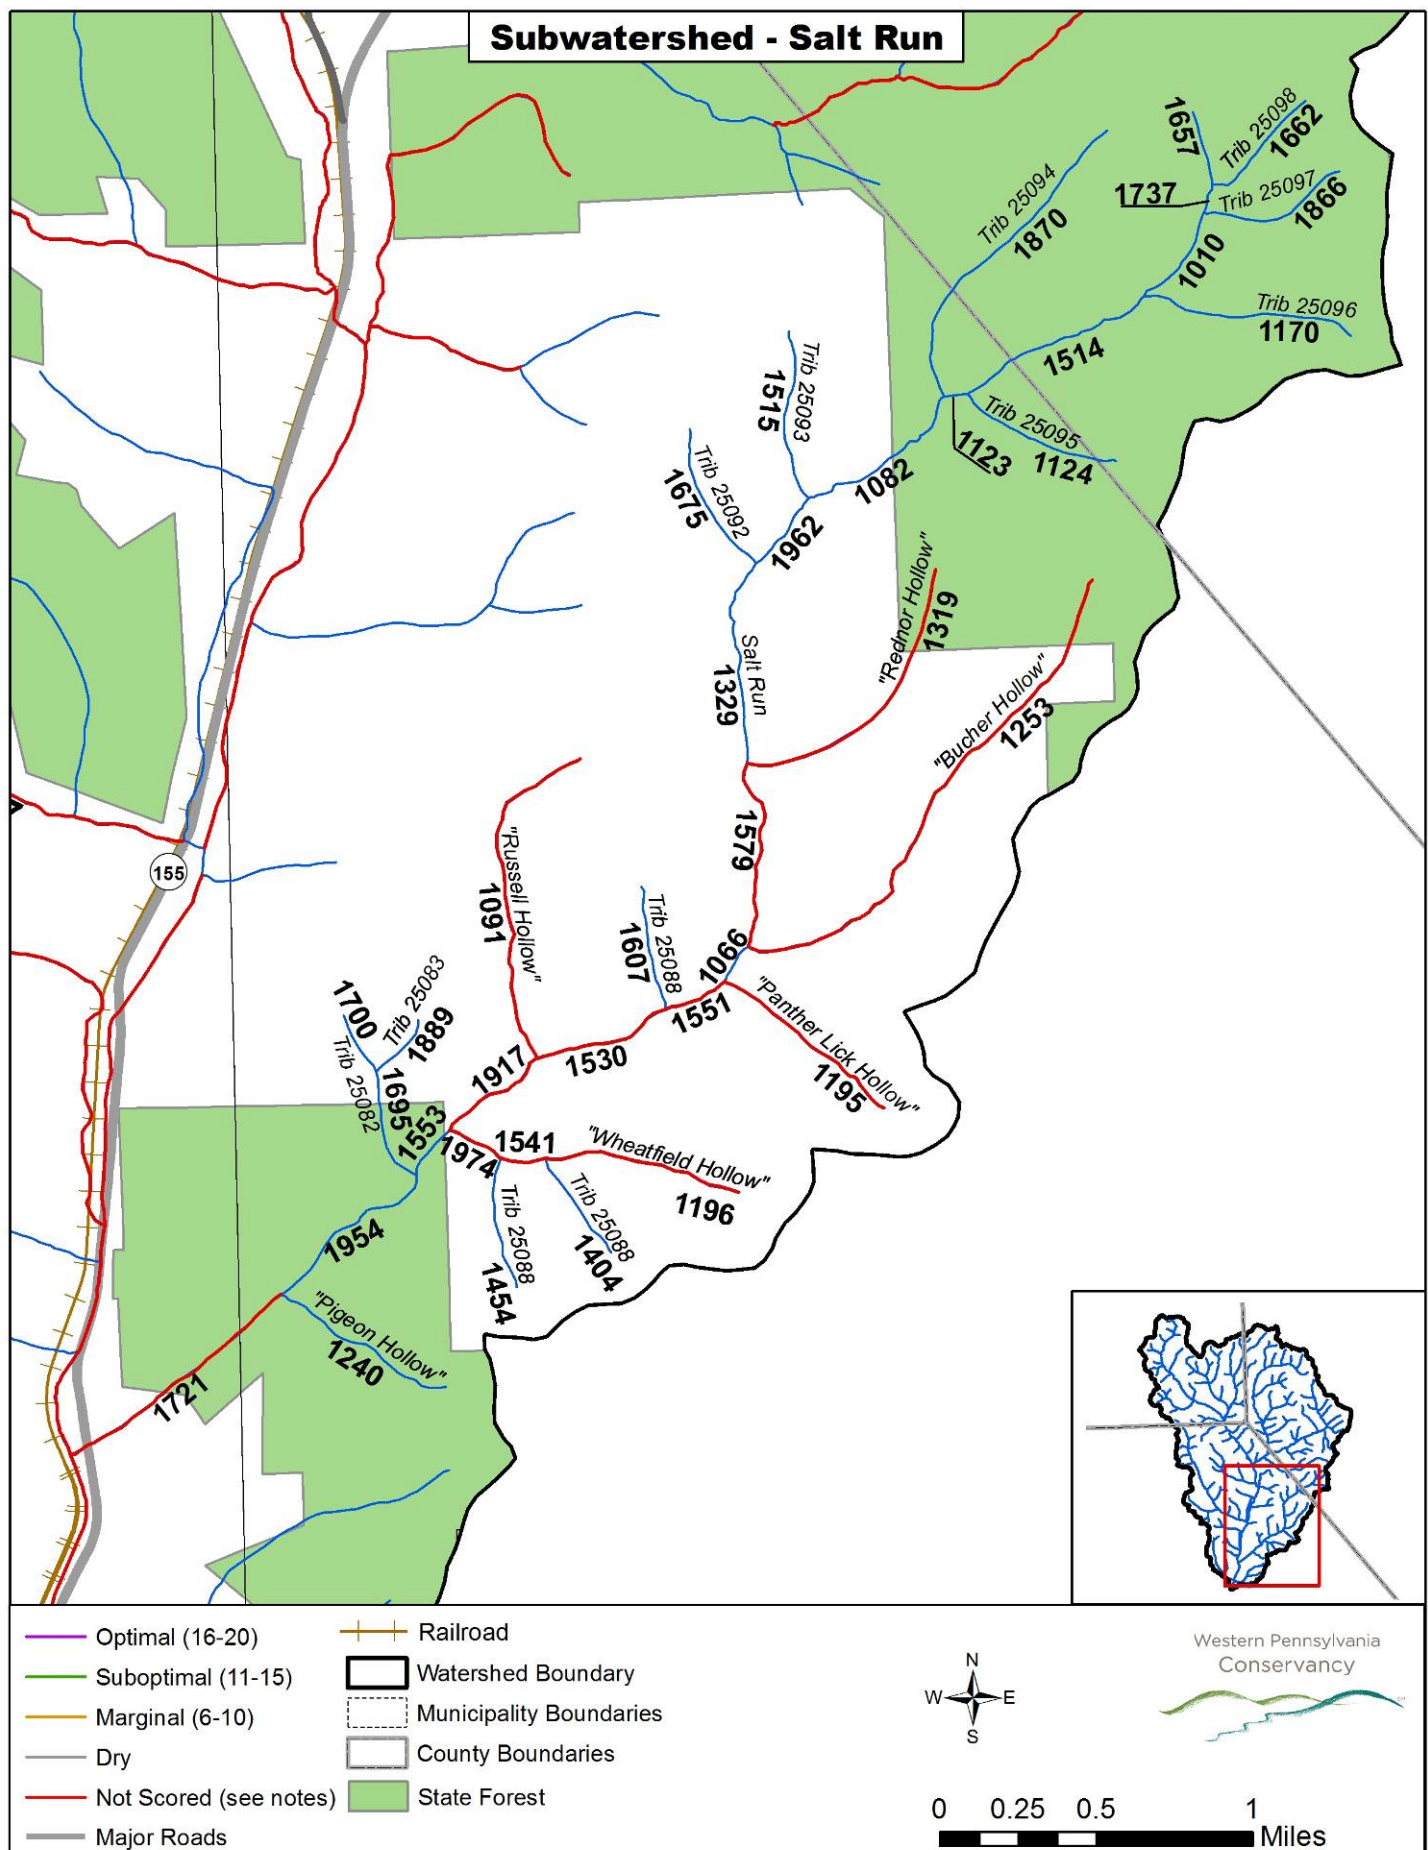
Figure 58. Segments needing improvement in the Salt Run subwatershed

Culvert replacement projects would also benefit this subwatershed. While the majority of the culverts are new and in good condition structurally, they are undersized and not ideal for aquatic organism passage or high flow conditions. Within the lower watershed, several old stream structures, such as jack dams were installed at some point in the past. Erosion was noted at several of these structures where the arms of the structures meet the banks. All previously installed structures should be evaluated for erosion and stability and repairs made where necessary.

Riparian buffer plantings would also be recommended on locations in the upper reaches, but especially along segment 1721. Some planting has been completed there, but more trees or shrubs could be added while still allowing access to the stream for fishing. The Emporium Water Company has been very cooperative with the completion of this assessment, both on their property and with developing contacts with other landowners. They will be an excellent and willing partner for future projects in the Salt Run watershed (Figure 58).

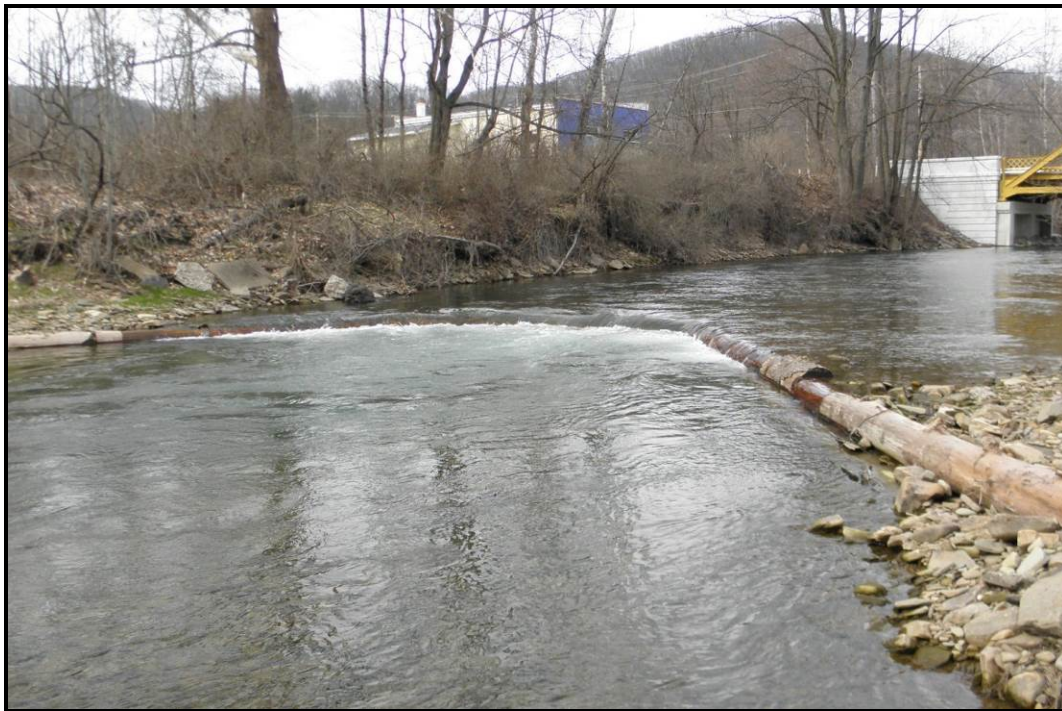
Fish habitat improvement and bank stabilization projects throughout the mainstem reaches of Sinnemahoning Portage Creek would be beneficial. Currently, Cameron County Conservation District has already completed several projects on segment 1526 (Figure 70), which was scored overall as Marginal due to a lack of habitat. Ongoing work on many reaches could include additional physical projects, as well as invasive species eradication and riparian buffer establishment. Partnerships with organizations such as the Sinnemahoning Invasive Plant Management Area (SIPMA) will be vital in accomplishing these projects. Segments needing improvement can be identified using Figure 72.

Figure 70. Log cross vane project completed by Cameron County Conservation District on segment 1526

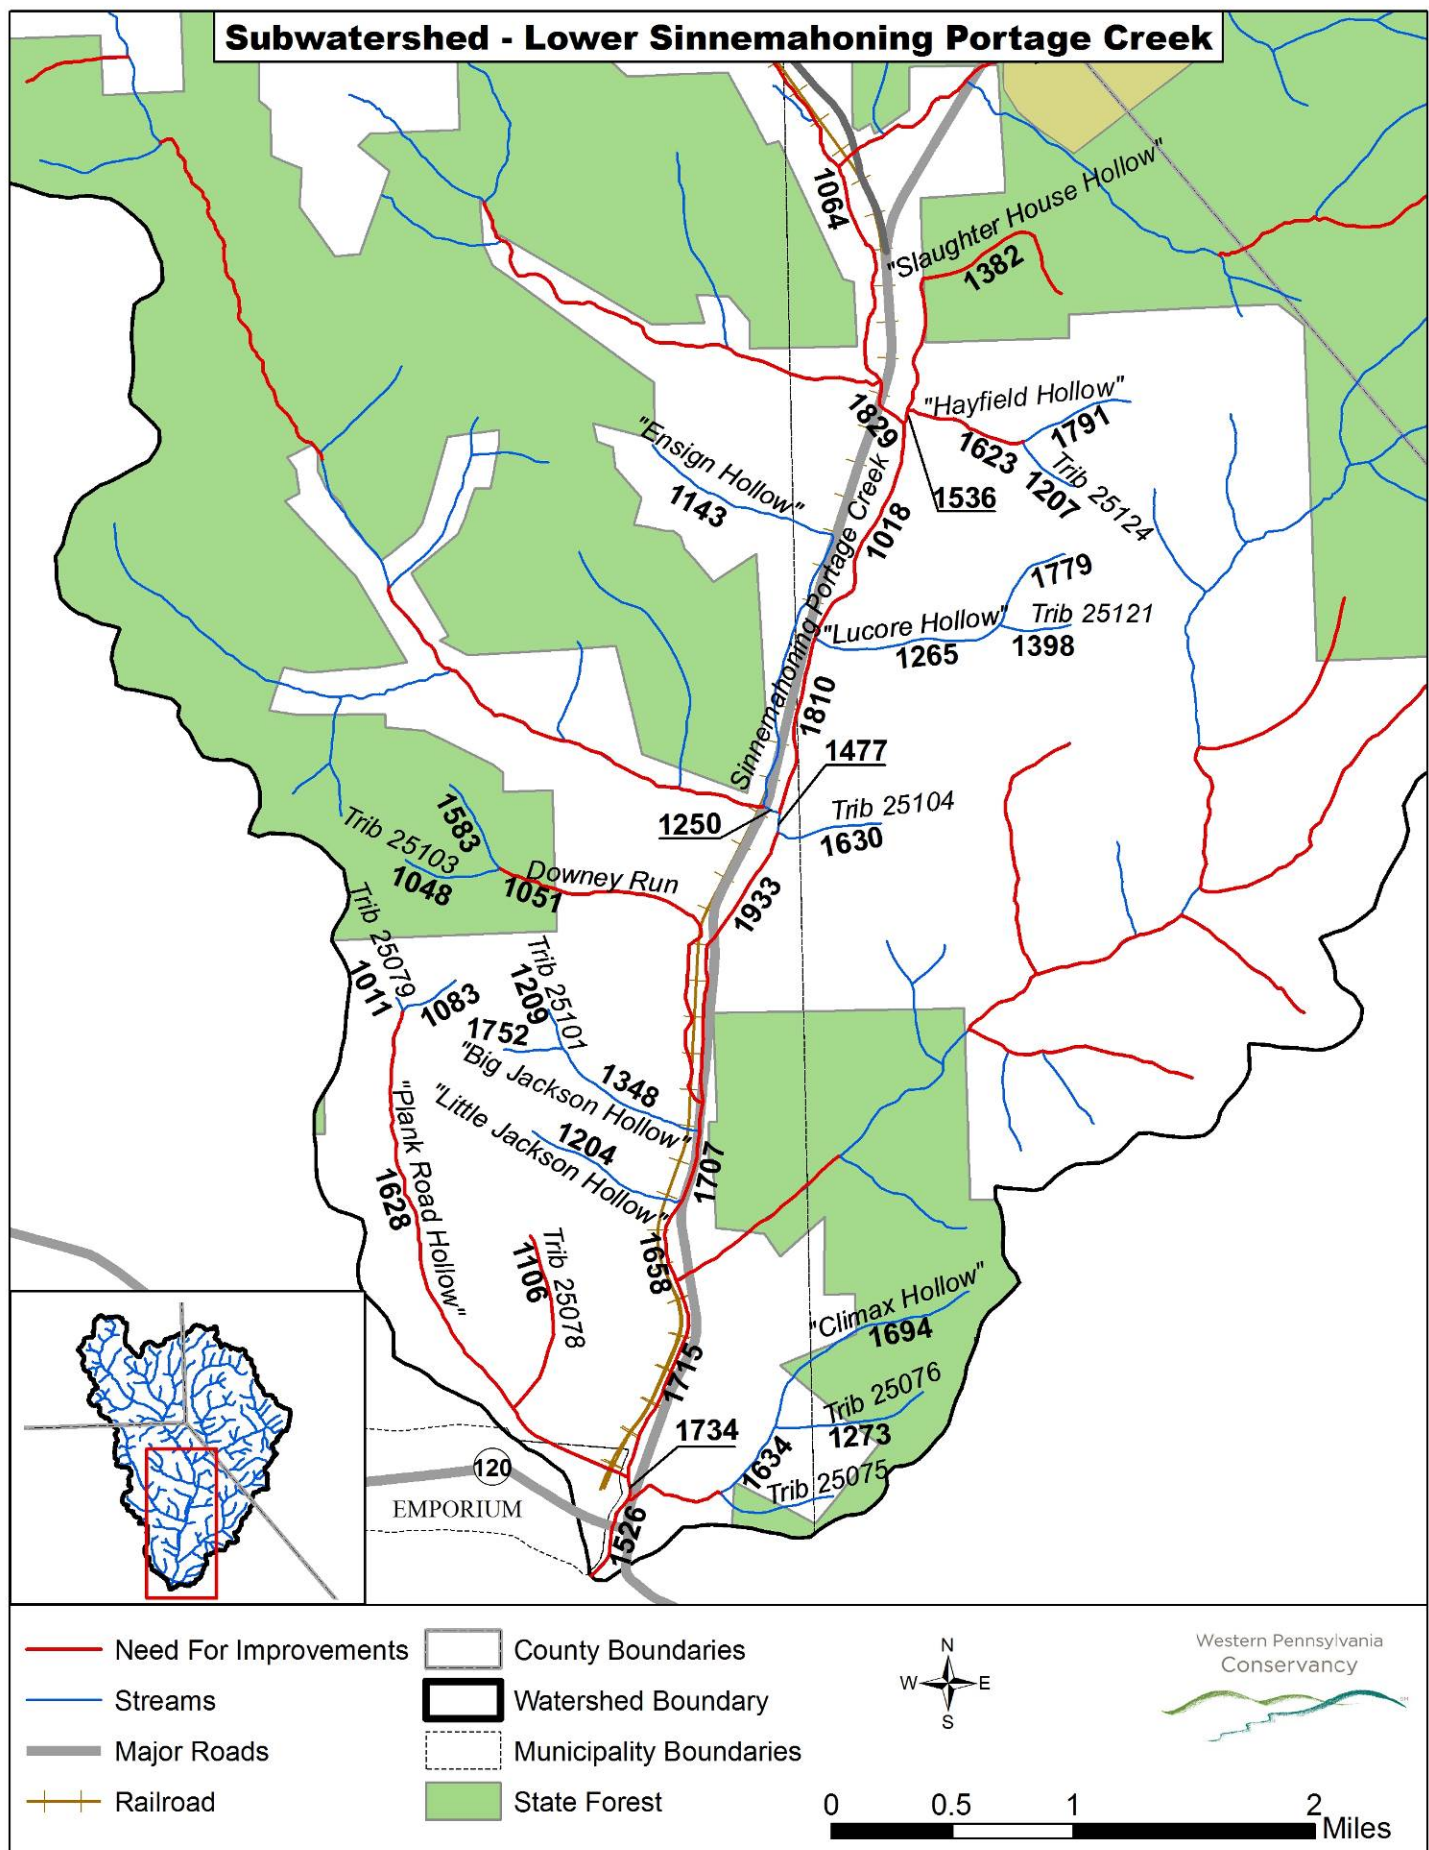
Figure 72. Segments needing improvement in the lower Sinnemahoning Portage Creek subwatershed
