ALLEGHENY COUNTY PARKS ECOLOGICAL ASSESSMENT AND ACTION PLAN WHITE OAK PARK

Prepared for the Allegheny County Parks Foundation
December, 2021

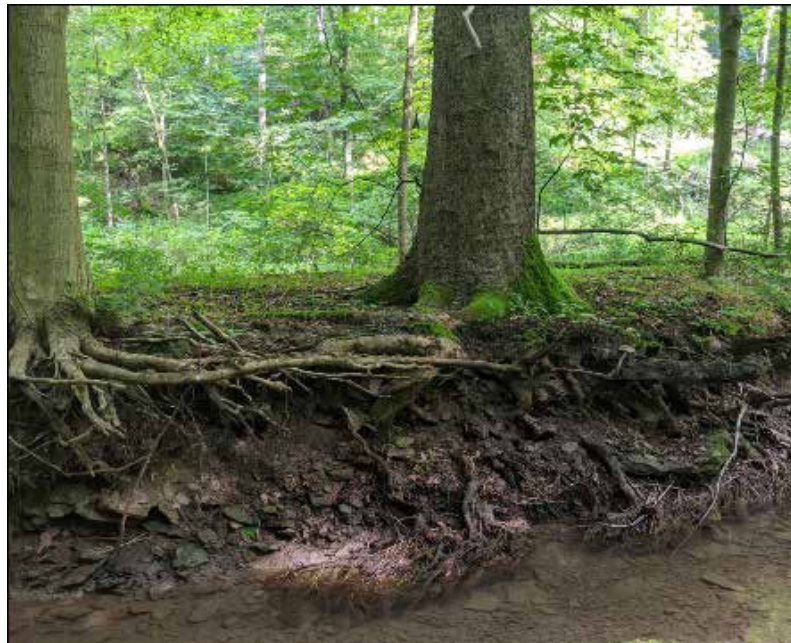
Streambank Erosion within White Oak Park

It is most ideal to redress the root causes through improved stormwater runoff management rather than treating only the end result through physical reinforcement where the erosion is occurring. Where streambank erosion occurs within “Best” or “Good” Ecological Integrity areas, physical restructuring should be approached with particular care for the potential of such projects to damage native vegetation, introduce non-native

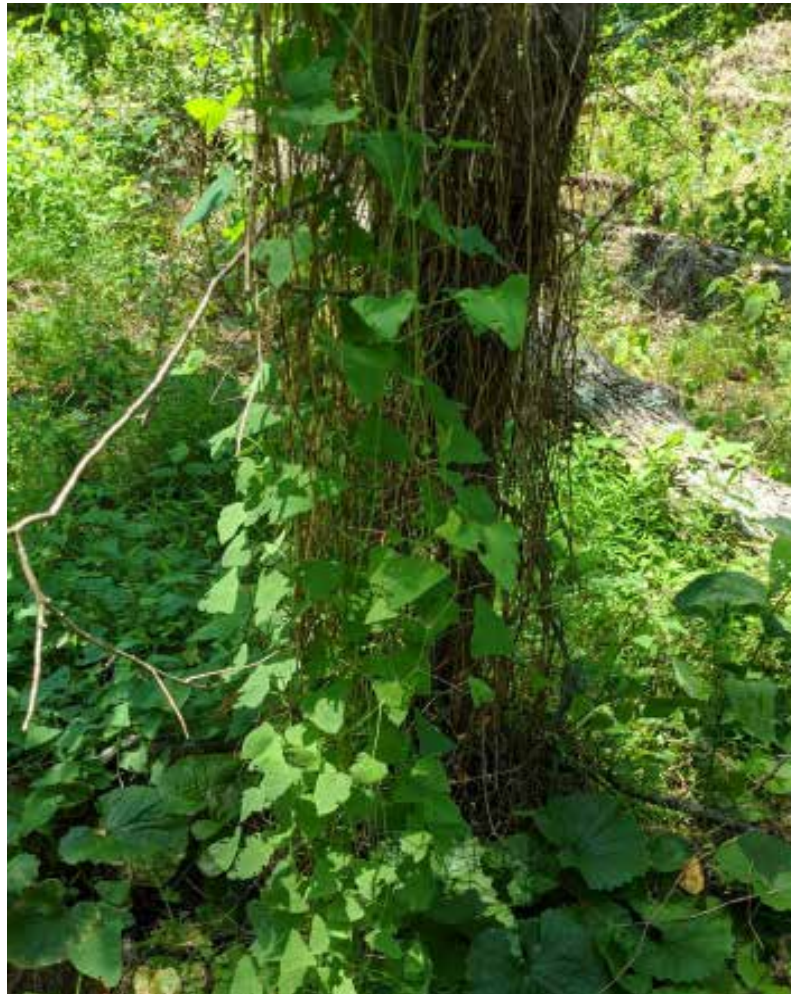
Mile - a - Minute climbing a tree at White Oak Park

- Prioritize removal & reduction of small populations, as this will limit their ability to spread more extensively. Hand-pulling with gloves on is effective and not difficult for a small number of plants. If seeds have not formed, plants can be left to dry; if seeds have already formed, plants must be bagged, removed, and destroyed.

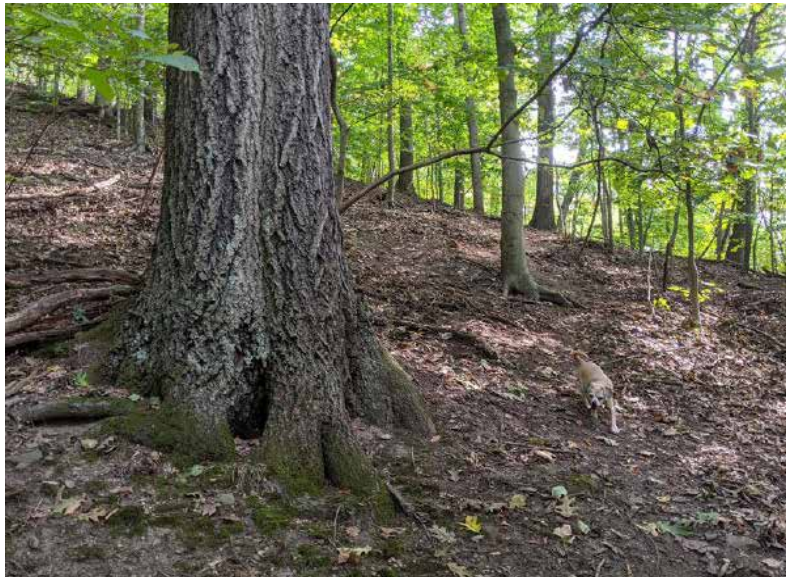
Deer Browse within White Oak Park

- Deer browse pressure makes natural areas more susceptible to the establishment of invasive species by creating bare soil areas and reducing competition from native species. Reducing deer browse pressure can strengthen the natural resilience of forest communities.

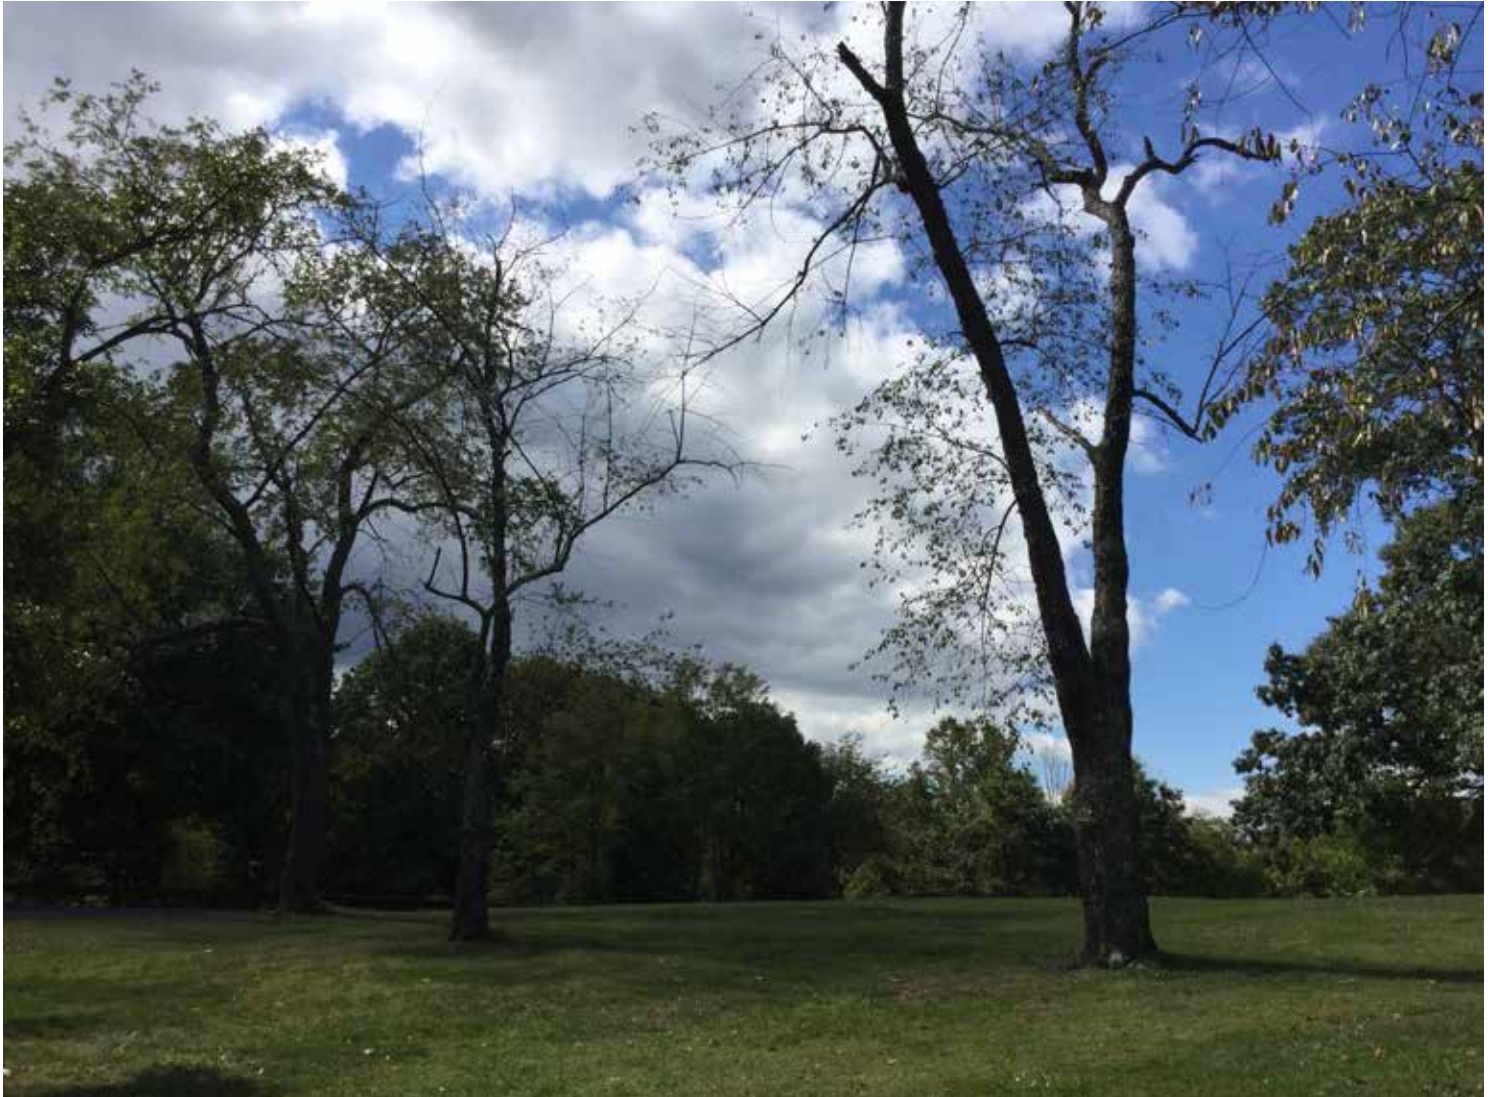
Diseased Black Cherry Trees within White Oak Park

The disease then spreads throughout the tree's vascular system. The tree will respond by plugging up its tissue in an effort to restrict further spread of the disease. In doing so, however, the affected area also becomes cut off from the flow of water and nutrients. This often causes the area to decline. In the case of a canker disease, the progressive growth of the infected area can eventually girdle a branch or stem, further restricting capacity of the tree's vascular system.

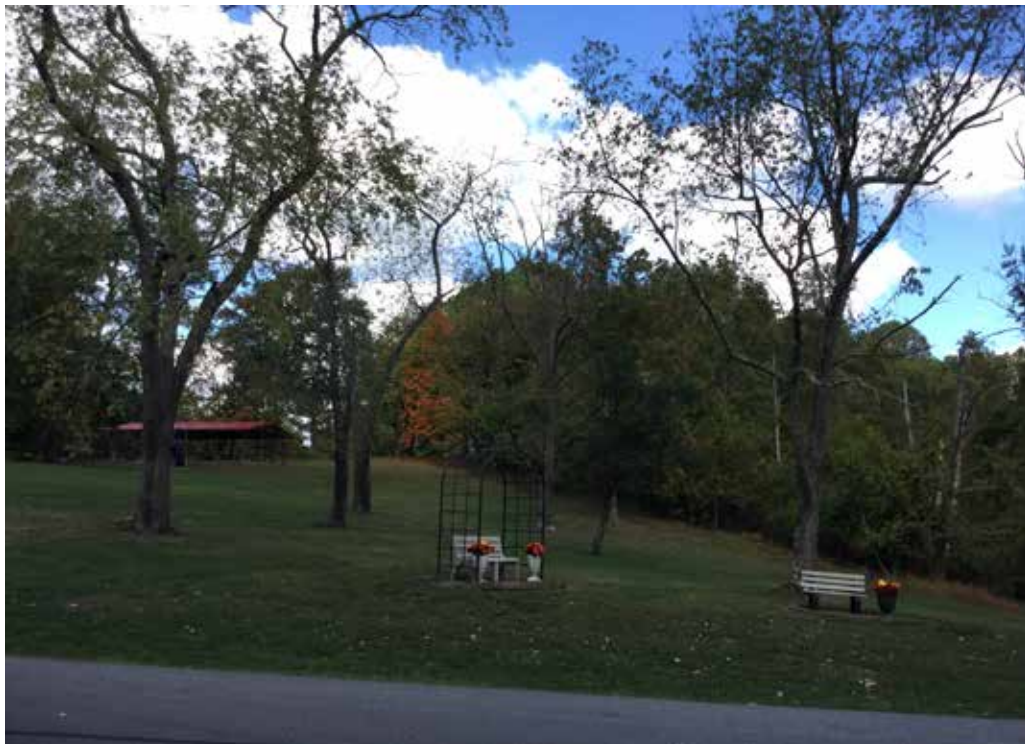
Diseased Black Cherry Trees adjacent to the Willow Shelter

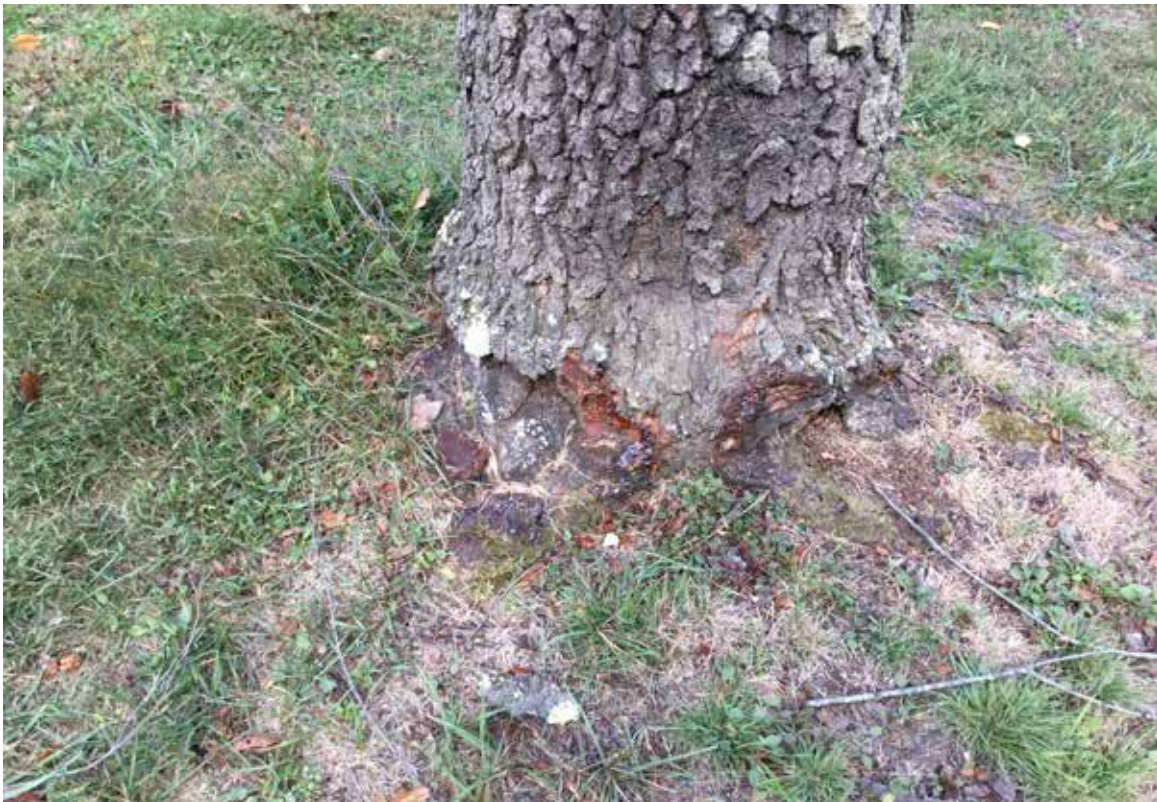
Tree Damage Caused by Mower Deck.

- Mulch all trees, regardless of size, to limit grass and weed growth near tree trunks and major roots.
 - Mulch rings should be maintained annually.
 - Mulch should be only two to four inches deep.
 - Mulch should not make contact with any part of the trunk.
 - Only use undyed, hardwood mulch.
- Raise mower decks and maintain grass at a taller height, at least immediately around a tree.
- Mow less frequently.
- Convert mowed lawns into natural meadows.
- Train park staff to mow/weed trim cautiously around trees.
- Only prune trees in winter.
- Sanitize pruning tools with alcohol after use on each tree.
- Plant trees species in mowed areas that are more tolerant of wounding or root damage (similar to construction sites)

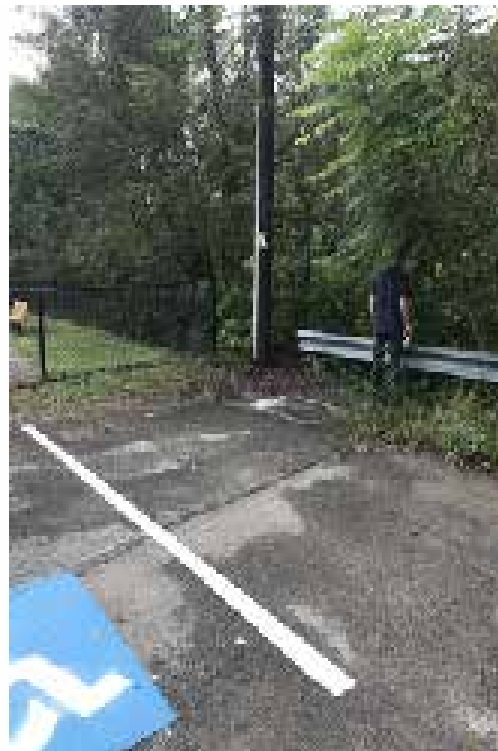
Parking Lot Catch Basin

Trenches installed within the parking lot to redirect the water to the northeast swale are not advisable due to a high level of maintenance.

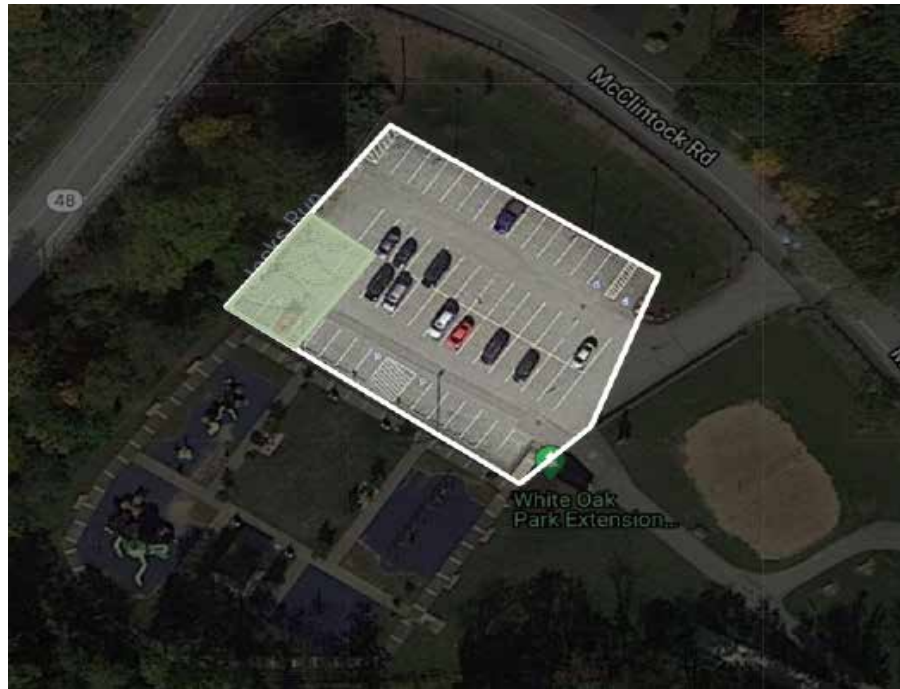
Proposed Location for the Vegetated Bioswale in the Chestnut Grove Parking Lot.

- Modeling data specific to the Chestnut Grove Parking Lot bioswale can be accessed online at <https://modelmywatershed.org/project/37239/>.

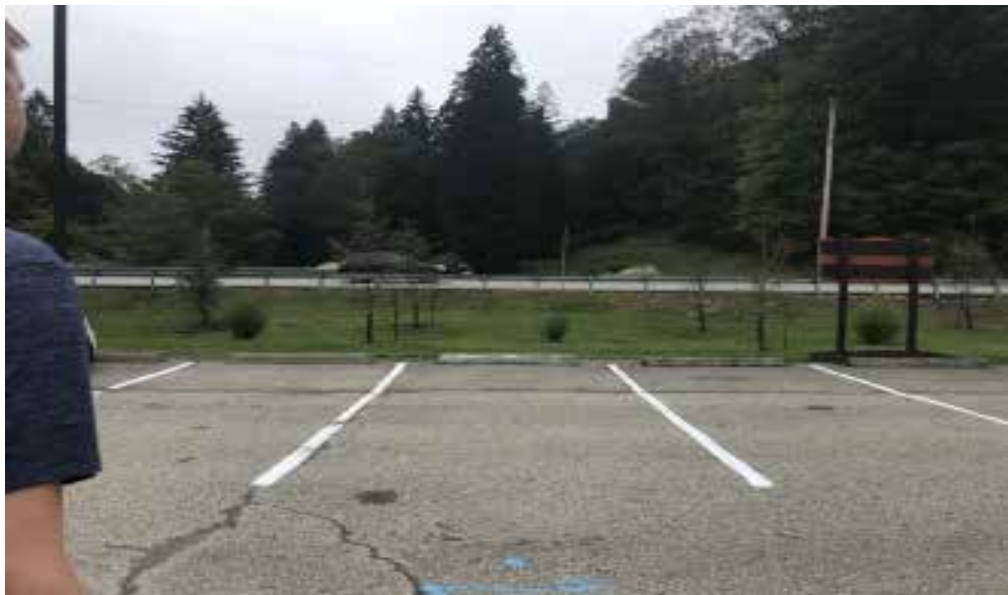
Greenspace adjacent to the Chestnut Grove Parking Lot. Stormwater does not currently enter this greenspace..

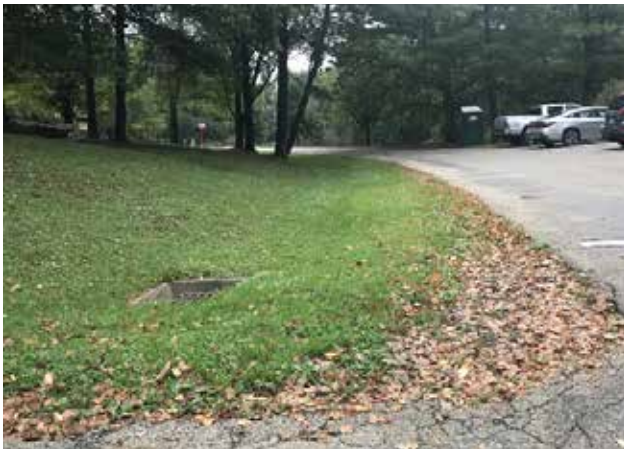
Wedding / Gardens Mountain Ash Area

At the Wedding Gardens site, runoff from White Oak Park Ext. (road) and the parking area is captured in a series of catch basins that lead to a stone culvert and then ultimately discharge to a large lawn area. Erosion is evident in this area, as it is in other similar situations throughout the park.

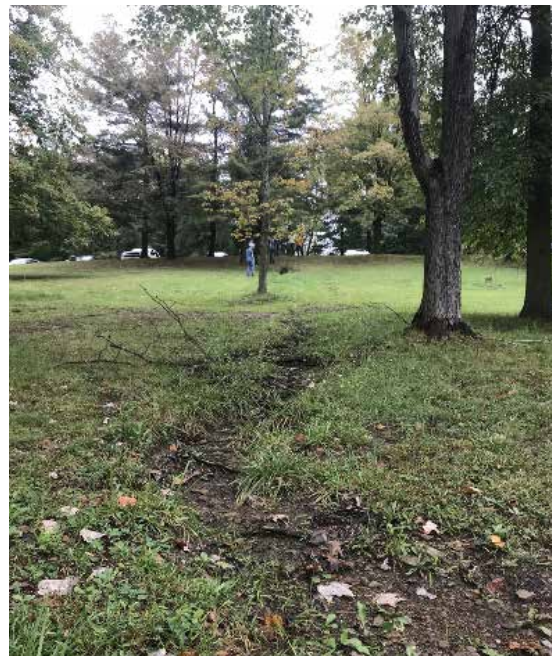
Erosion from Runoff off the Parking Area

In this case, runoff calculations using the Wikiwatershed web toolkit do not show any impact from upstream bioswale installation, mostly given the existing vegetation cover. The approach here is to address the flush of runoff in the adjacent open greenspace with riparian buffer plantings and features such as stone weirs that will slow the runoff and promote infiltration before erosion and sedimentation can negatively impact the nearby forest and stream. Implementation of this project will also help reduce maintenance issues such as mowing wet, eroded areas.

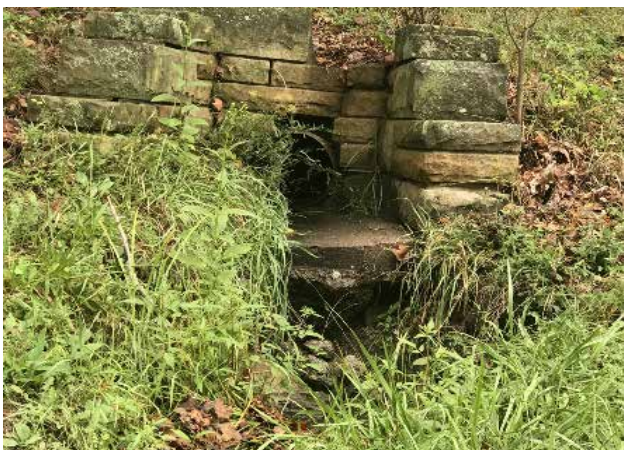
Stone Culvert

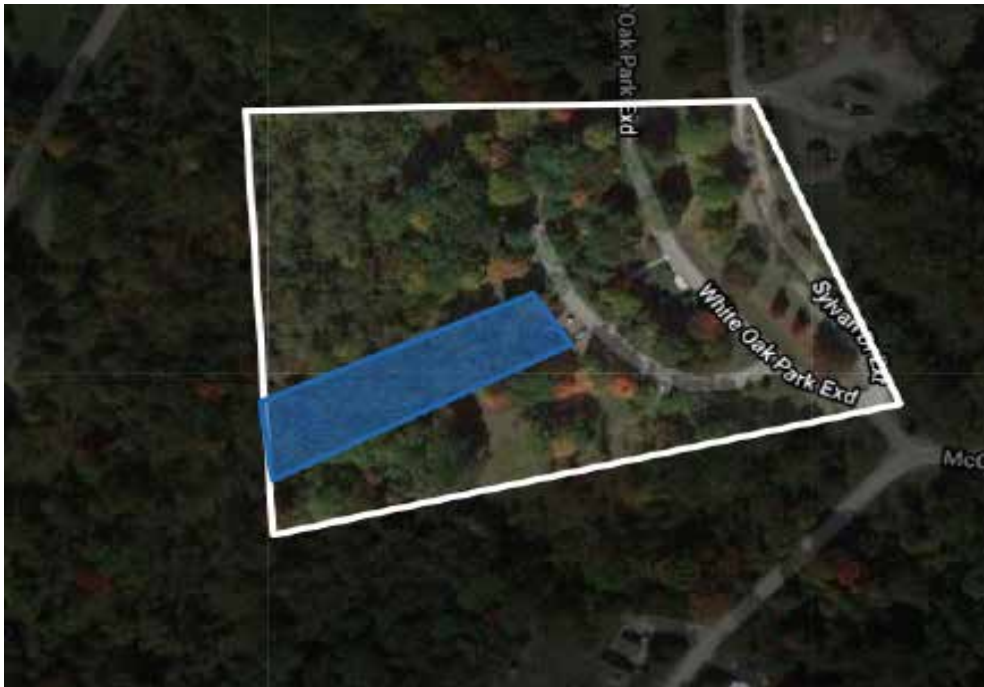
Proposed Culvert Improvement and Riparian Buffer

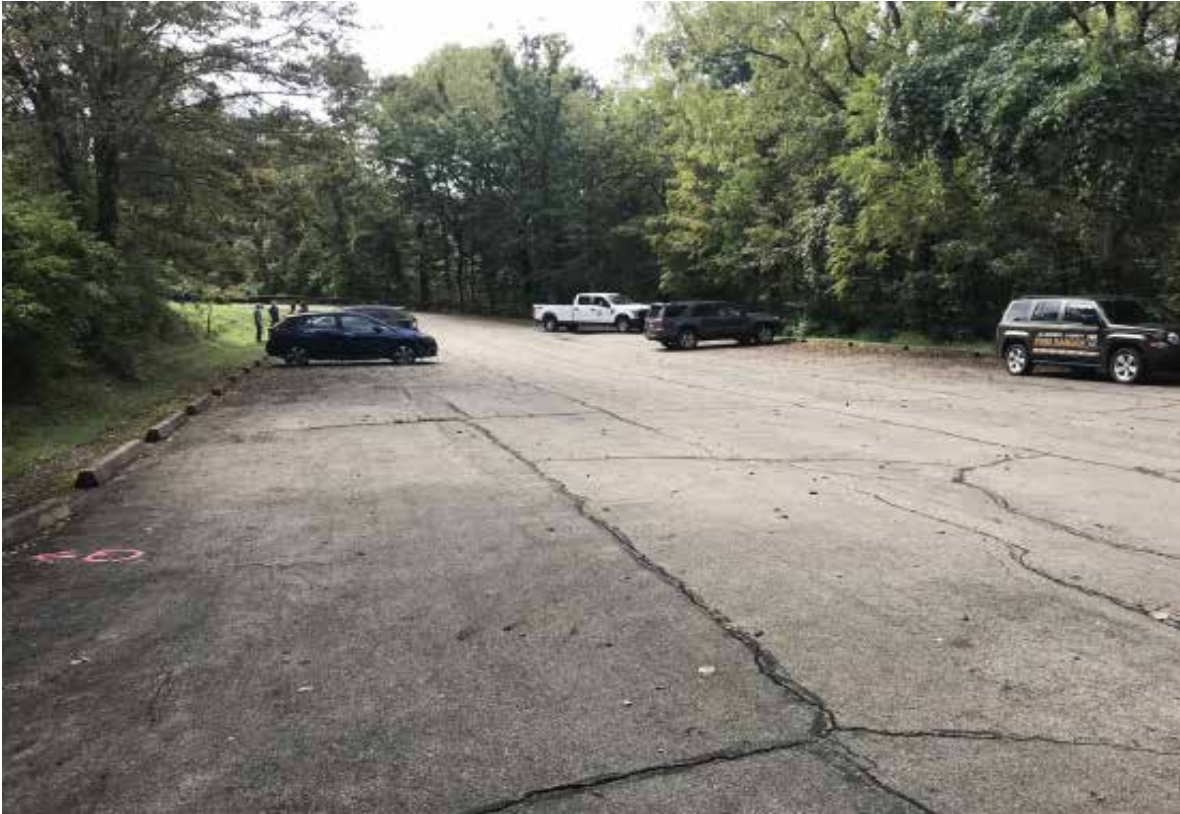
Cedar One Shelter Parking Lot

The catch basins within and around the “Cedar One” shelter parking lot capture a significant amount of stormwater runoff from other nearby parking areas and White Oak Park Exd Road, causing severe runoff, erosion, and sedimentation in the adjacent woods and unnamed stream. This may be a location where subsurface retention facilities would be effective. Otherwise, retention would be required further up the sewershed to slow runoff and reduce non-point source pollution and sedimentation in the stream.

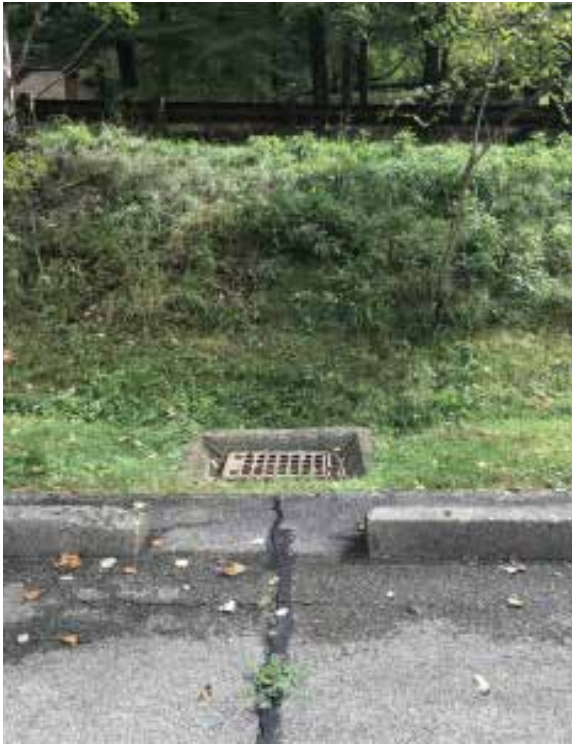
Catch Basin next to the Cedar Grove Lot.

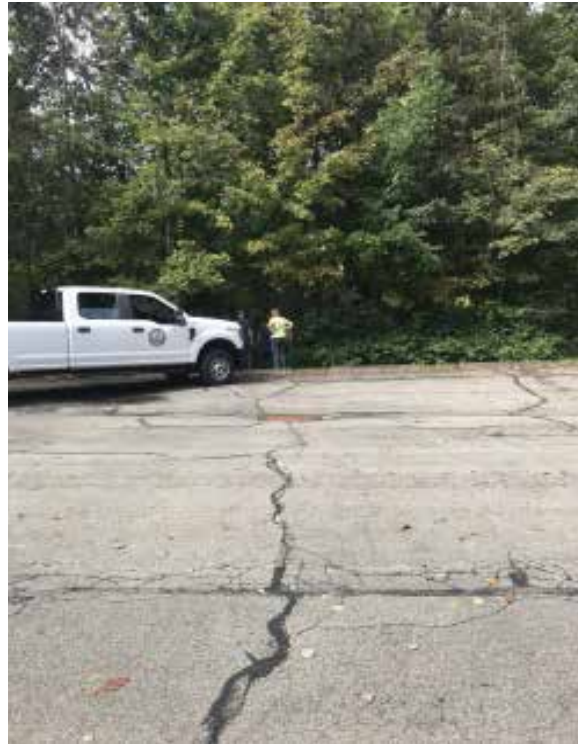
Catch Basin in the Center of Cedar Grove Lot, just above the Outfall Pipe

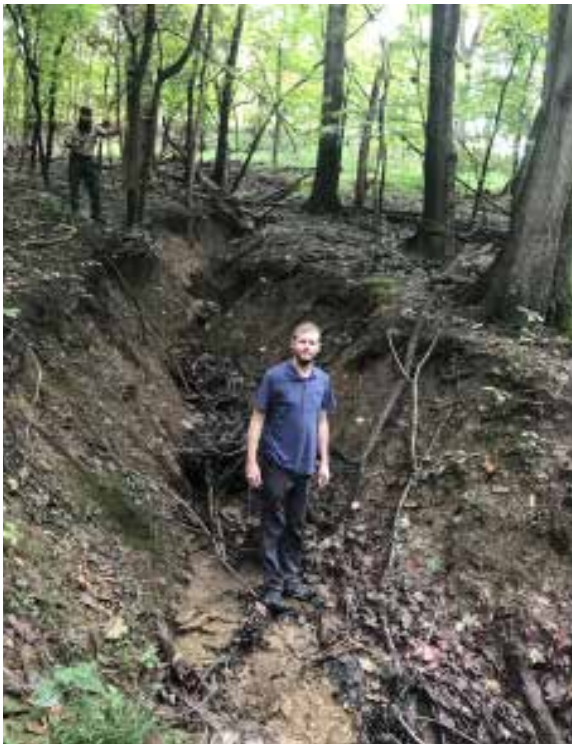
Severe Erosion Affecting Stream Morphology & Habitat.

- Hydrologic analysis to determine runoff volume and size of retention tanks.
- Infiltration Testing
- Land Survey
- Riparian buffer design and planting plan.
- Demolition of existing asphalt parking lot.
- Construction—excavation, tank installation, sewer/catch basin connections, stone weir installations.
- Volunteer planting and maintenance events.
- Monitoring and maintenance.
- Informational signage.

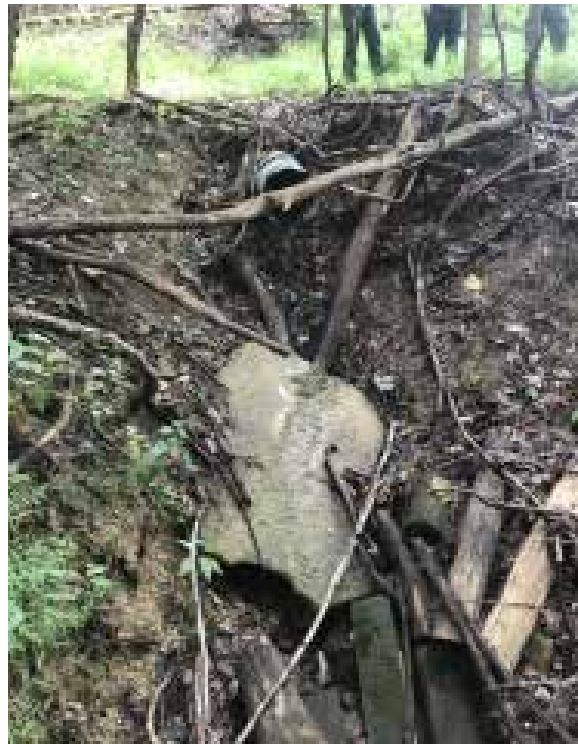
Severe Erosion from the Outfall Pipe from the Cedar Grove Lot

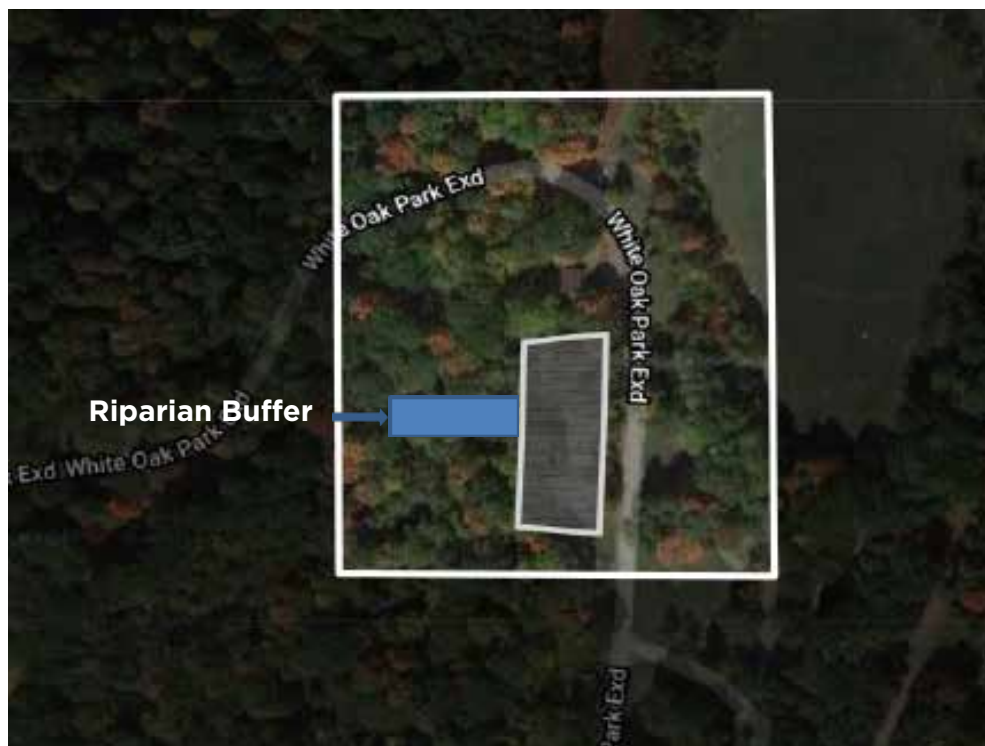
Proposed Retention Tanks & Riparian Buffer Plantings for Cedar Grove Lot
